TAS WATER – Negligence – Resident Heavy Metal ingestion, Breach of Contracts, Misuse of Public Monies

22 October 2019 Pitt&sherry Roofing inspection report

Structural Assessment for New Roof Replacement Date 11 September 2019

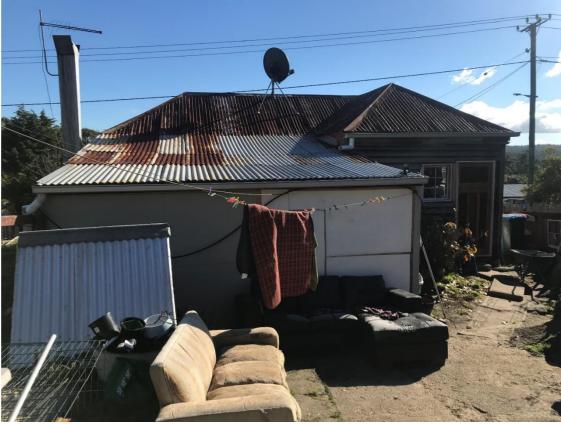
Figure 1: The roof was identified as corrugated iron, with no evidence of paint noted

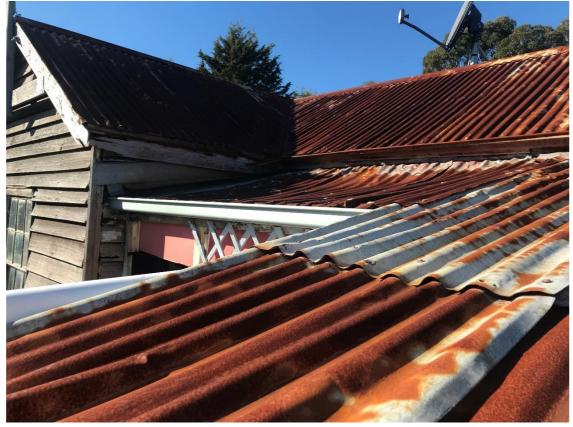
Figure 2: The iron was very rusty across the majority of the roof area

- The roofing is made of unpainted corrugated iron (rusty), yet evidence that the roof was previously painted was identified. The roof is very old and in poor condition

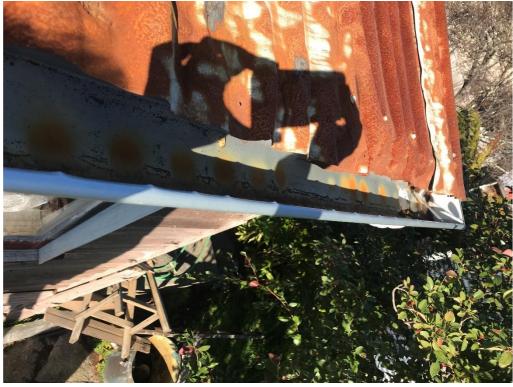
Figure 3: The gutters appeared to be new and clean

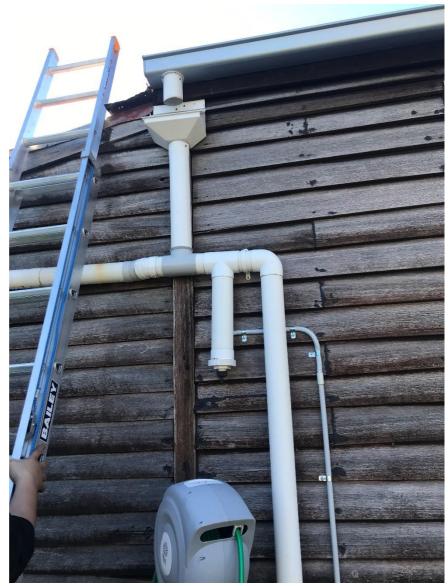
Figure 4: The water collection system. First flush systems were present on the downpipes

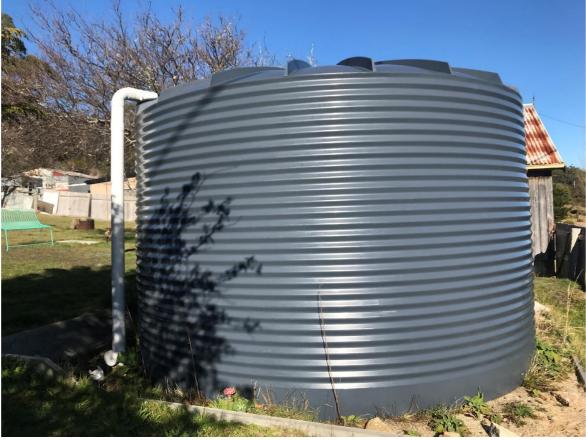
Figure 5: Water tank supplied by TasWater. No tap was present

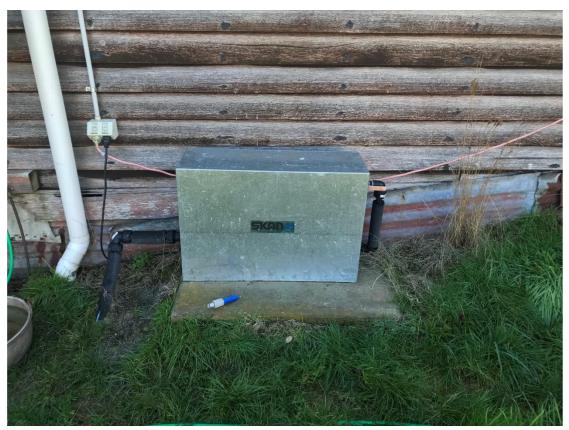
Figure 6: Filter box provided by TasWater. The owner indicated he has cleaned the filter since moving into the property

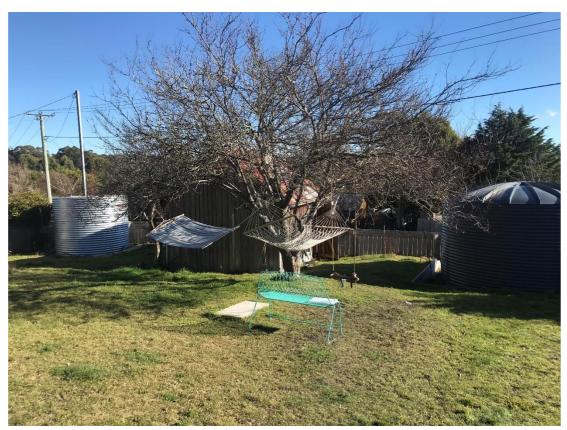
Figure 7: The firefighting tank (left) and main water tank (right)

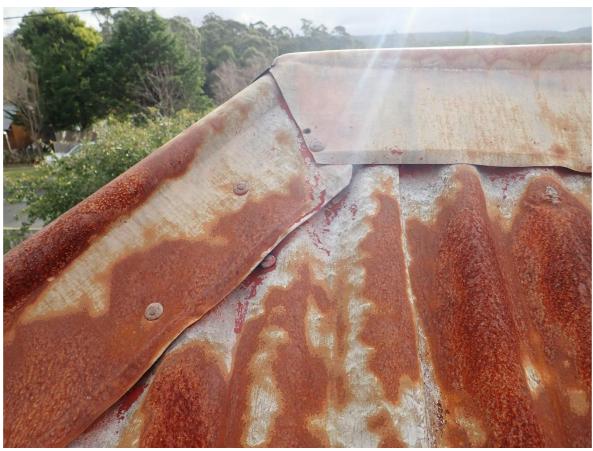
Figure 8: Evidence of paint noted in and around ridge capping

- Based on the above results, the patches of paint on the roof have been identified as the only potential source of cadmium contamination in the water. The tank should be emptied, cleaned and disconnected from the roof. It is not recommended that rainwater is collected from the roof of this property as an ongoing drinking water supply.

- The tanks were emptied, cleaned and refilled on 24/07/19. The tanks have been disconnected from the roof; and
- A structural and roofing assessment was undertaken at the property on 25/07/19 by pitt&sherry and an
 independent roofing plumber to assist with scoping re-roofing options. The outcomes and recommendations of
 this assessment are to be provided in a separate report.

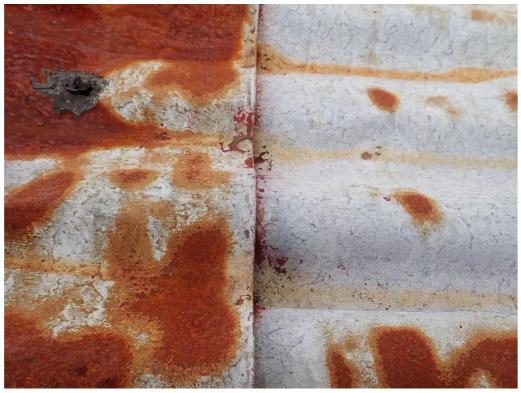
Figure 9: Small amounts of paint noted between some sheets

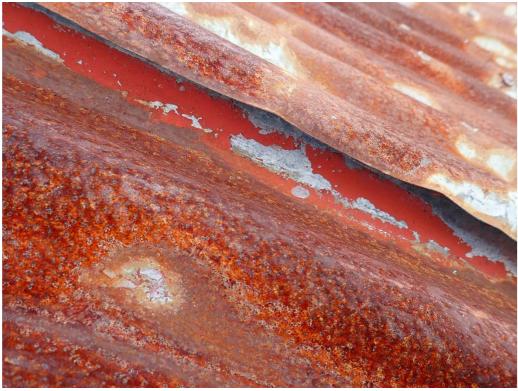
Figure 10: Large patches of paint noted between the two sheets where weather has not worn the paint

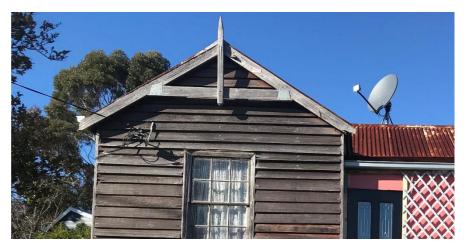
Figure 4: Barge boards on northern gable

The barge boards, routed mouldings and ornamental timber at the gable end have significantly weathered with little to no paint remaining.

- Survey of the existing roof to establish condition, structural integrity of arrangement, connections etc.
- Desktop analysis to determine structural remediation required
- Design and detailing of structural remediation
- Replacement of barge boards
- Replacement of fascia boards; and
- Replacement of routed mouldings/barge rolls.
