From: Kevin Moore
Sent: Monday, 14 July 2014 1:00 PM
To: Graeme Wood
Cc: Stuart Loone; Craig Heron
Subject: TRIM: Wharf Purchase
Attachments: Spring Bay Wharf Remedial Works 2011 PKC.doc.doc; ASD Pile inspections wharf stem.pdf.pdf; ASD Pile inspections wharf head.pdf.pdf

RE Triabunna Mill Wharf Inspection 1.7.09

SPRING BAY WHARF

Spring Bay Wharf

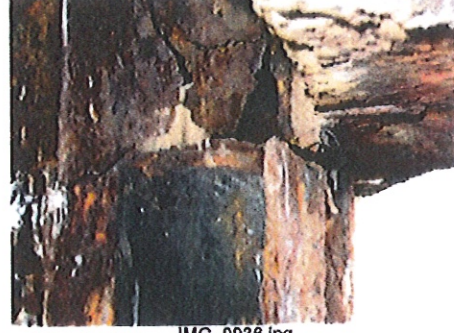
IMG_0936.jpg
01/07/2009

Areas to note: Steel columns on BD4. One column connection to steel fendering has broken away. Remaining three have bad deterioration to plating in same area. In water area of these columns are in good condition, splash zone has moderate rusting.

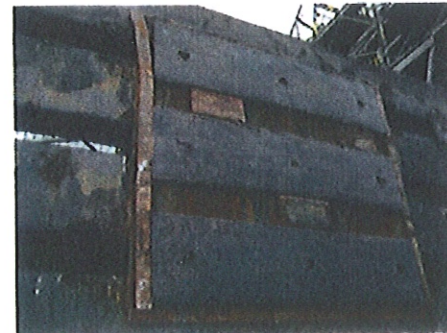
IMG_0940.jpg
01/07/2009

Mild section rubbing strips are coming to end of wear period, having worn down to frame depth.

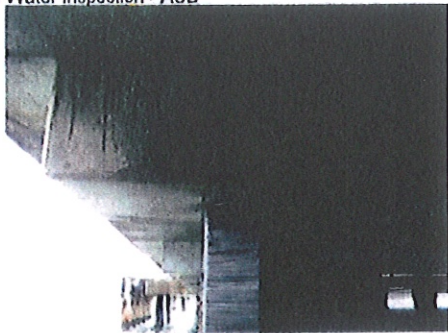
IMG_0943.jpg
01/07/2009

Cracking to 5mm over approx 3m side and underside of beam
[943](#)
[944](#)

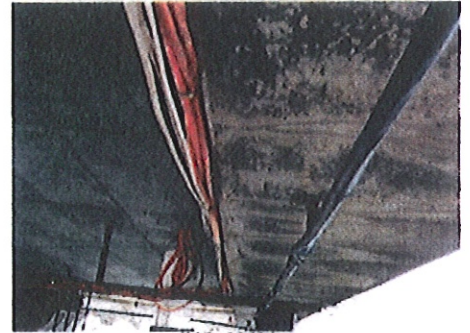
IMG_0948.jpg
01/07/2009

Cracking to 3mm to underside of beam over approx 2m
[948](#)

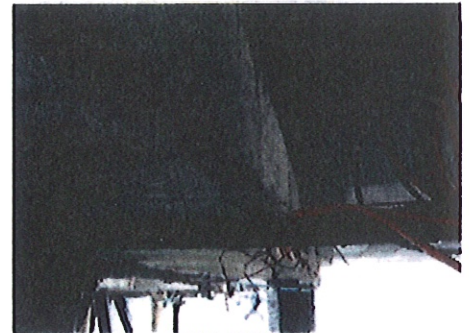
IMG_0951.jpg
01/07/2009

Cracking to 5mm to side and underside of beam over approx 2m
[951](#)

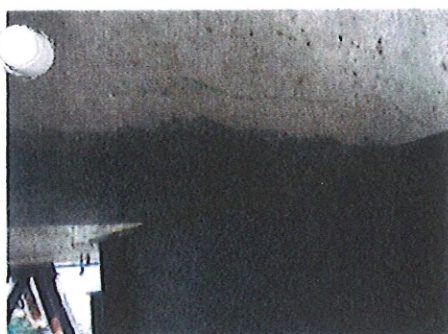
IMG_0952.jpg
01/07/2009

Cracking to 1mm on side of beam over approx 2m

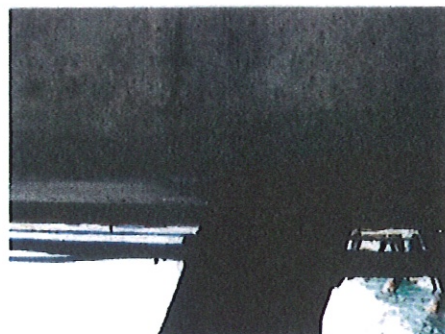
IMG_0953.jpg
01/07/2009

Cracking to 3mm on side of beam over approx 1.5m

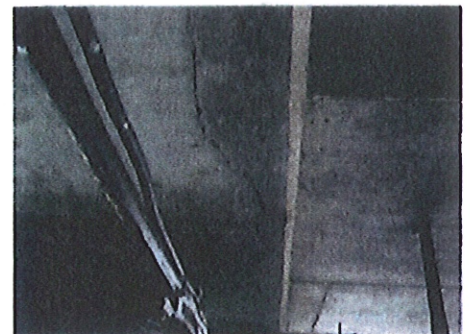
IMG_0954.jpg
01/07/2009

Cracking to 3mm on side and underside over approx 2m

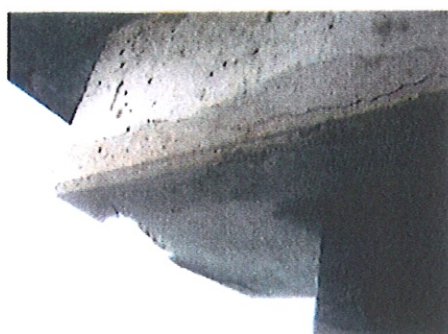
IMG_0955.jpg
01/07/2009

Cracking to 5mm on side and underside of beam

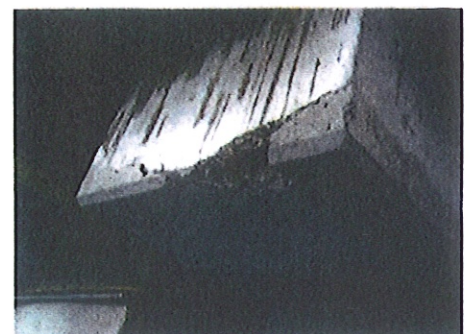
IMG_0957.jpg
01/07/2009

Cracking and spalling with reinforcement visible and rusting

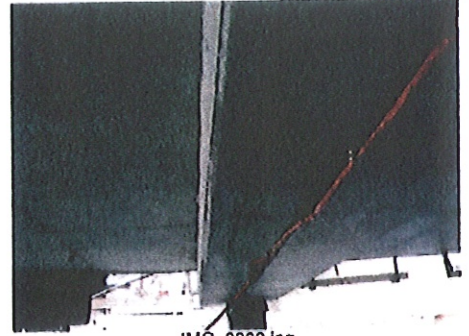
IMG_0960.jpg
01/07/2009

Cracking to 3mm to underside of beam over approx 2m

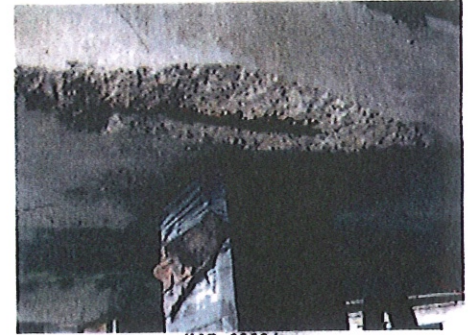
IMG_0963.jpg
01/07/2009

Spalling to approx 100mm with reinforcing showing and rusting

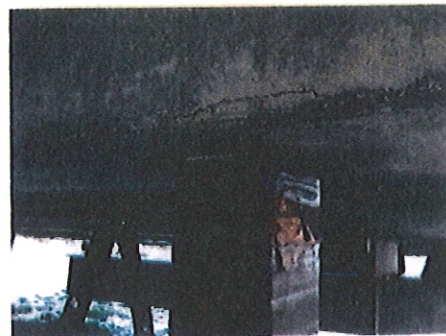
IMG_0964.jpg
01/07/2009

Cracking to 5mm on side of beam over approx 1m

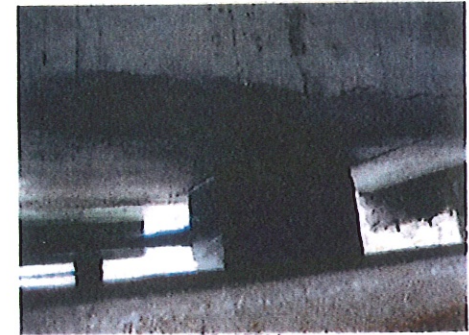
IMG_0966.jpg
01/07/2009

Pile # 1
Cracking to 5mm on side of beam over approx 1m
[966](#)

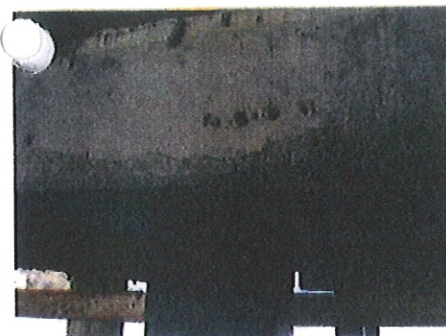
IMG_0967.jpg
01/07/2009

Cracking to 5mm to side and underside

Pile # 1
Cracking to 5mm on side and underside of beam over approx 4m
[967](#)

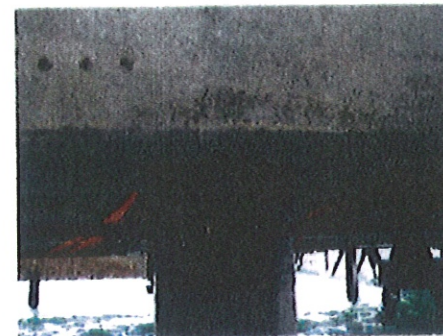
IMG_0968.jpg
01/07/2009

Pile # 2
Cracking to 5mm on side and underside of beam over approx 1m
[968](#)

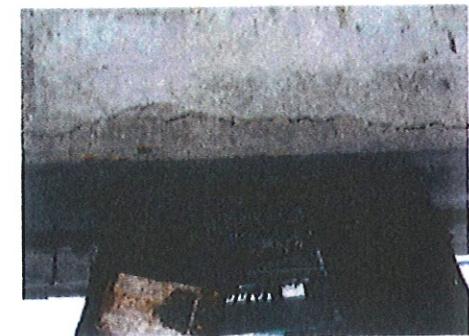
IMG_0969.jpg
01/07/2009

Pile # 3
Cracking to 5mm on side and underside of beam on both sides over approx 4m
[969](#)

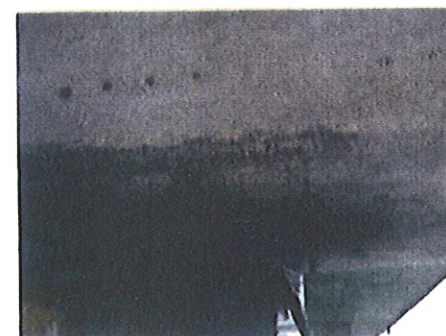
IMG_0970.jpg
01/07/2009

Pile # 4
Cracking to 2mm on side and underside of beam, both sides over approx 1m
[970](#)

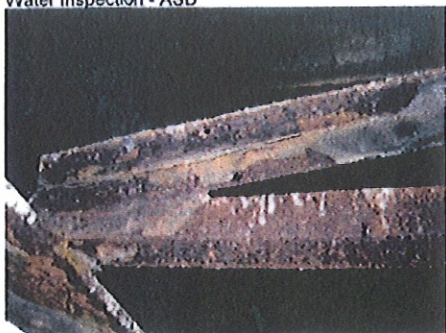
IMG_0973.jpg
01/07/2009

Steel cross bracing under walkways has moderate to severe corrosion, photos show general condition.

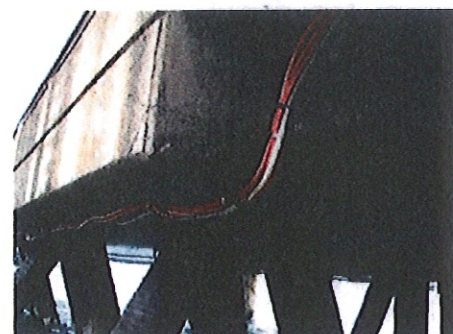
IMG_0981.jpg
01/07/2009

Concrete at north western corner has cracking to 5mm over 2m to side and underside.
[981](#)

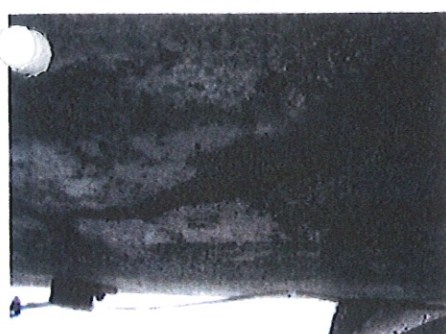
IMG_0982.jpg
01/07/2009

Spalling to soffit over approx 2m square, no reinforcement or rust leaching visible.
[982](#)
[984](#)

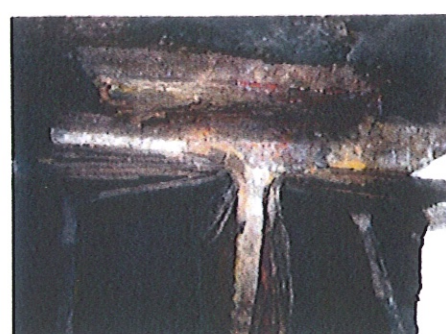
IMG_0985.jpg
01/07/2009

Connections of walkway tressel pile sets, connection of crossheads to walkway beams and connection of crosshead to pile, have moderate to severe corrosion, with delamination. Photos show worst sighted.

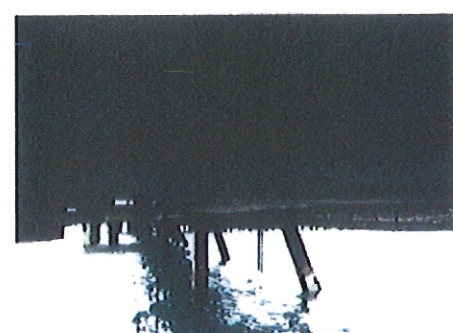
IMG_0987.jpg
01/07/2009

General spalling to soffit over area of approx 30%. No reinforcement or leaching visible.
[987](#)

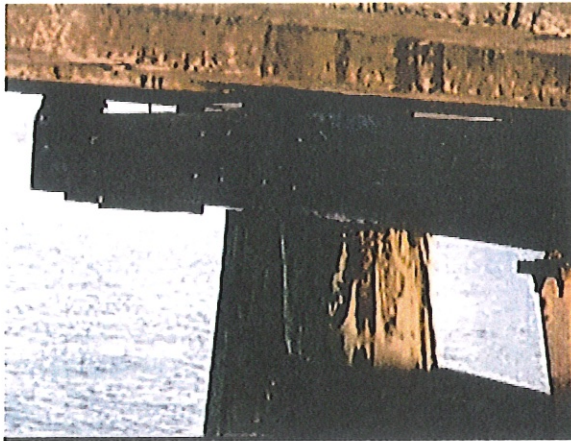
- The crossheads, supporting the main stem of the wharf have severe horizontal cracking through the sections where they are secured to the vertical piles.
- The cantilever section of the crossheads have sagged due to the weight of the conveyor supports prior to the recent addition of vertical piles.
- A significant number of the crossheads, particularly where exposed to the weather show significant end rot, softening and shrinkage to the timber. This deterioration is also evident to the timber packers between the crossheads.

Photo shows the severity of the cracked crossheads

- Due to the deteriorating condition of a number of crossheads, install additional support systems under the crossheads to provide support to the deck and conveyor system.

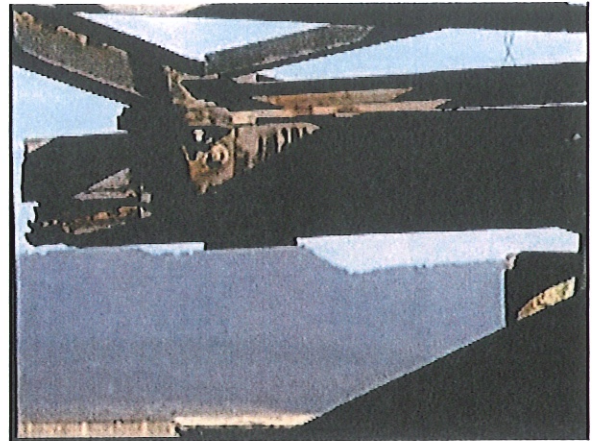
Photo shows the cantilever section of the crosshead & the level of decayed in a section of crosshead

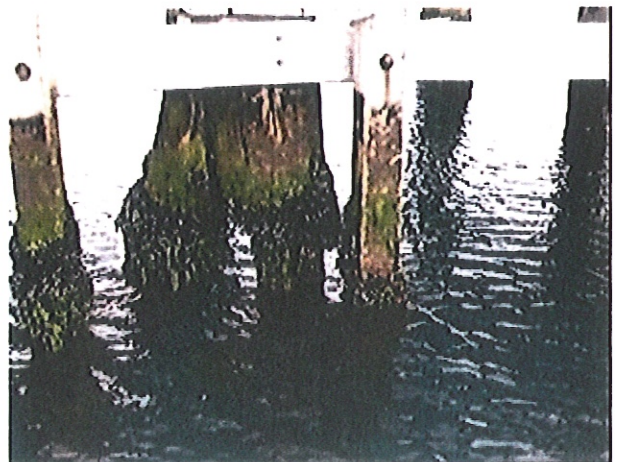
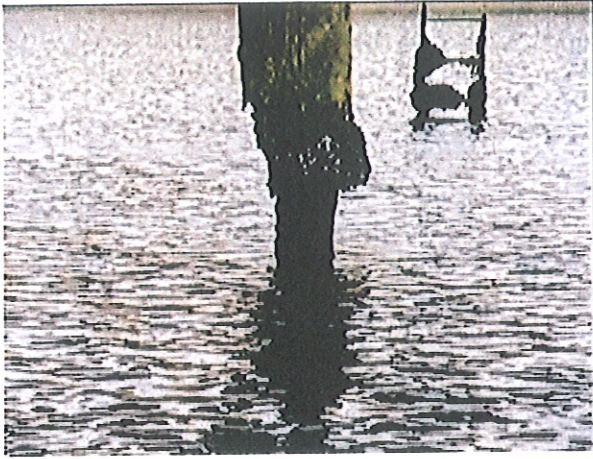
- The treated timber piles supporting the wharf stem have substantial loss of section mainly in the tidal zone caused by wave action due to damaged or no pile wrapping. The underwater sections of the piles have large amounts of marine growth and indicate that the pile could be subjected to Toredoworm attack. Toredoworm attack occurs from the inside out and the pile ends up with honeycomb sections and loss of

Photo shows the extent of the deterioration and pile condition

- Pending the results of the underwater survey undertake further concrete encasement of piles identified as needing repair.
- Replace missing pile wrapping to protect the piles from erosion and Toredoworm attack.

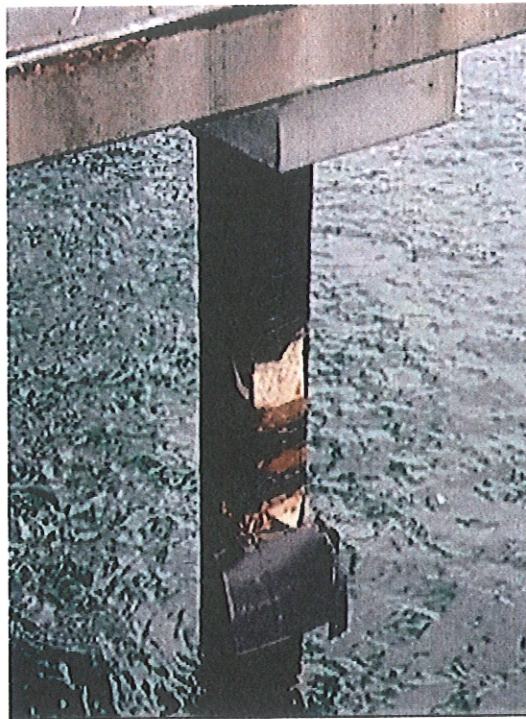
- During the original wharf construction the steel piles in the head of the wharf were wrapped with a Denso 200 series wrapping system to protect them from corrosion. Over time the method of securing the outer wraps has failed allowing the wraps to fall off leaving the steel section vulnerable to corrosion/erosion.
- Damage to the pile wrapping has also been caused by recreational fishing vessels operating in the area as they lay up against the piles.

Photo shows the condition of some of the pile wrapping

- Undertake repairs/replacement to the pile protective wrapping system to prevent future corrosion.

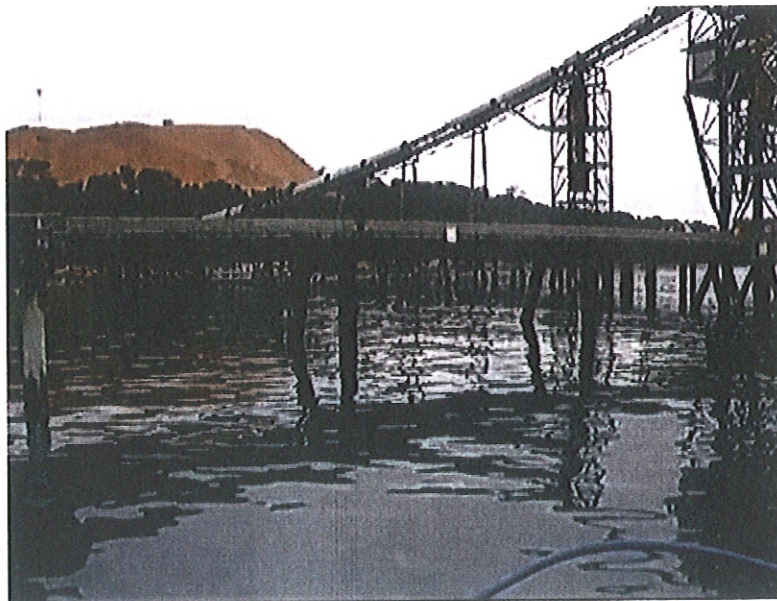
- The steel trestle beams that span between the wharf head concrete dolphins are in a deteriorated condition caused by corrosion. The original paint protection system has deteriorated over the years and exposed the steel to the salt water environment causing rust and delamination.

Photo shows the trestle beams that span from each concrete wharf head dolphin

- The trestle beams require sandblasting to remove the build-up of rust. A suitable paint protection system then needs to be applied to protect the beams from future corrosion.

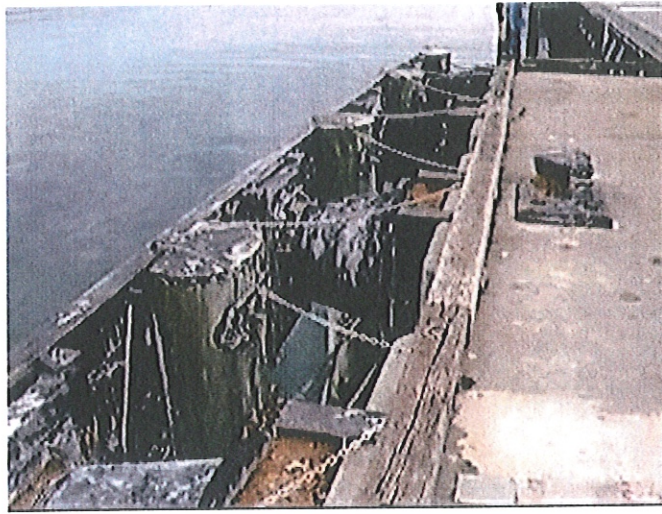
Photo shows the fender system configuration

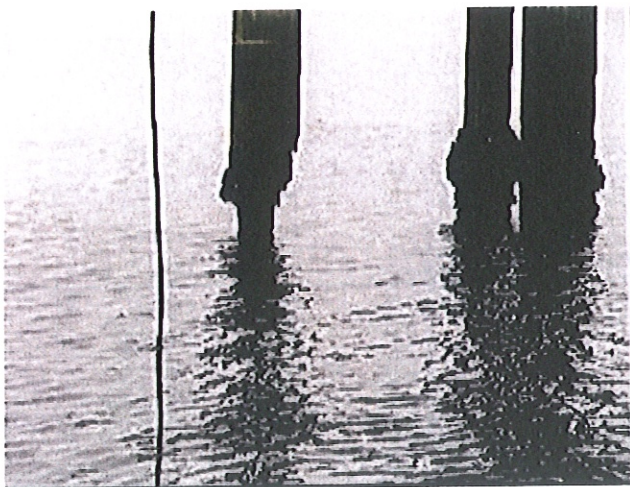
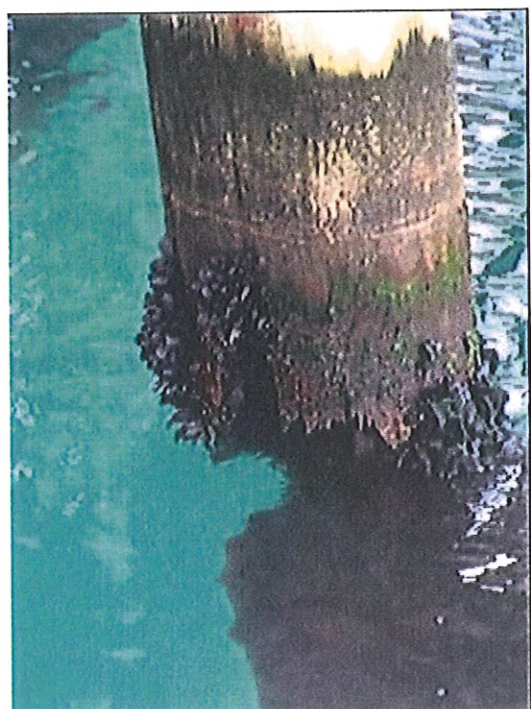
- Currently a number of the treated timber piles are providing little or no support to the fender system, with over the years the pile wrapping becoming non-existent and the piles exposed to Toredoworm attack, erosion from tidal movement and wave action. eg. the third dolphin from the eastern end of the wharf has three piles that are providing little structural support and need to be replaced to support the fender frame.

Photos show the deteriorated condition of some of the piles in the stem and fender system

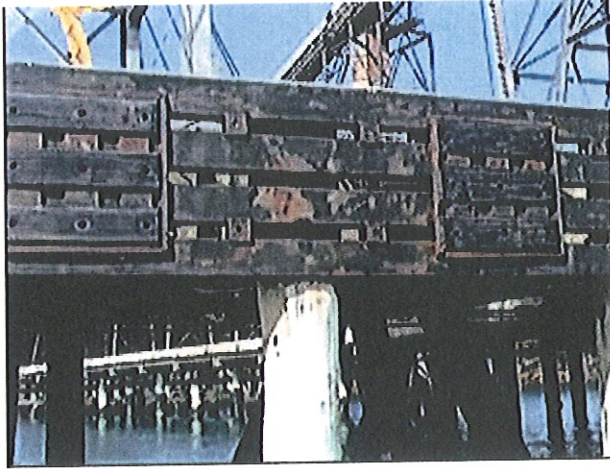
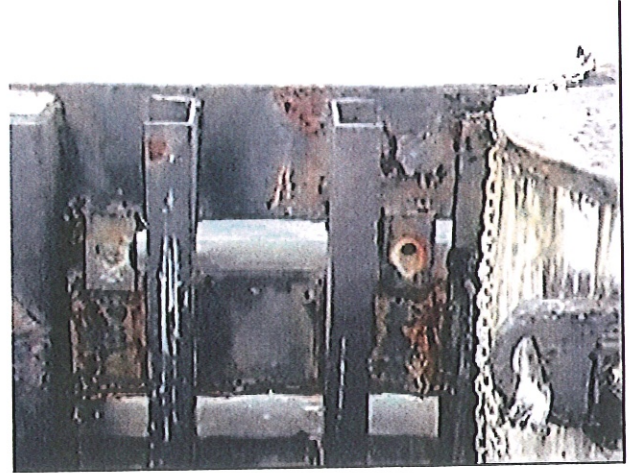
- The large steel fender frames fabricated from 150x200 RHS are showing signs of severe corrosion and a heavy build-up of delaminated rust. The fender frames were originally painted with a two pack epoxy resin paint system of which has eroded and now provides little protection to the steel.

Photo shows the wharf face fender frames and corrosion

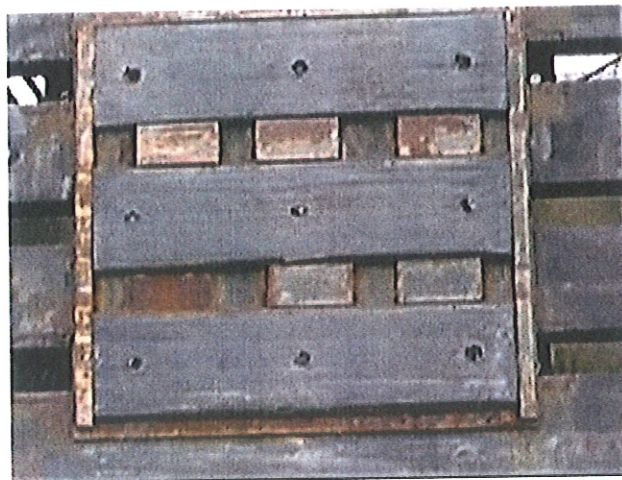
- Secured to the face of the steel fender frames are steel plates with high density polyethylene (HDPE) rubbing strips installed. The HDPE strips have worn over the years and are now at a point where they have worn down level with the steel sections. Some steel sections have been damaged due to the vessels rubbing steel on steel.

Photo shows the HDPE fender face rubbing strips

- Investigate the need for the current berthing fender arrangement and determine if there is a simpler fender system that can be progressively installed to service the needs of future ships utilising the berth facilities.
- Pending the outcome of the fender investigations, and should the current fender system be retained the following should be considered.
 1. The fender frames require removal, repair, sandblasting and the application of a suitable marine grade paint system or galvanising.
 2. The replacement of the fender support piles identified in the underwater timber pile assessment as requiring replacement
 3. Installation of protective pile wraps to protect the piles from future erosion
 4. The HDPE protective rubbing strips on the face of the fender system require replacement to reduce friction on the steel sections and damage to the vessels.

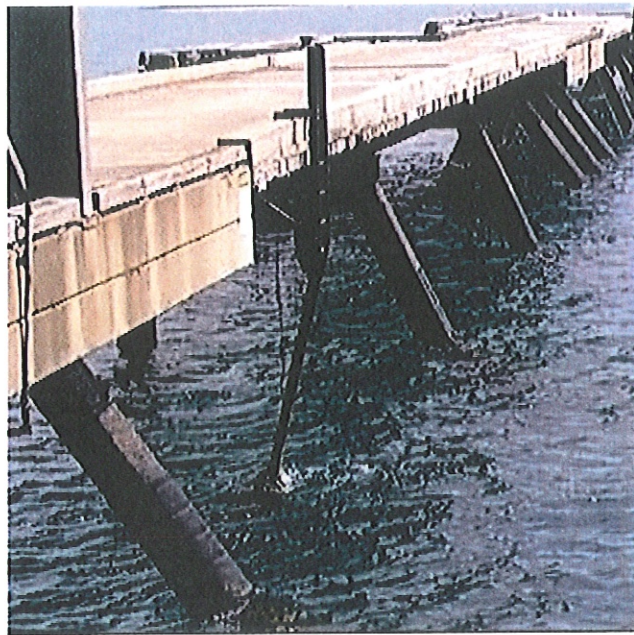
- Four steel fabricated safety ladders have been strategically positioned along the rear face of the main wharf head to assist in the retrieval of persons should they fall over the side during wharf operations. The safety ladders are in a state of disrepair and fail to comply with current standards AS1657.

Photo shows damaged non-compliant safety ladders

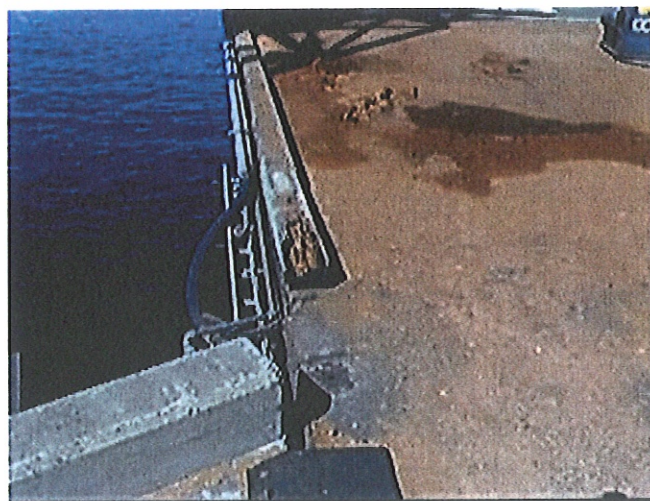
- The original timber curbs are in a deteriorated condition due to the constant exposure to the weather. A number of the timber curbs have split away from their securing bolts or have been damaged through wharf operations. Prior to the uncertainty of the ongoing operation of the facility a program had commenced to over a period of time to replace the timber curbs with galvanised steel sections.

Photo shows damaged deteriorated wharf curb sections

- Progressively replace damaged curb sections as required

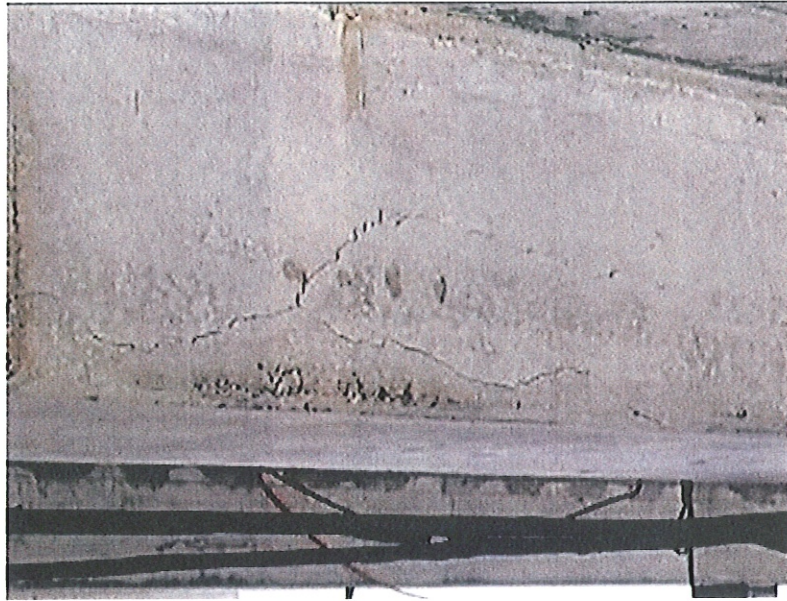
- The wharf head concrete structural beams are showing severe signs of cracking & spalling. The wharf head section that carries the chip loader consists of three rows of five main beams. The structural beams have large cracks around the area where the piles have been encased in the concrete and horizontal cracking of the beams over lengths of 2.5-3.0 meters.

Photo shows the severity of the cracking to the main beams in the concrete wharf head

- Undertake repairs to the main structural beam under the chip loader to prevent further cracking and spalling.

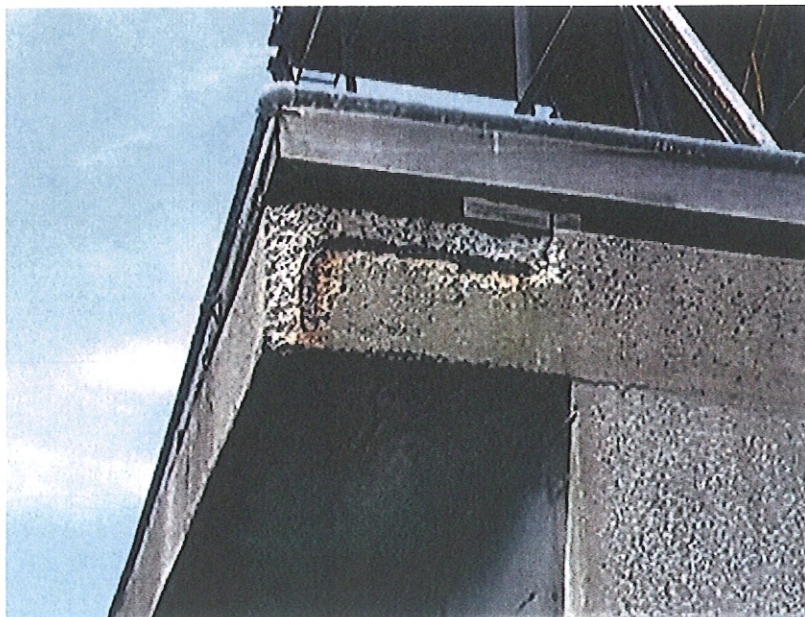
- The areas where the concrete has spalled from the beams, highlights the lack of concrete cover to the reinforcement (in some cases as low as 20mm). The cracking of the beams has been observed for some years now and is progressively getting worse.

Photo highlights the lack of concrete cover to the reinforcing steel

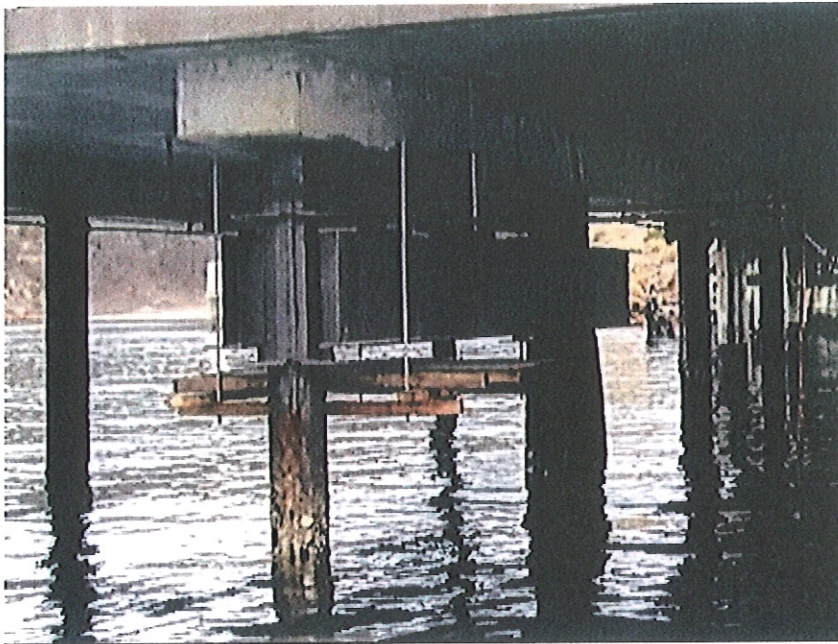
- During 2002 a steel support system was added to the main beams directly below the chip loader support structure. Originally these additions were considered “temporary” at the time and little if any attention to corrosion protection was provided to the system leading to its deteriorated state.

Photo shows the attempt to support the decaying concrete beams
