# Memo

## RE: HB13604 Macquarie Heads Development Road Upgrade – Additional test pitting at Mill Bay

Project No.: HB13604

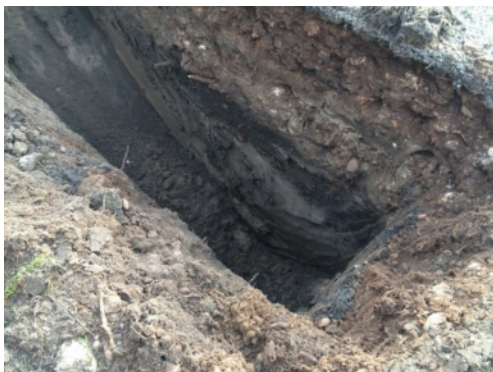
Photo

- OBR\_3 (chainage 1.75km): The test pit was excavated in the shoulder until a depth of 1.10m where the excavation had to be interrupted due to loose material collapsing underneath a water main located on the side of the road. The subgrade is composed of sand with an estimated CBR value of 25%. A gravel layer approximately 400mm thick with an estimated CBR value of 40% was found over the subgrade.

GP	GRAVEL; coarse grained, quartzite, rounded to sub rounded, with coarse sand fines, none plastic, brown. (Pavement and Shoulder material)	40	D-M	MD		
	0.5		SP-SM	silty SAND; fine grained, with some coarse, rounded, quartzite gravels, grey.  Excavation collapsing around water main discontinued pit at 1.1m	25				
	1.0								
	1.5			Hole terminated at 1.10m at target depth
