TASMANIA FIRE SERVICE

Fire Investigation Report

555 Freestone Point Road Triabunna

8th February 2014

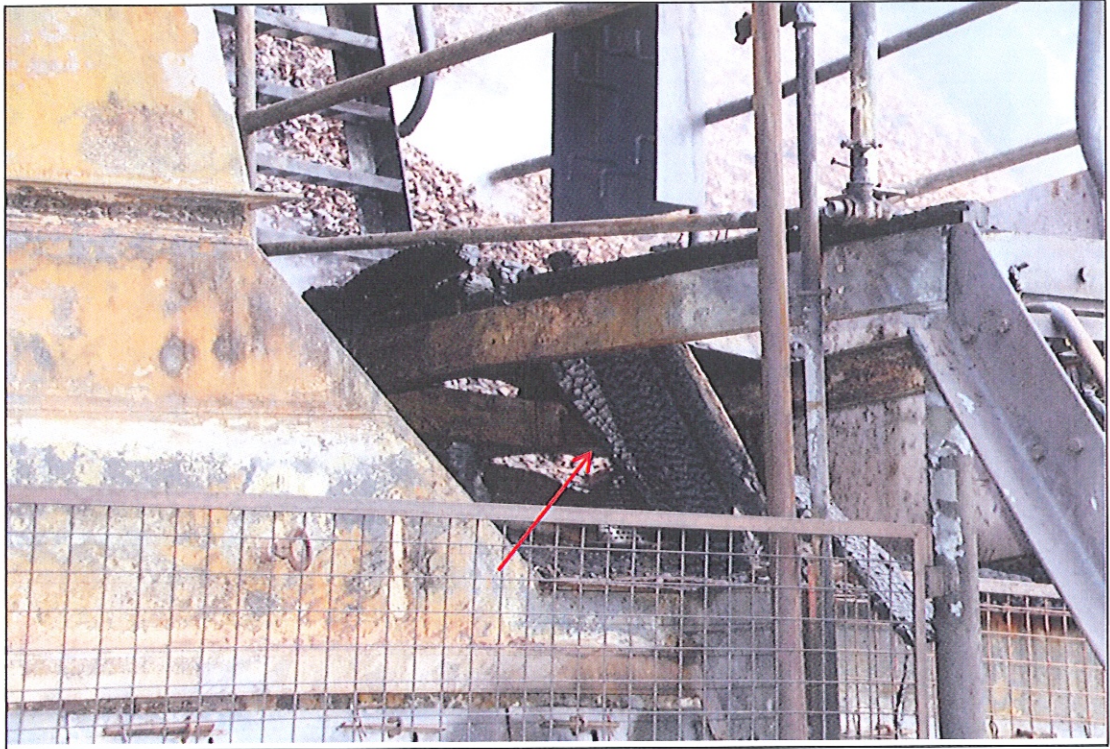
Most overhead damage was evident to the timber platform containing the main switchboard for the hopper. (see photographs 1, 10 and 11)

PHOTOGRAPH: 1. Timbers from platform

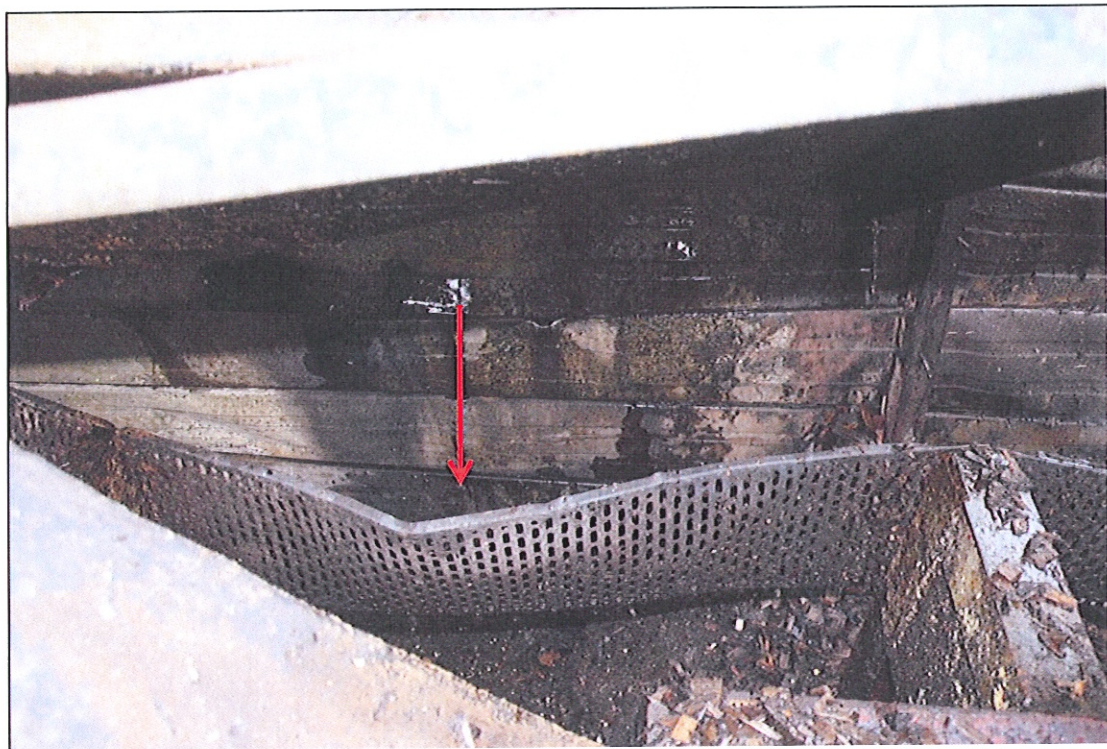
PHOTOGRAPH: 4. Lowest point of heat damage to retaining wall

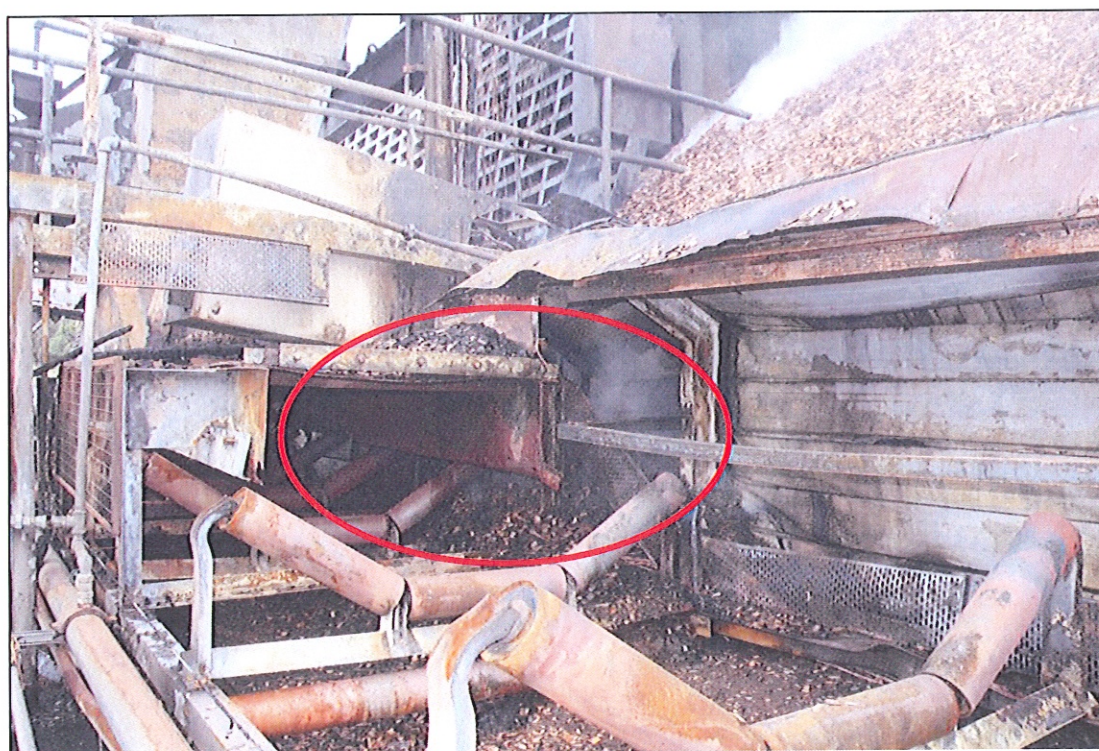
Considering the timeline of events preceding the fire, information obtained from persons at the scene, and the physical fire language indicators present, this fire has originated below the platform where the main switchboard was located, at the base of the steel retaining wall.

PHOTOGRAPH: 6. Approximate area of fire origin.

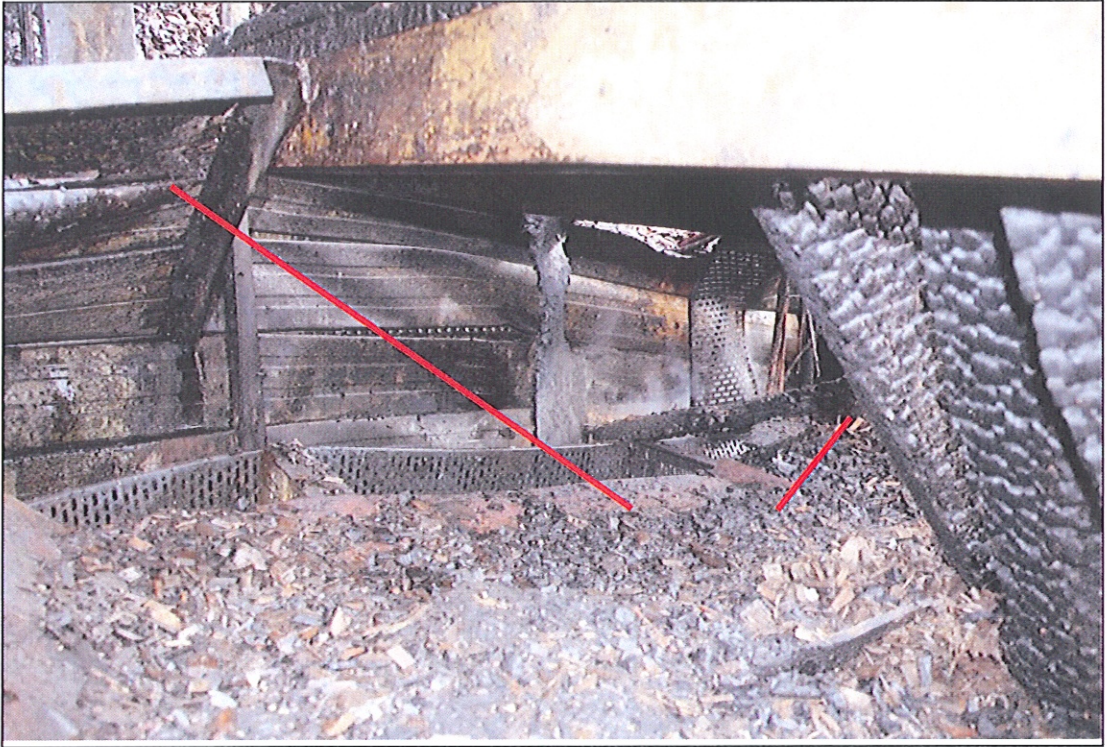
The lowest point of burning was evident by the heat damage to the retaining wall below the timber platform. (See photographs 7 and 8). The wiring conduit in photograph 9 clearly shows less damage to the upper areas of the conduit indicating the fire has originated below the bottom of the wiring.

There was a V pattern on the metal retaining wall below the timber platform travelling in an upward and outward direction. (see photograph 7 and 8)

PHOTOGRAPH: 7 Partial V Pattern from lowest point of burning

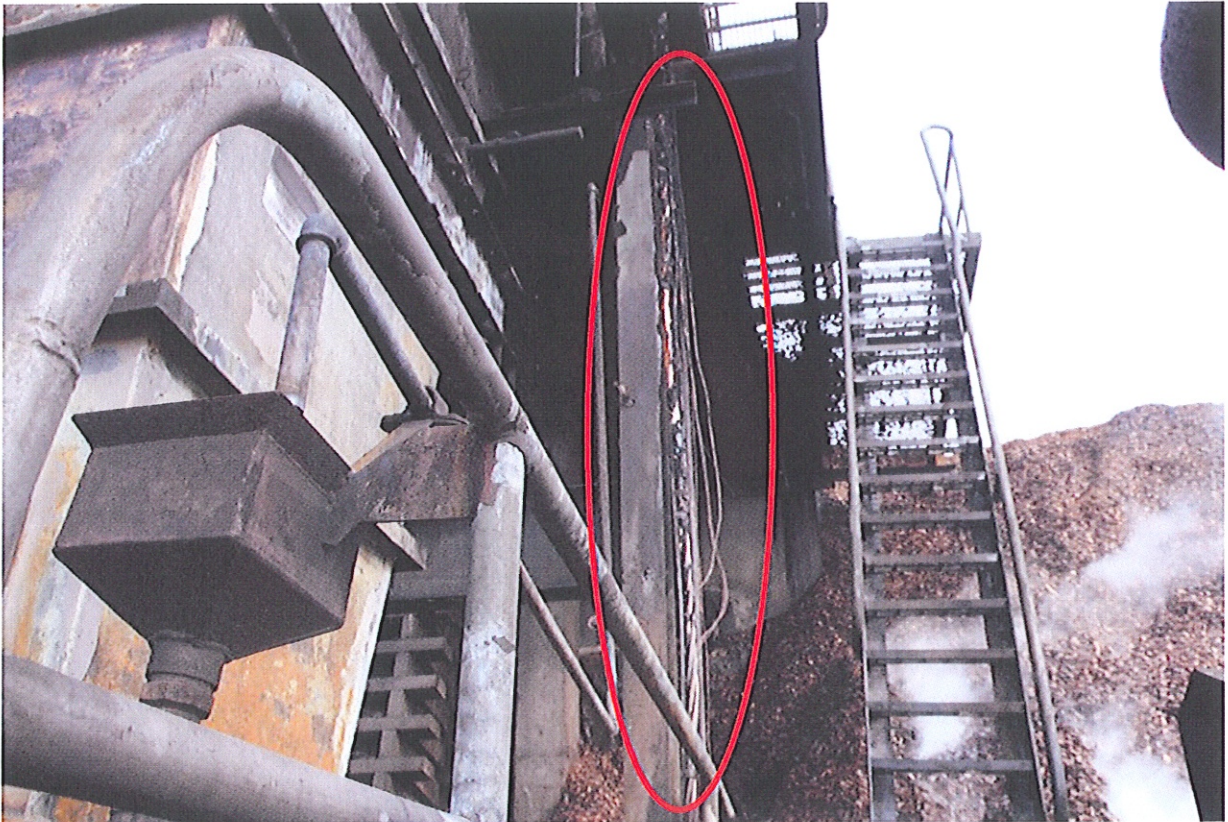
PHOTOGRAPH: 9

Remains of conduit at top of cabling, bottom of conduit has been totally consumed by fire.

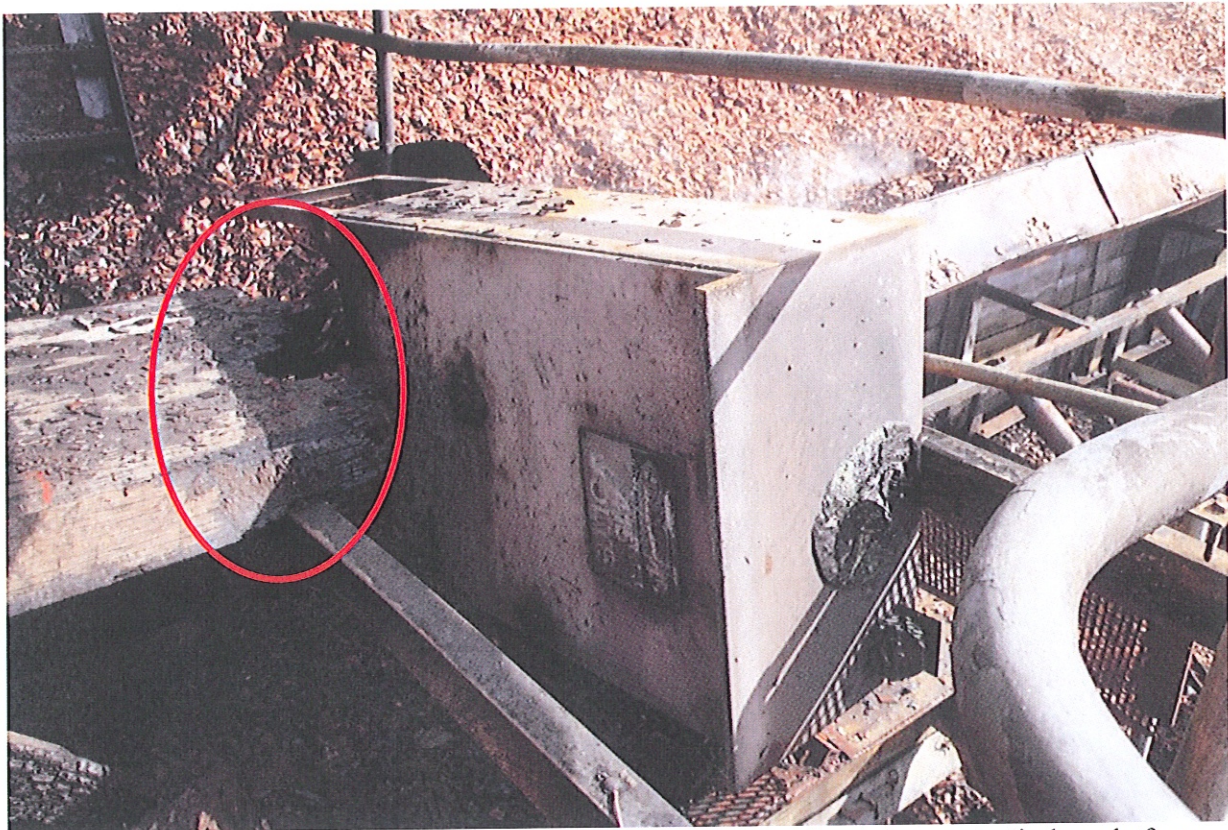
PHOTOGRAPH: 11 Main switch above area of origin. Most overhead damage to timber platform

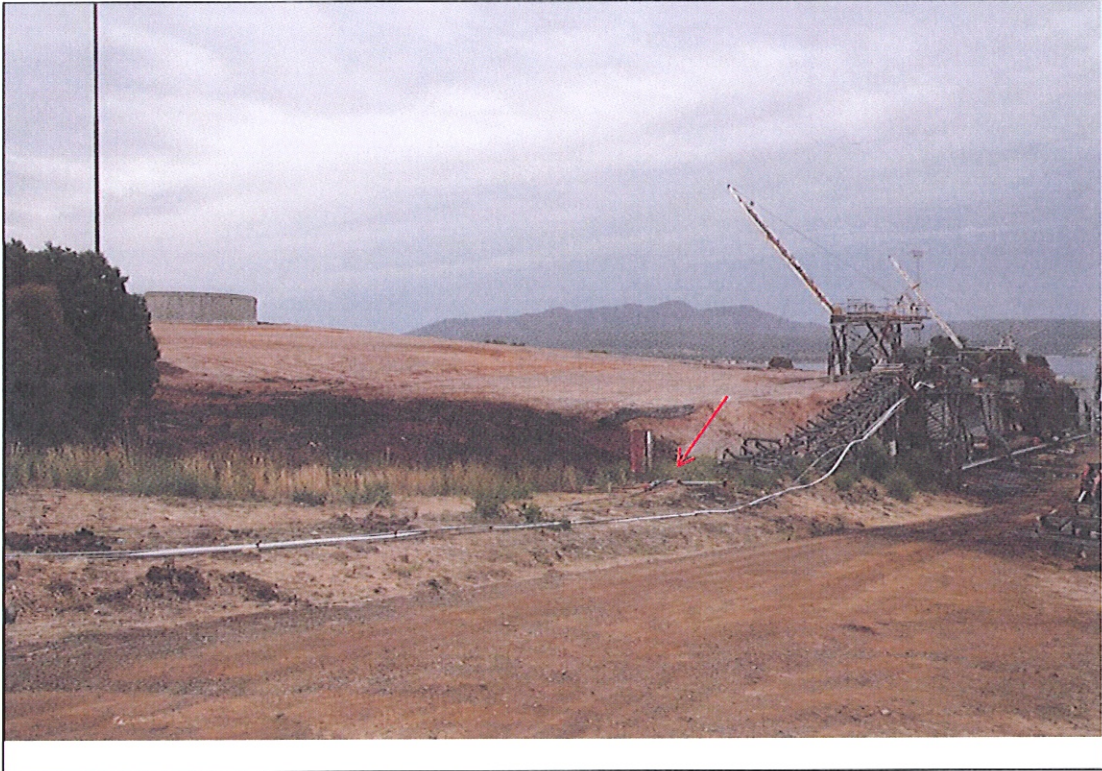
PHOTOGRAPH: 1. Fire origin on Southern end of conveyor belt frame.

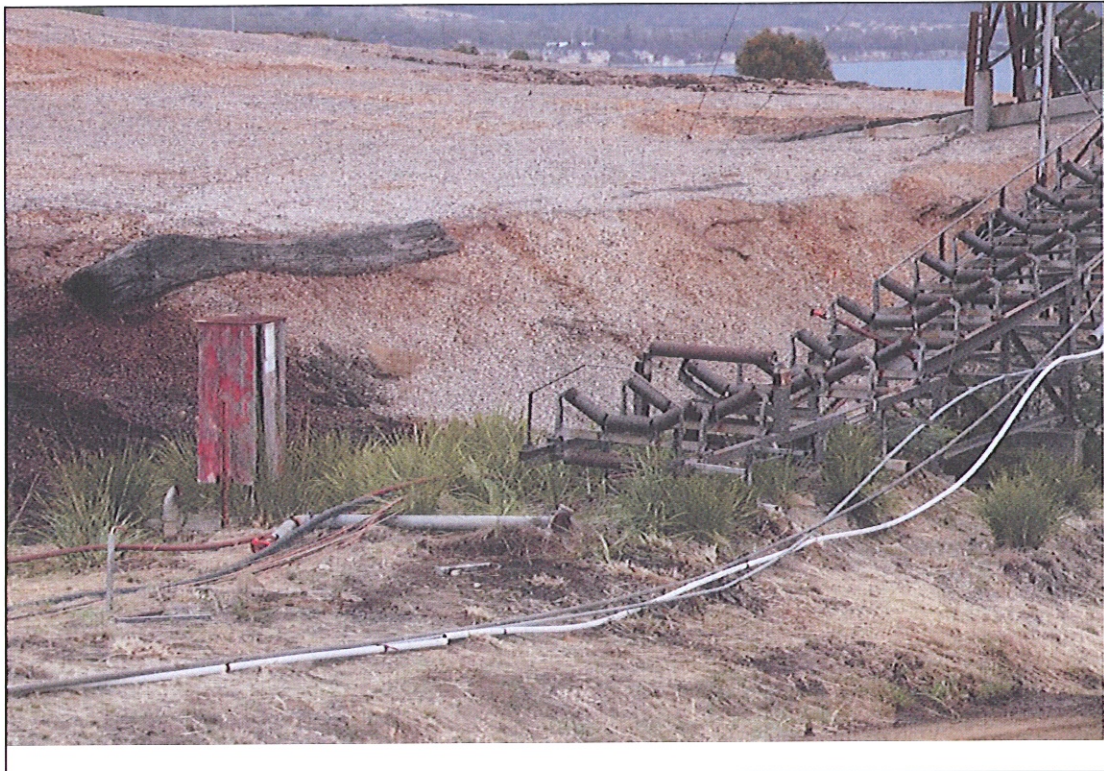
PHOTOGRAPH: 2. Fire origin on Southern end of conveyor belt frame.

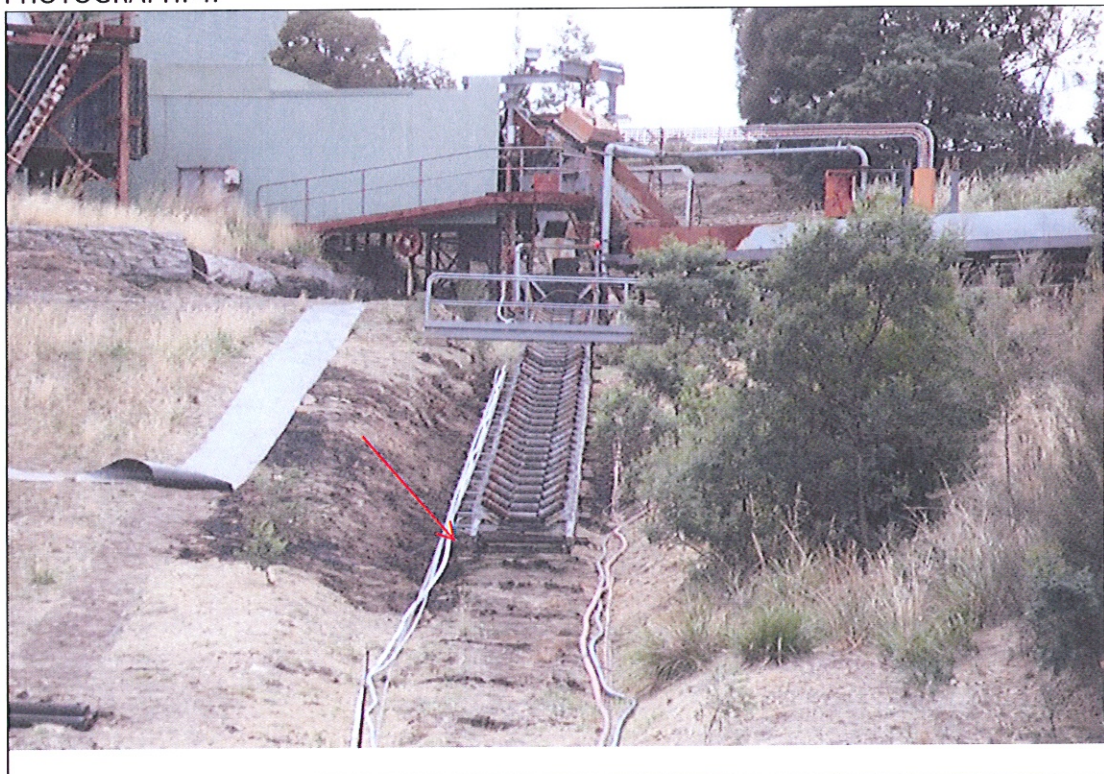
PHOTOGRAPH: 5. Fire origin on northern end of conveyor belt frame.

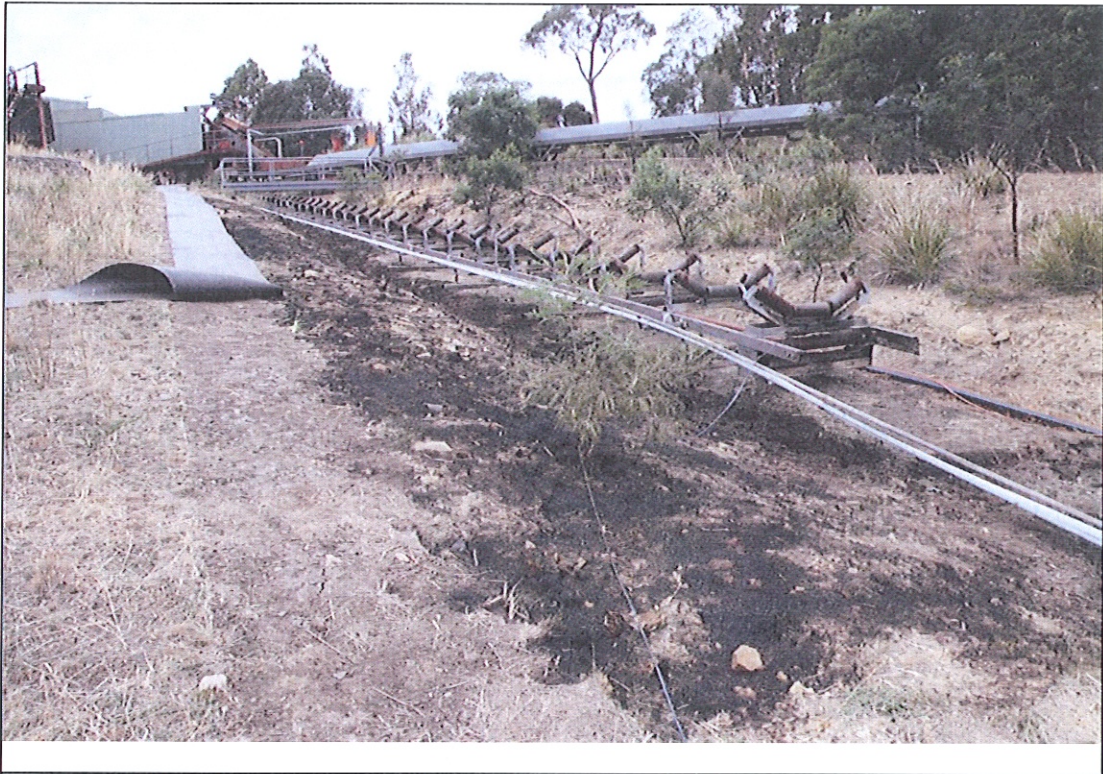
PHOTOGRAPH: 6. Fire origin on northern end of conveyor belt frame.

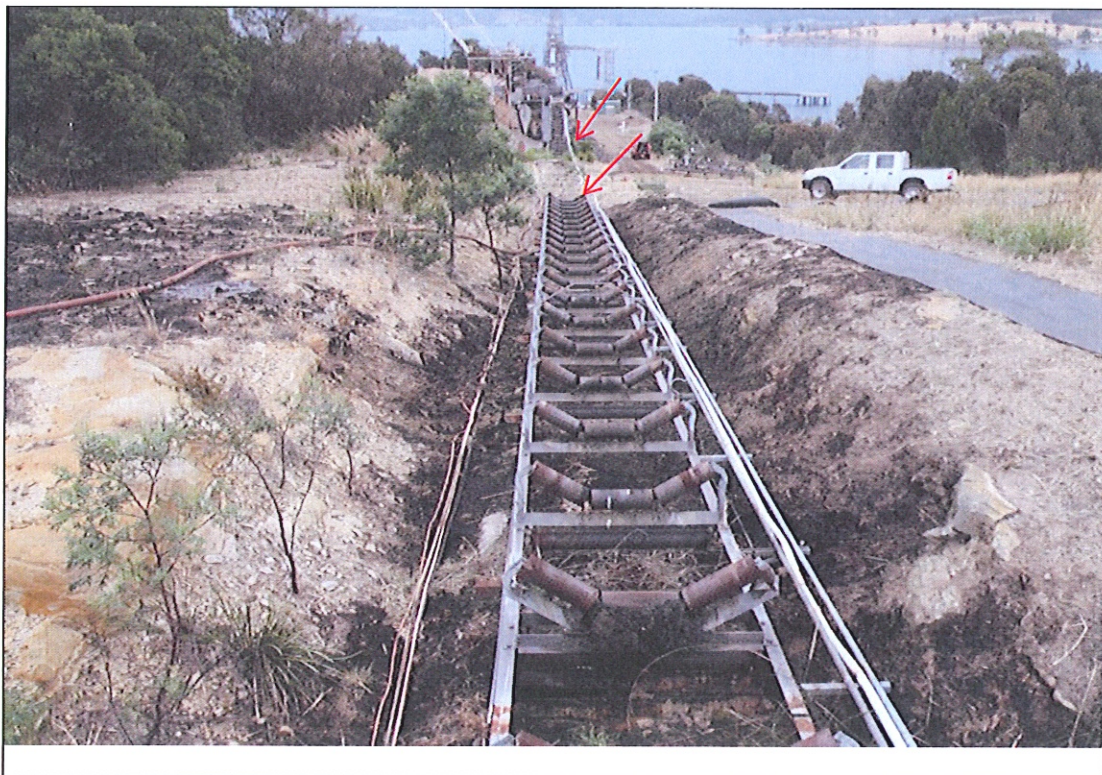
PHOTOGRAPH: 7. Area of removed conveyor belt frame.

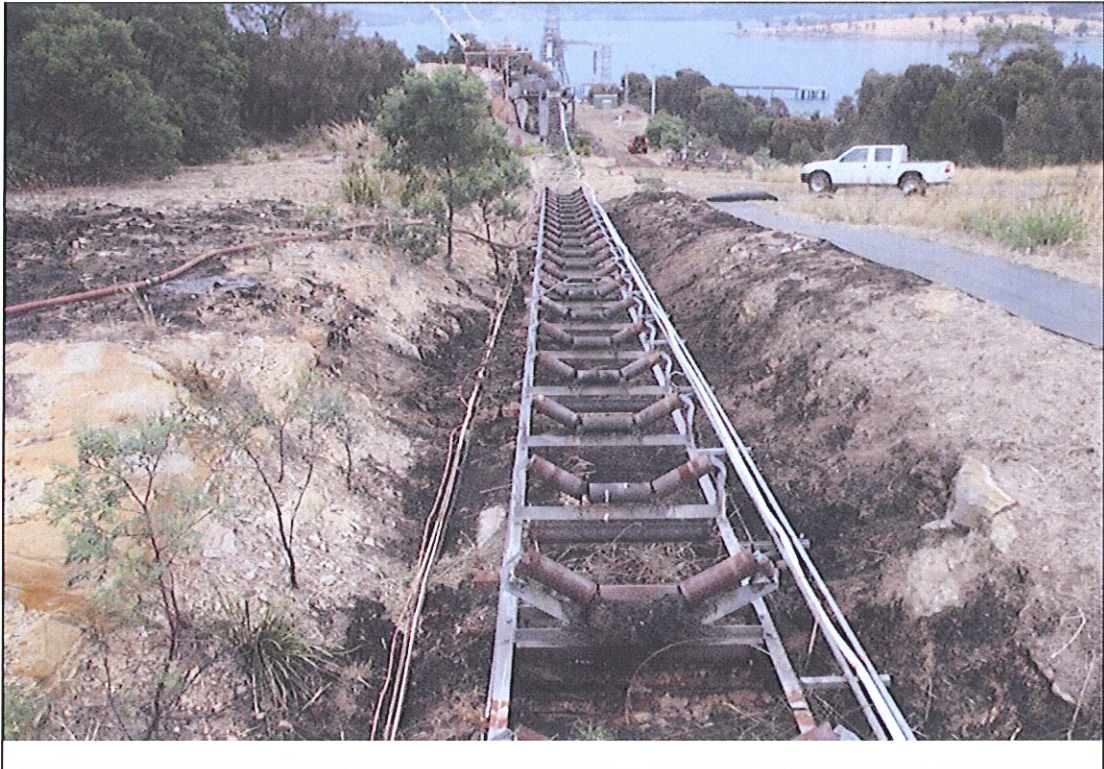
PHOTOGRAPH: 8

Upon inspection of the fire scene it was evident there were two areas of fire origin. One fire had originated on the southern end of the conveyor belt frame and one on the northern end of the conveyor belt frame where a section of approximately twenty meters had been removed. (see photograph 8) It is most likely sparks from a grinder has caused the grass to ignite.
