PARLIAMENT OF TASMANIA.

DRAINAGE OF THE HOSPITAL FOR THE INSANE AT NEW NORFOLK:

REPORT OF THE ENGINEERING INSPECTOR OF THE. CENTRAL BOARD OF HEALTH.

REPORT ON THE DRAINAGE OF THE HOSPITAL FOR THE INSANE AT NEW NORFOLK.

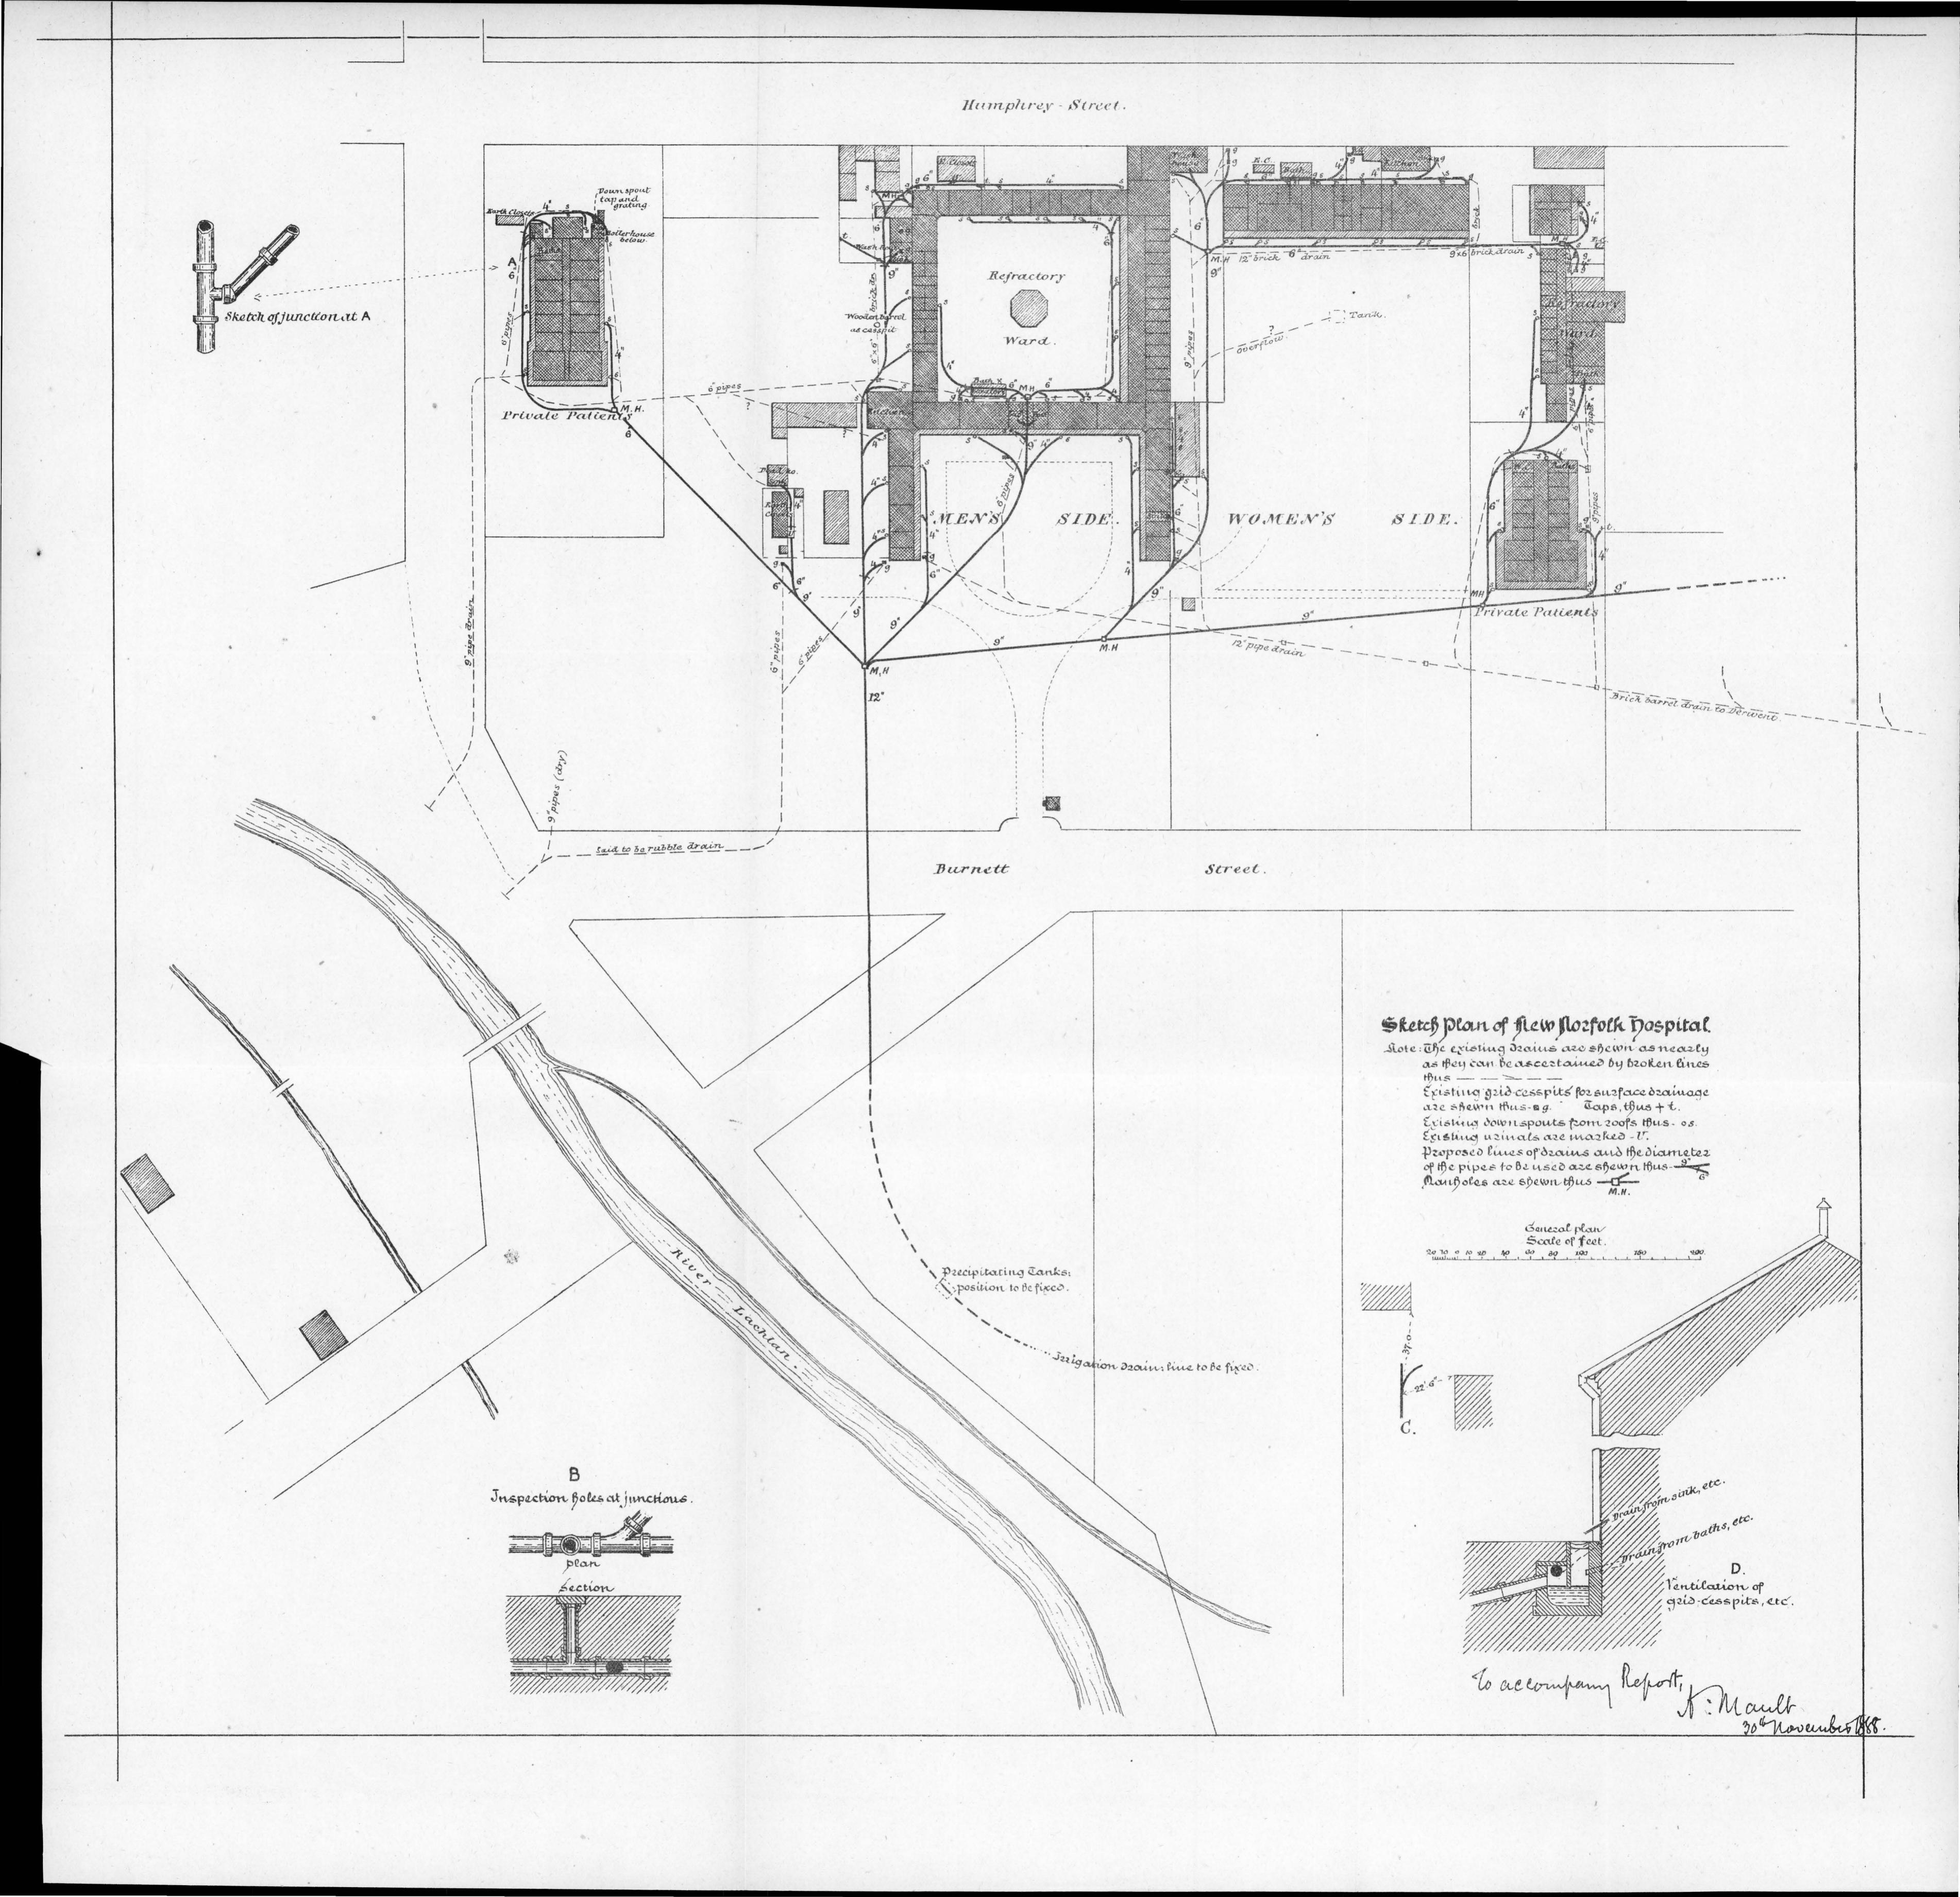
1. The existing drains of the Hospital are divided into three groups, each with a separate outfall. A pipe drain, nine inches in diameter, having its outfall at the bank of the Lachlan River, is laid up Grey-street, and takes the drainage from the wards of the private patients on the men's side and from the men's refractory ward and wash-house, workshops, &c. Pipes six inches in diameter, leading into what is said to be an old rubble drain along Burnett-street, with an outlet on the same bank of the Lachlan River, take the drainage from the men's latrines and the woodyard. But the greatest portion of the drainage—that from all the rest of the establishment—is carried by a brick barrel-drain that is laid across the grounds to the angle at the junction of Burnett and George streets, and thence all along Burnett-street to the River Derwent. This drain is about half a mile long, and is about 26 feet deep where it crosses High-street, a spot the level of which is much higher than the site of the Hospital. The sewage carried by this drain is diverted at Montagu-street by an arrangement of pipes leading to the garden of Hall Green, the late Sir Robert Officer's residence, where it is used for irrigation purposes. When not used, or when used, after use, the sewage of this drain is delivered by some 12 inch pipes into the Derwent at the Esplanade opposite the end of Burnett-street.

2. Originally all the drains appear to have been constructed in brick, even the smallest. From time to time these have been repaired and partially renewed with earthenware socket pipes, and in some cases altogether new socket pipe drains have been constructed. As far as could be judged from the openings made, the repairs, renewals, and new drains have been negligently done. For instance, in front of the women's ward a twelve-inch brick drain delivers its sewage into a nine-inch pipe drain; and the old drain under the women's refractory ward is first formed of six-inch pipes, then of bricks, and then of pipes again. The junctions especially seem to be badly constructed. As there is no correct plan of the drainage, it was not practicable to examine many of them, as some time had to be expended in finding them. Those found were usually, in the case of junctions with brick drains, formed by inserting the branch drain nearly at right-angles into the crown of the brick arch; and in the new drains from the men's private wards, the junction of the drain from the bath-room was formed with a right-angled junction pipe into which the branch drain was inserted at a different angle, as shown at A on the plan, as if intended to produce a stoppage or a leakage. 3. Most of the drains opened were fairly clean, as very large quantities of water are used for bathing and washing purposes; but in the part of the main outlet sewer lying within the grounds of the Hospital a deposit was found varying from two to six inches in depth. Not many ventilating pipes from the drains were found, and in some cases a decided want of ventilation was observed.

7. The character and condition of the drains of the Hospital being such as is above described in paragraphs 1 and 2, it is very desirable that they should be reconstructed. In the first place, it is not a good arrangement to have so many outfalls. In the next place, the partial examination that has been made has shown so many defects that it is necessary that every drain should be examined along its whole length, and made homogeneous in character by being altogether constructed of glazed earthenware socket pipes with proper junctions. The cost of this examination and alteration would go far towards that of taking up and again using the pipes as a portion of a new system of drainage.

8. The following recommendations are therefore made :--The use of the main outfall drain to the Derwent should be discontinued, except for draining the grounds and carriage drives and, where desirable and convenient, rainwater from roofs. All the other drains, whether formed of pipes or bricks, should be taken up, and the trenches they have occupied should, after having been, where necessary, disinfected, be filled up with dry, sound materials. Every drain should be followed up until it was certainly ascertained that no old drains were left in the ground. The new drains should be laid on the lines and of the sizes shown on the accompanying plan, and built of good salt-glazed earthenware socket-pipes properly and evenly bedded and jointed in cement, such of the existing drain pipes as are good being utilized. The sizes marked for the pipes are amply sufficient to provide for any probable future extension of the Hospital.

Every junction not occurring at a manhole should be followed by an upright pipe coming to the surface, and covered with a slab so as to admit of inspection, as shown at B on plan. An accurate plan of the drainage must be prepared, and as the work proceeds the position of every junction must be marked thereon, and fixed by two measurements to prominent parts of the buildings, as shown at C on plan.

- The drains from sinks, baths, cistern overflows, and all other drains from inside the buildings, except water-closet drains, should deliver their drainage either in the open air above a grid or on the open air side of the trap of the grid; from the closed side (the sewer side) of which an air pipe, with perfectly close joints, must be taken to the ridge of the roof, where the opening must be at least eight feet from the nearest chimney, skylight, dormer, or other opening communicating with the interior of the buildings. (See D on plan.) Every water-closet soil-pipe should have from the sewer side of the trap a ventilating pipe

- From the highest inlet of each of the five principal lines of drains shown on the accompanying plan, a similar ventilating pipe should be carried up.
