<u>Stage 1</u> – <u>Lilydale</u> (starting at <u>21.1 km</u>, clear of the 'Station Road' Level Crossing, and about 300 metres on the Launceston side of the Station platform) **through to** <u>Wyena</u> (finishing at <u>37.5 km</u>, about 600 metres ahead of the Wyena Station platform, and about 150 metres short of the 'Shepherds Rivulet' Trestle Bridge).

Sleeper replacement and Rail-Joint Rehabilitation:

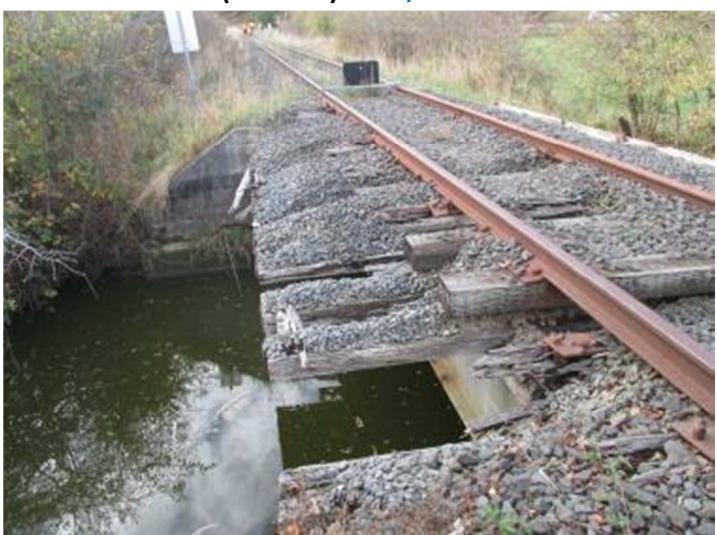
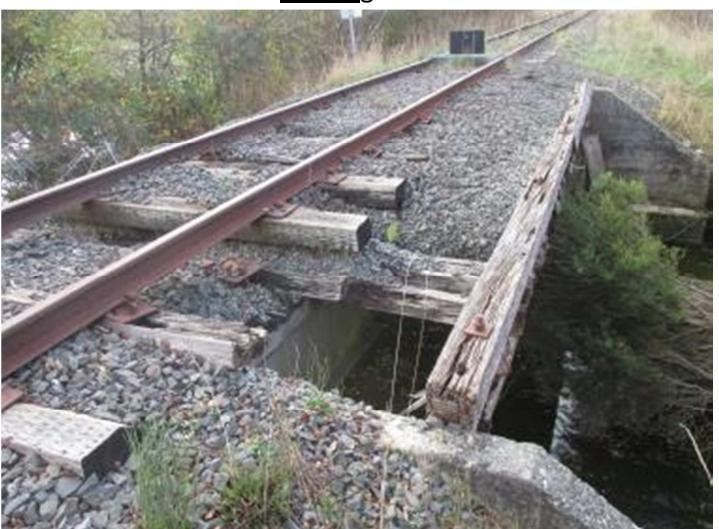
a. 'Local Low Point' (22.6 km) 9747,

b. This bridge is the shortest on this railway, being a single span of about 8 metres. It is not equipped with Guard Rails. The bridge is of the 'ballasted track over timber-deck' type, and accordingly has problems with rotting timber decking and side-kerbs, causing ballast losses and, consequently, a

poorly supported track skeleton. However, beneath its failing decking, its main steel box-girder structure and supporting concrete abutments appear to be structurally sound. Again, a Transom-top <u>ballast-free</u> track structure, similar to the 1987 rebuild of Greeta's "Lisle Creek" bridge (45.8 km), is recommended for this bridge's form of track-support. One secondary issue warranting consideration: The shortness of this bridge will require either some <u>lowering</u> of the adjoining track approaches (possibly undesirable for peak flood events, but operationally tolerable due to the 40 km/h speed limit already applying close by). Alternatively, increasing the effective crosssectional depth of the bridge's track-transoms (possibly by robust packing), rail levels could match <u>existing</u>. 9748

'Local Low Point' Bridge – Lilydale side of Goldconda Road, approaching Lilydale Falls. This bridge is about 8 metres long and its main supporting structure of concrete abutments and steel beams is sound and fit-for-purpose. However, its existing ballasted-tracksupporting timber deck and associated timber side-kerbs, are failing and need to be replaced by about 14 evenly spaced pre-cast concrete transoms fixed to the main steel beams. The finished (ballast-less) track's rails will be resiliently fastened onto every transom.

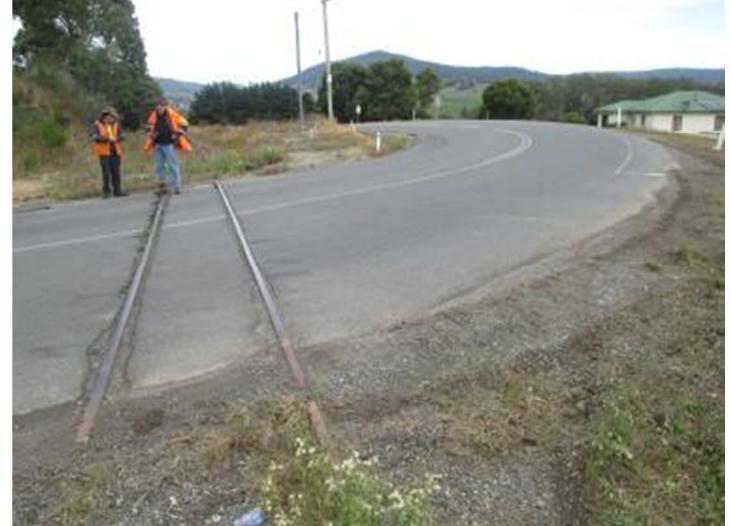
24.1 km Highway B 81 (Golconda Road) beyond Lilydale Falls. 9693,

Looking towards Lilydale Falls.

It is strongly recommended that an extra <u>Actively Protected</u> Level Crossing be included at <u>Bacala Road</u> as it is a long straight stretch of road (at 100km/h) with heavy log trucks travelling at speed. There would be no existing cables connected to this level crossing's track, so this could be a cost that might need to be included.

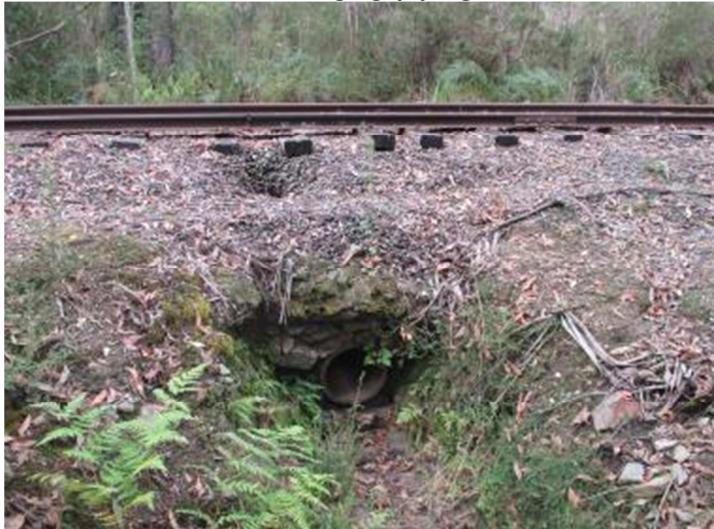
Below: Inlet-rocks encouraging 'piping'. 9638

Uphill from Tunnel station 200mtrs. The drainage has not been built properly. floodwaters have pushed the ballast out from between the sleepers. This has allowed the track to buckle. The culvert needs to be rebuilt but the expertise and experience of the LNER group would enable this to be achieved. It needs to be backfilled with cement stabilised sand to prevent any further wash away. and needs to be realigned. This can easily be done with an excavator and volunteer labour . (\$1,500 was included in the 'On Track' report for these works).

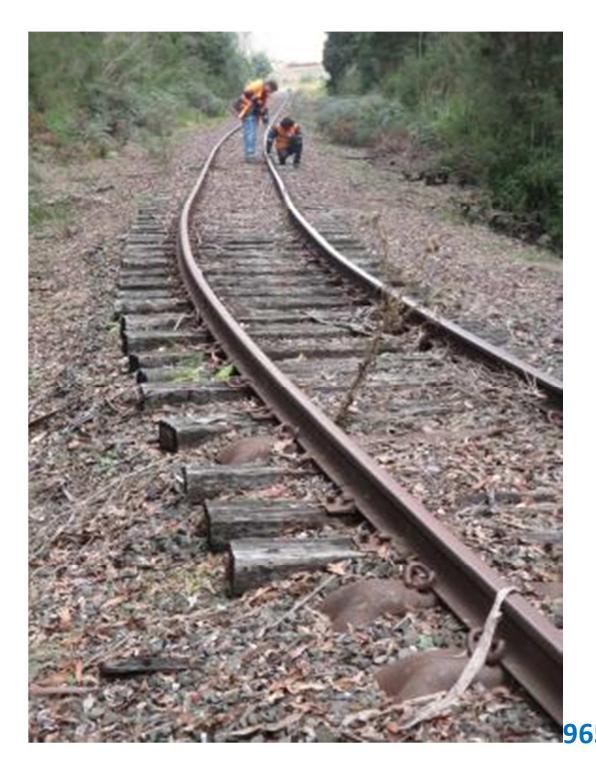
...causing <u>Formation collapse</u>,

9652 ... & ballast <u>Wash-out</u> & <u>Track Buckle</u>, and

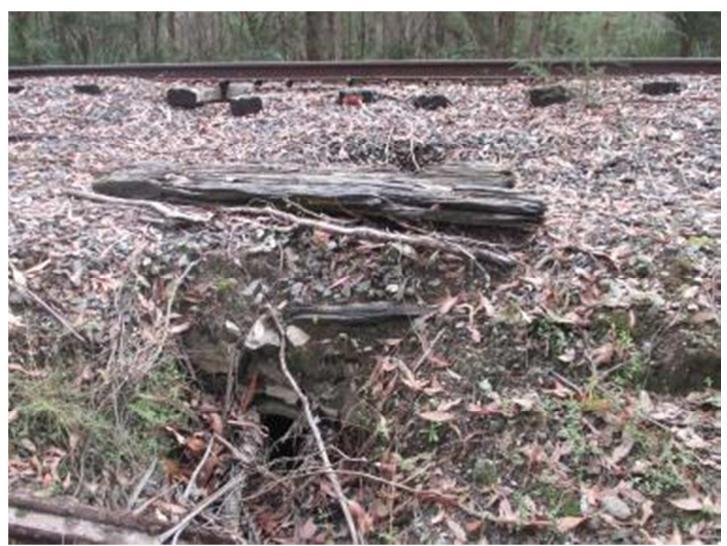
9637 ... the partially obstructed Outlet (obstructed by flood debris ex the track area), & formation-piping's outlet-flow hole (covered by the old sleeper). <u>Warning</u>: Encouraging or not-preventing drainage-water '*Piping'* through the track-formation around the <u>outside</u> of culvert pipes is effectively inviting formation wash-out which also removes track-ballast, compromising track-integrity.
