4.5 SEDIMENT

This section describes the condition of sediment in the potential footprint of the proposed New Bridgewater Bridge. The description includes a review of available information combined with a broad-scale sampling of shallow sediments to around 2.5 m below sediment-water interface to characterise their condition prior to commencement of construction works. In conjunction with hydrodynamic modelling, this information will be used to determine the risk of suspended sediment to the adjacent estuarine ecosystem and to identify appropriate controls to mitigate risk. The information will also be used by pitt&sherry to guide the appropriate handling and treatment of material removed from the water during construction.

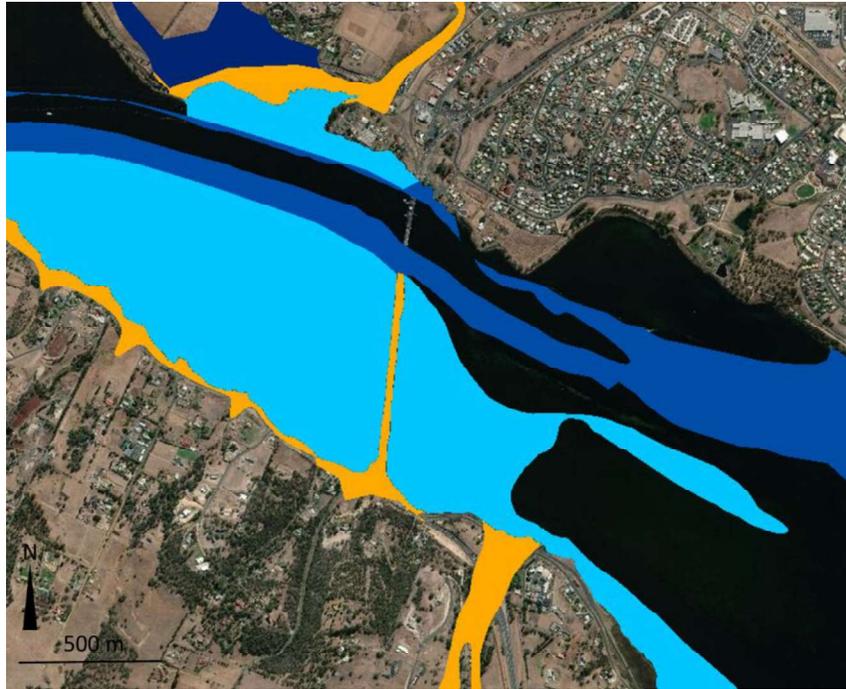
Figure 27. Risk of acid sulfate sediment according to LISTmap. Dark blue = subtidal, high probability of occurrence. Light blue = intertidal, high probability of occurrence. Orange = coastal, low probability of occurrence.

Information from the Land Information Systems Tasmania (the LIST) indicates a high modelled probability of PASS in most of the intertidal and subtidal sediments around the Bridgewater causeway (Figure 27).

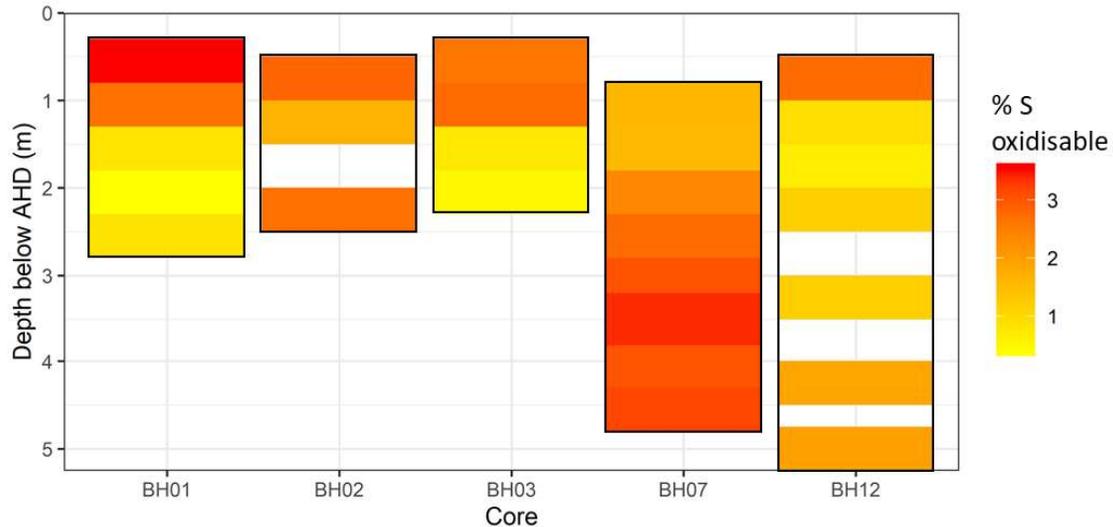
Figure 28. Results of acid sulfate sediment tests in five cores collected by pitt&sherry (pitt&sherry 2020). Data are peroxide oxidizable sulfur % S including acid neutralizing capacity. Action criteria is 0.1 % S. No colour indicates that data is not available for that section of the core.

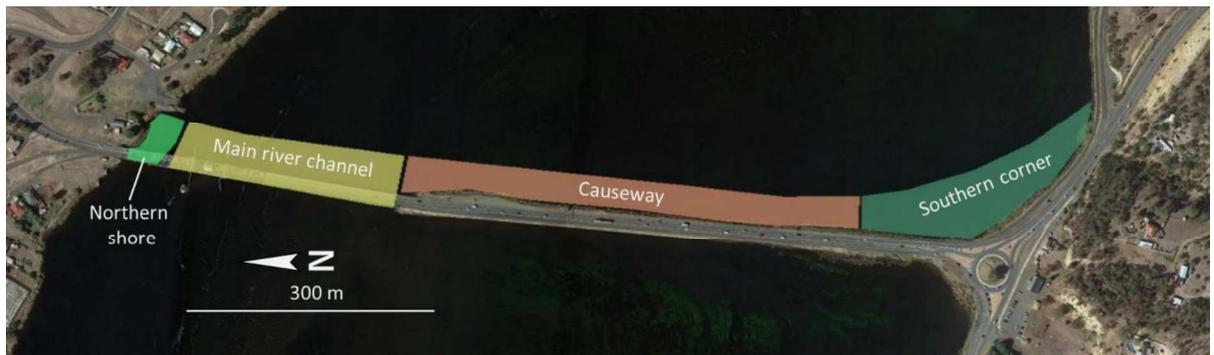
Figure 29. Environmental domains in the area likely to be directly affected by the development (based on the designs being considered at the time of writing), which are expected to differ in their sediment characteristics and therefore contaminant profiles. These domains were used to guide the distribution of sediment sampling. Delineation of domains is based on water depth, expected sediment particle size and hydrodynamics (i.e. zone of scouring or deposition).

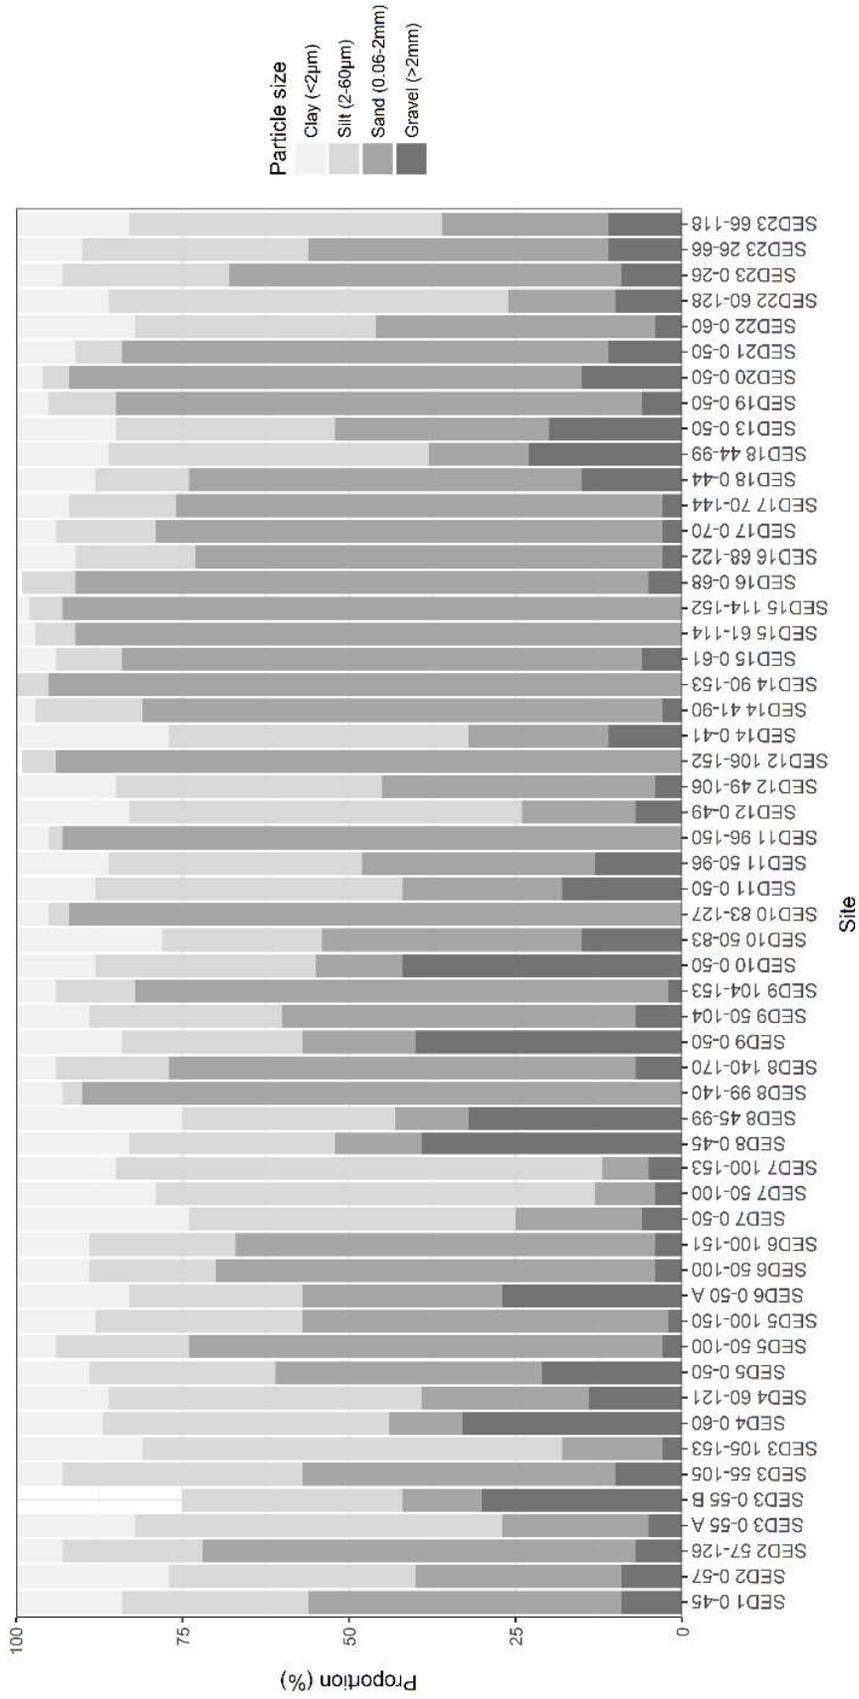
Figure 31. Sediment particle size. Sites are approximately ordered from south to north moving left to right on the graph.

Consistently high contributions of sand (around 75%) were evident towards the northern end of the causeway at sites SED15, SED16 and SED17 (Figure 31).

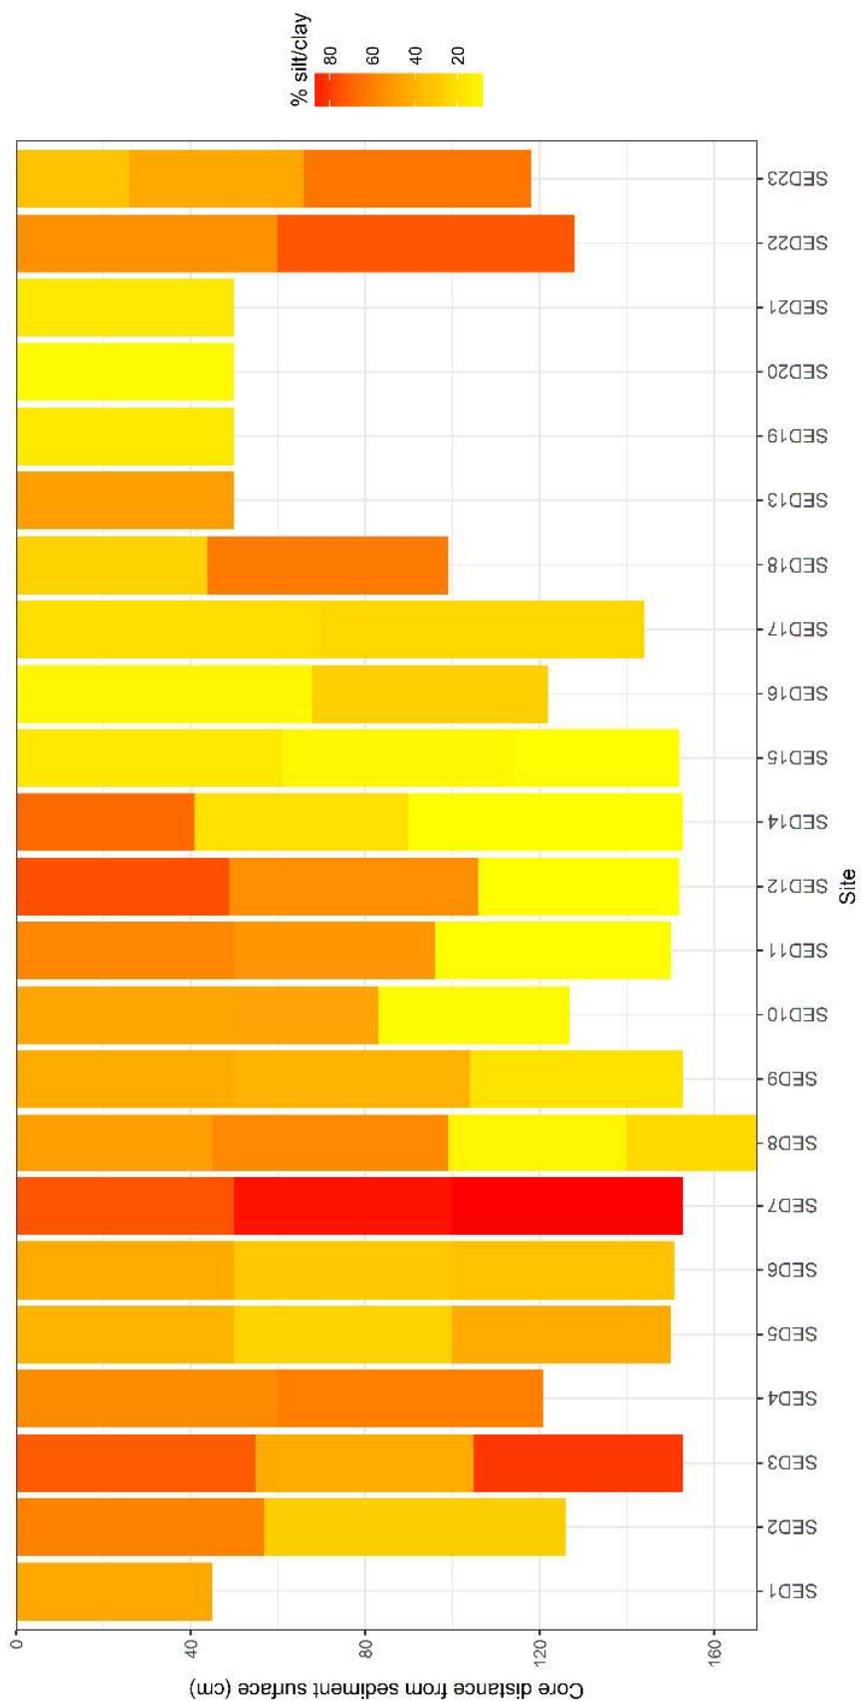
Figure 32. Vertical distribution of finer sediment fractions (< 60 μm). Sites are approximately ordered from south to north moving left to right on the graph.

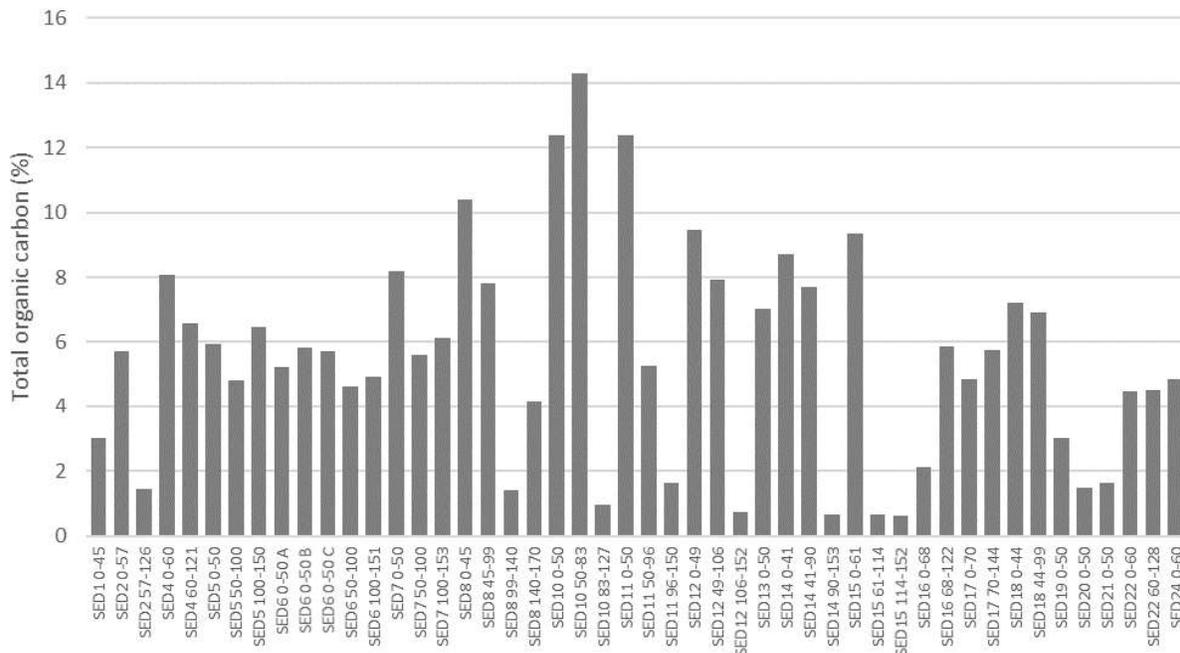
Figure 33. Variation in total organic carbon among the samples. Sites are approximately ordered from south to north moving left to right on the graph.

Total organic carbon (TOC) was generally high across the sites with an average of 5.5% (Figure 33). The percent TOC was generally higher in the surface sediments and in the central-northern section of the causeway. TOC was generally lower in deeper sediments.

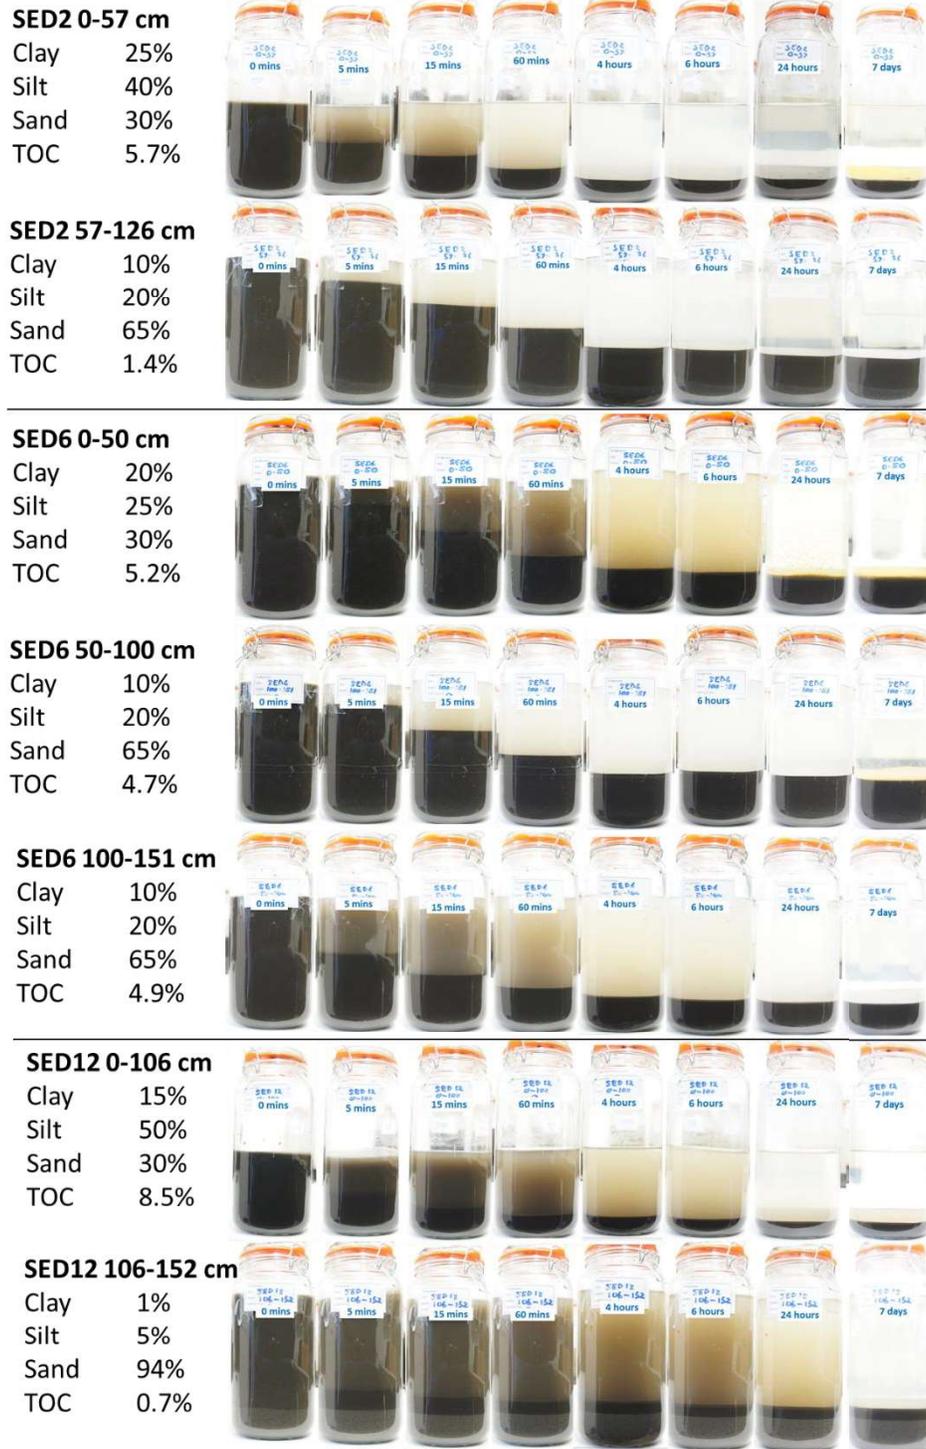
Figure 34. Sediment settlement rates after agitation at the following intervals: 0 mins, 5 mins, 15 mins, 60 mins, 4 hours, 6 hours, 24 hours, 7 days. TOC = total organic carbon.

In most samples, approximately 50% of the particles causing the highest visual turbidity had settled out of suspension after 15 minutes, and most of the turbidity-causing particles had settled out after 1 hour (under still conditions).

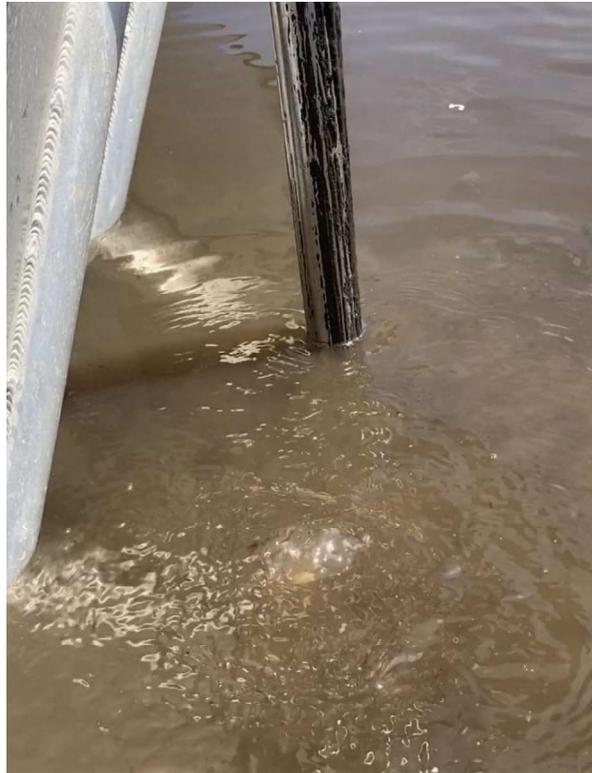
Figure 35. Vigorous stream of bubbles emerged from the hole as the corer was removed.

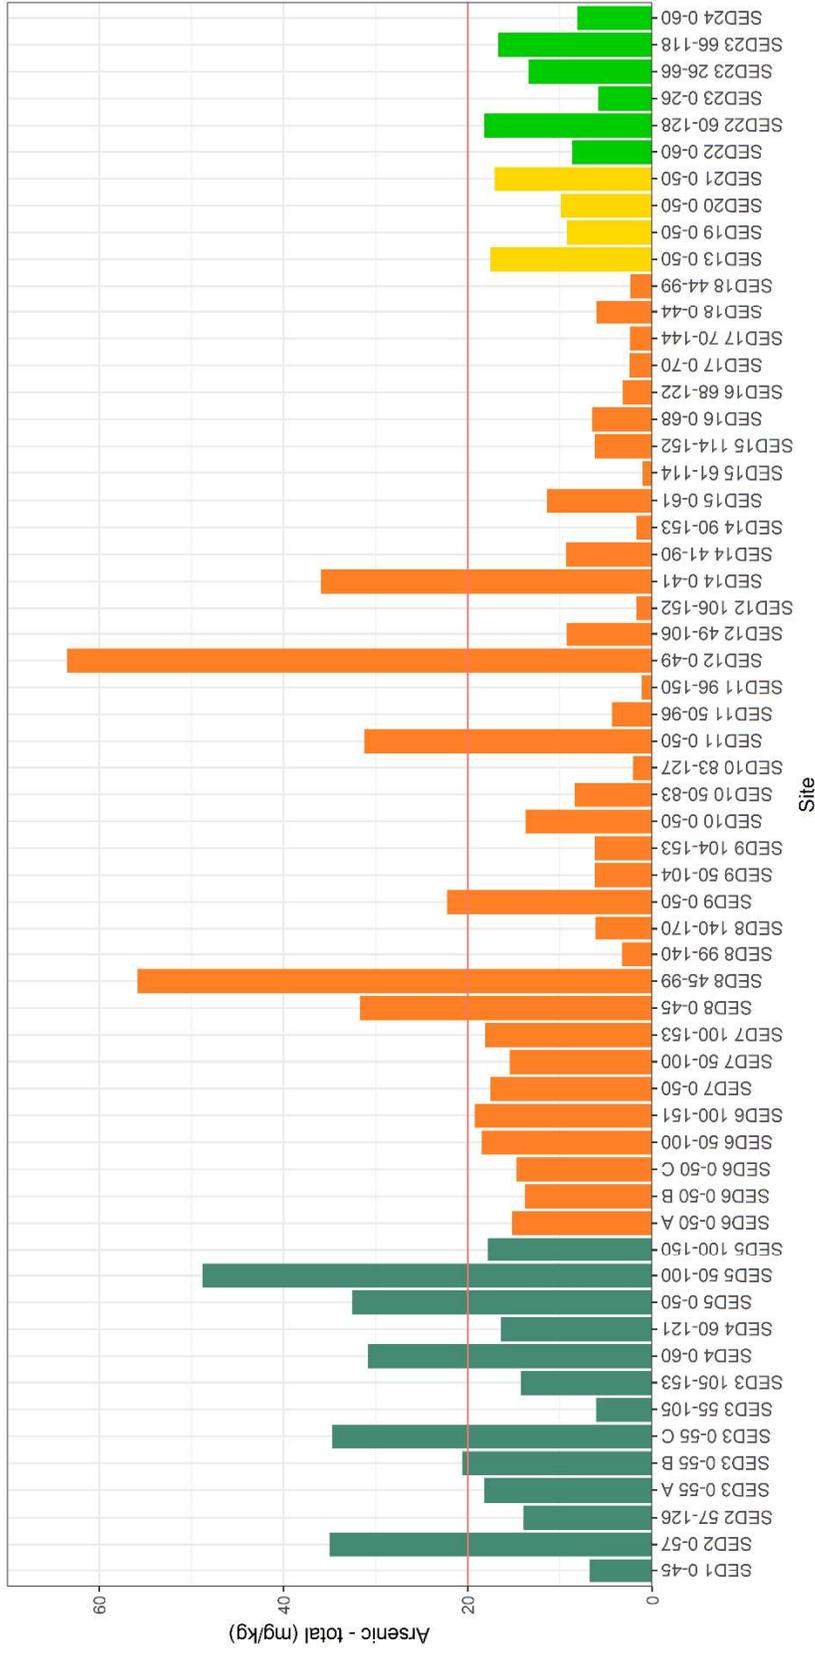
Figure 36. Concentration of total arsenic in sediment. Red line indicates the sediment quality guideline value from ANZECC/ARMCANZ (Simpson and Batley 2016). Sites are approximately ordered from south to north, with dark green in southern corner, orange along the causeway, yellow in the river channel and light green on the north shore of the river channel.

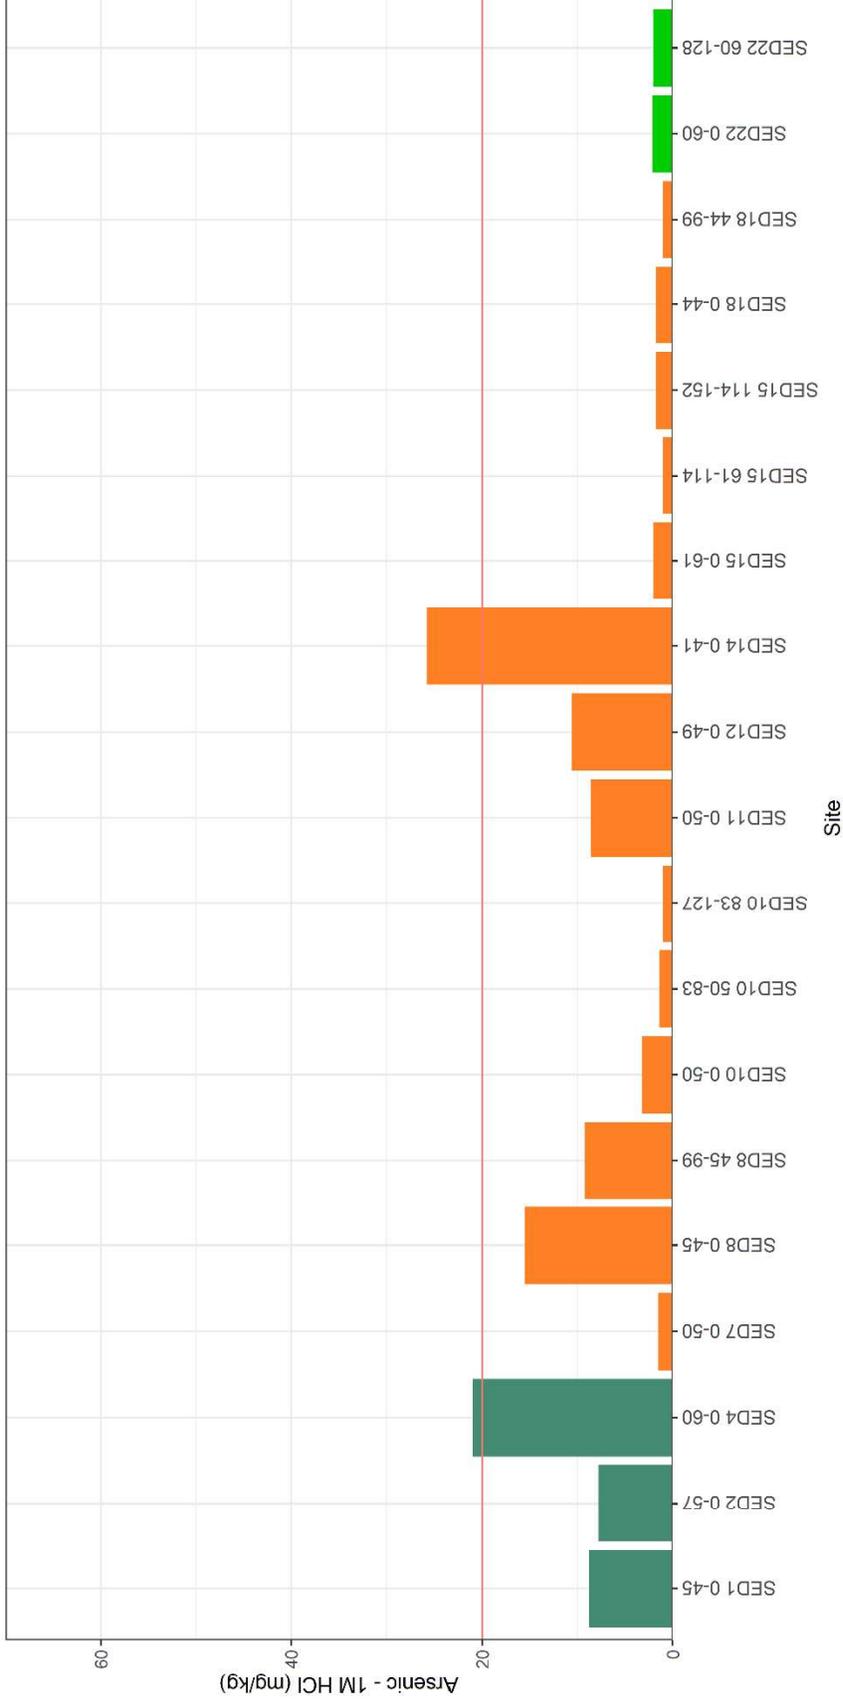
Figure 37. Concentration of bioavailable arsenic according to 1M HCl digest. Red line indicates the sediment quality guideline value from ANZECC/ARMCANZ (Simpson and Batley 2016). Sites are approximately ordered from south to north, with dark green in southern corner, orange along the causeway and light green on the north shore of the river channel.

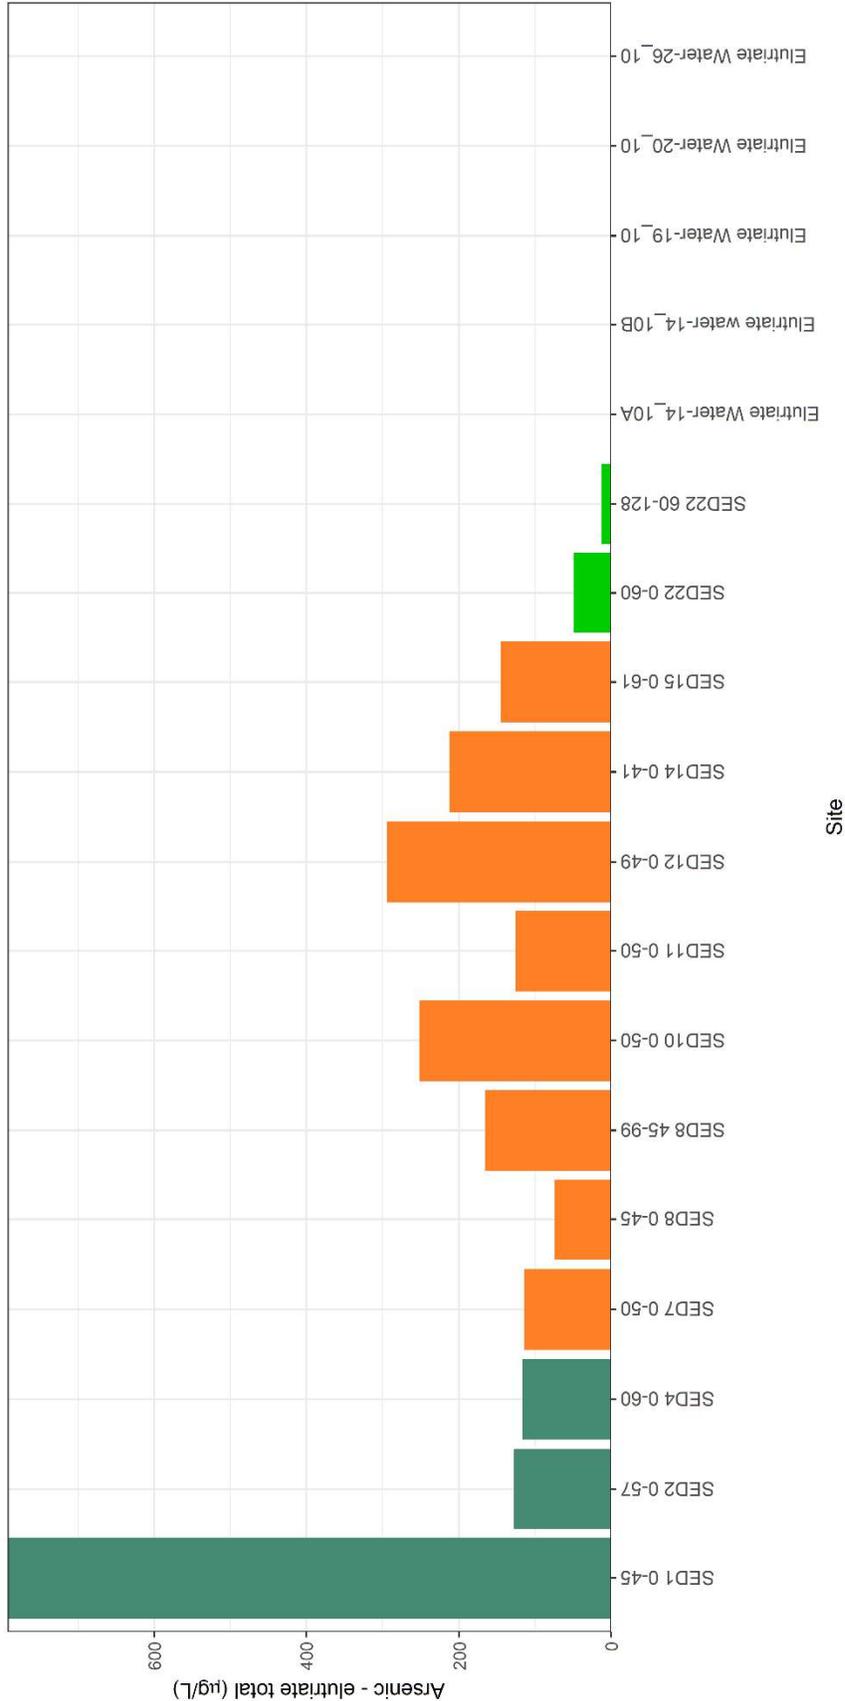
Figure 38. Concentration of total arsenic resulting from elutriate testing. No water quality guidelines are available for total arsenic, but see results for As(V). Sites are approximately ordered from south to north, with dark green in southern corner, orange along the causeway and light green on the north shore of the river channel.

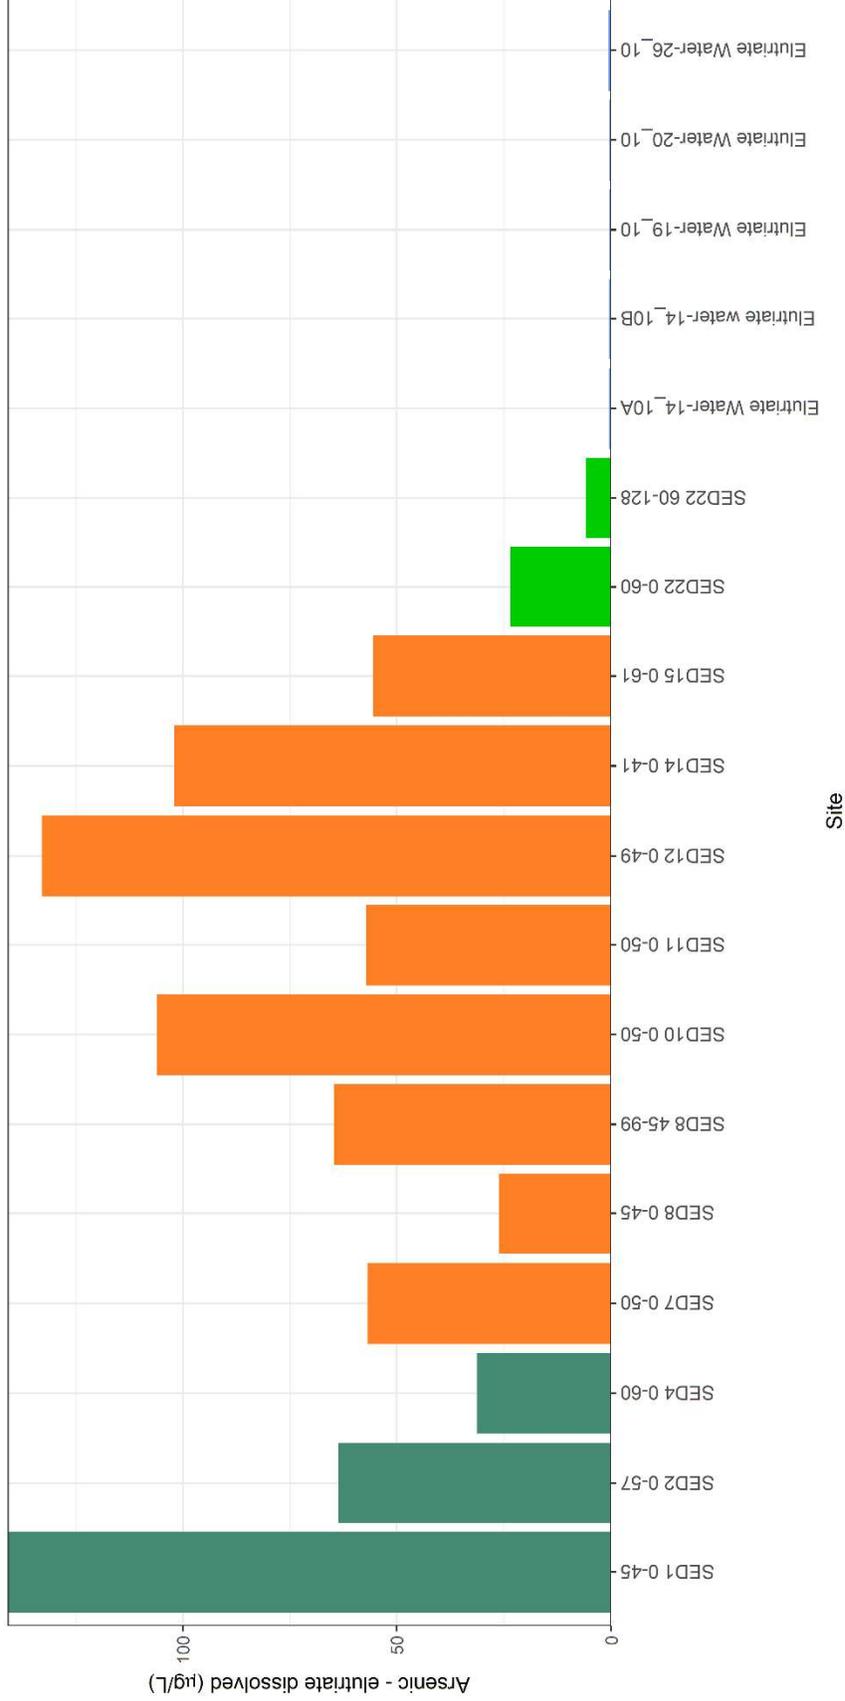
Figure 39. Concentration of dissolved arsenic resulting from elutriate testing. No water quality guidelines are available for total arsenic, but see results for As(V). Sites are approximately ordered from south to north, with dark green in southern corner, orange along the causeway and light green on the north shore of the river channel.

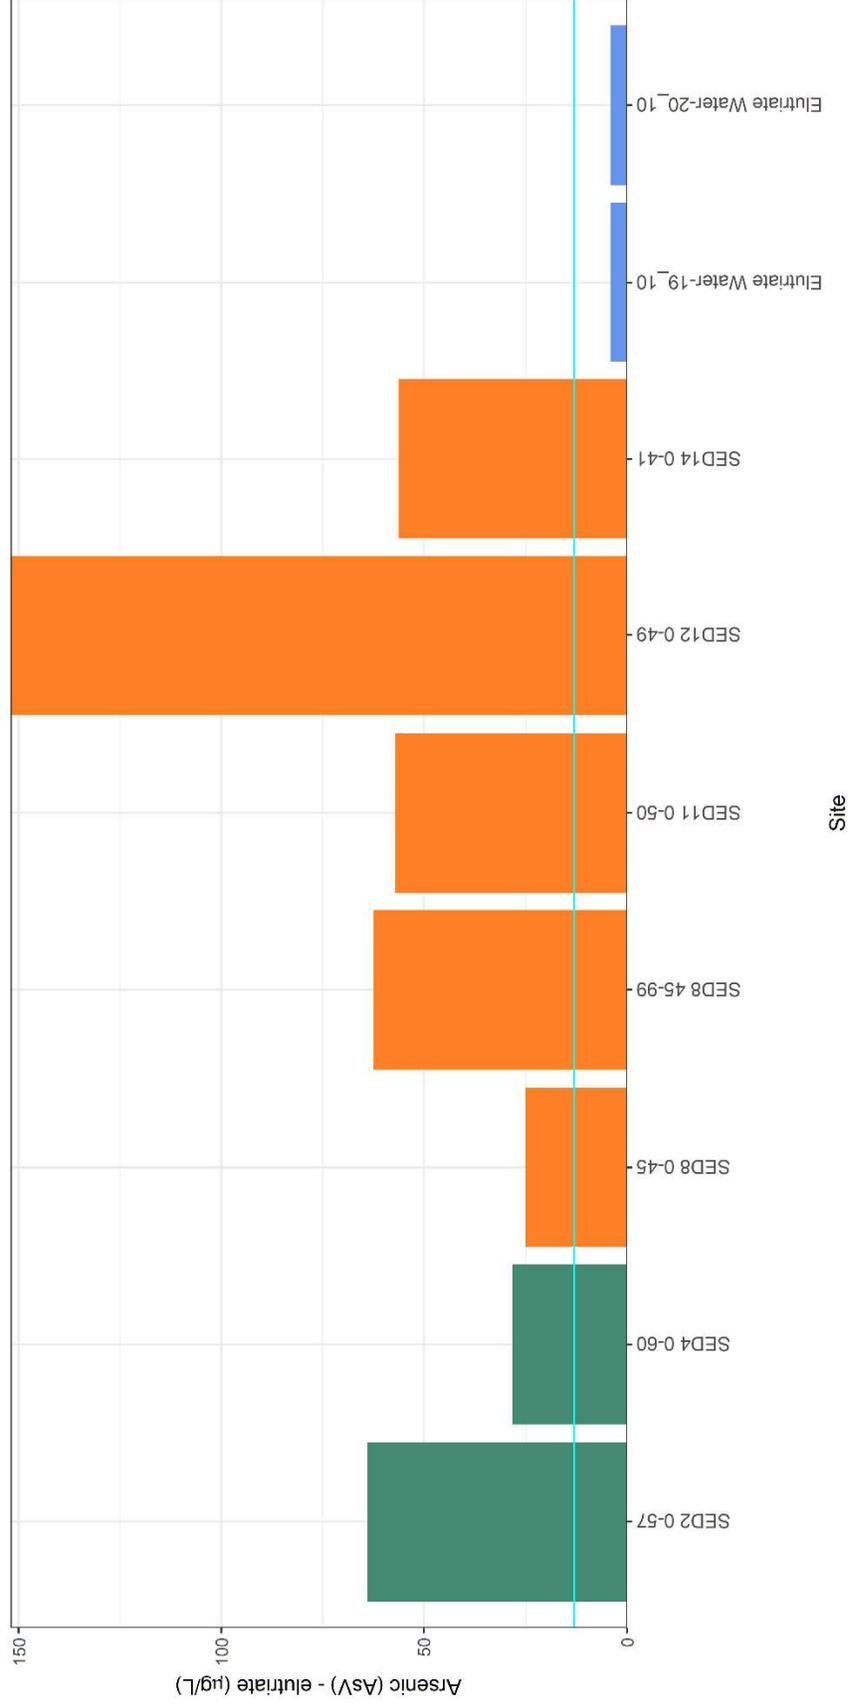
Figure 40. Concentration of arsenic (V) resulting from elutriate testing. Green line indicates the freshwater toxicant default guideline value from ANZECC & ARMCANZ (2000). Red line indicates the sediment quality guideline value from ANZECC/ARMCANZ (Simpson and Batley 2016). Sites are approximately ordered from south to north, with dark green in southern corner, orange along the causeway and light green on the north shore of the river channel.

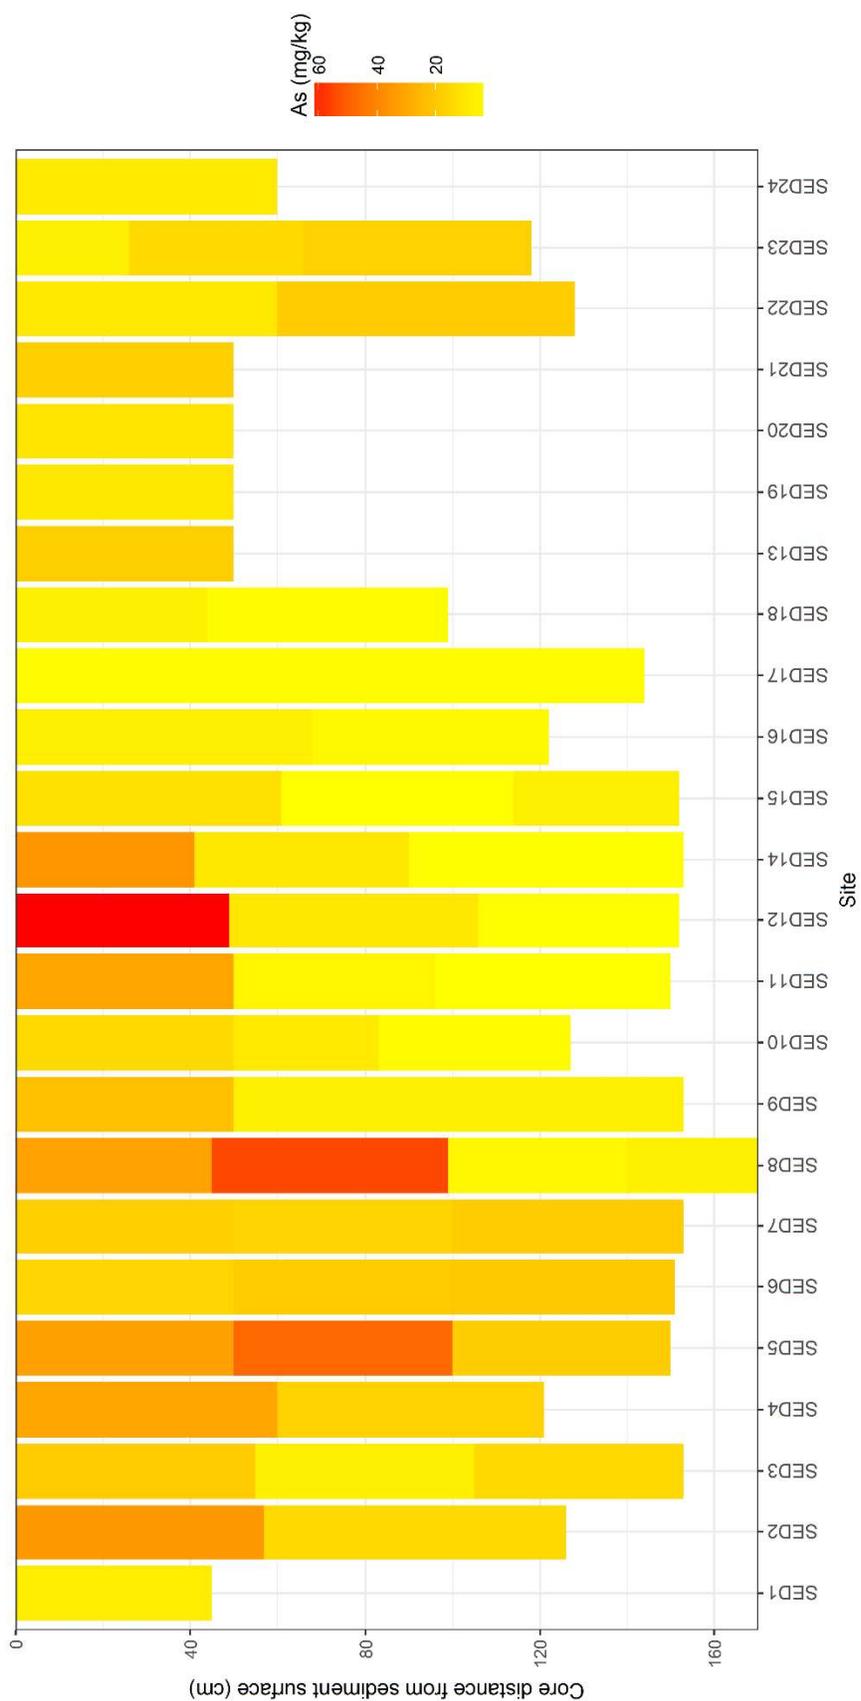
Figure 41. Vertical variation of total arsenic in sediment along cores. ANZECC SQGV is 20 mg / kg, with high SQGV of 70 mg / kg.

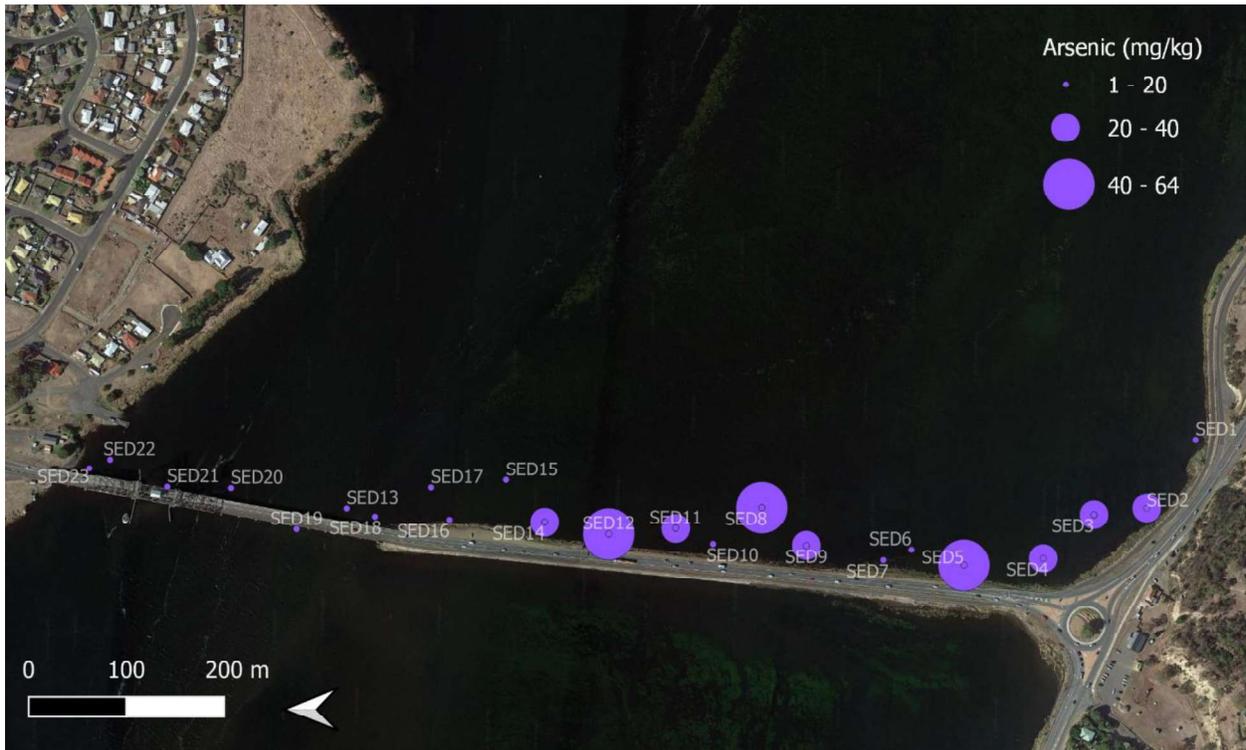
Figure 42. Map of total arsenic concentrations in sediment.

High in southern corner and along causeway, and highest in centre causeway. Below SQGV in river channel and north shore of channel (Figure 42).

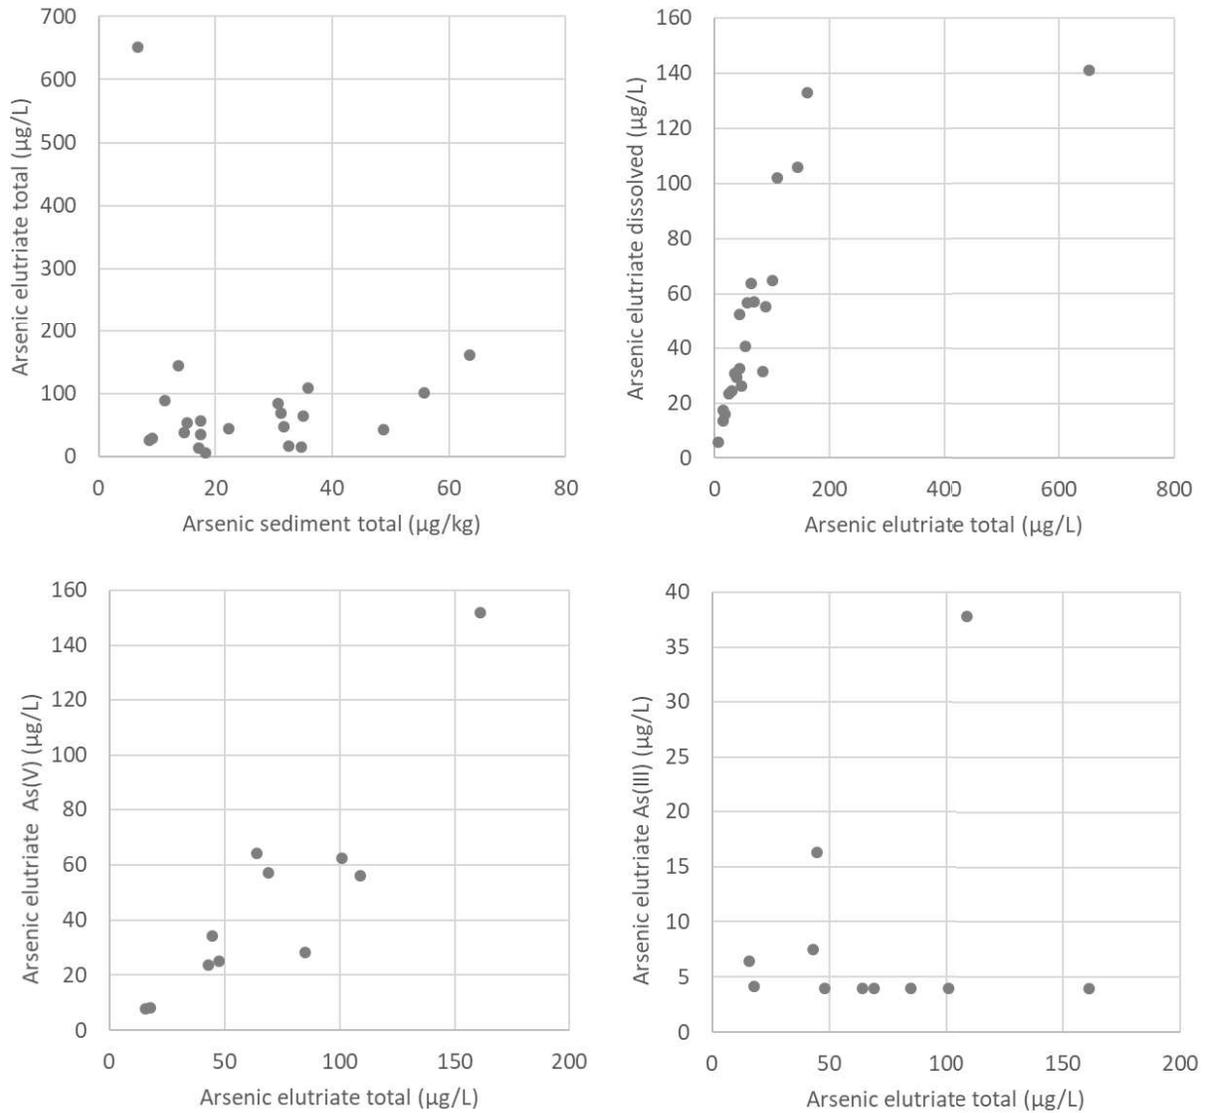
Figure 44. Relationship between different components of arsenic in sediment and elutriates. Outlier in the upper two panels is SED1 0-45.

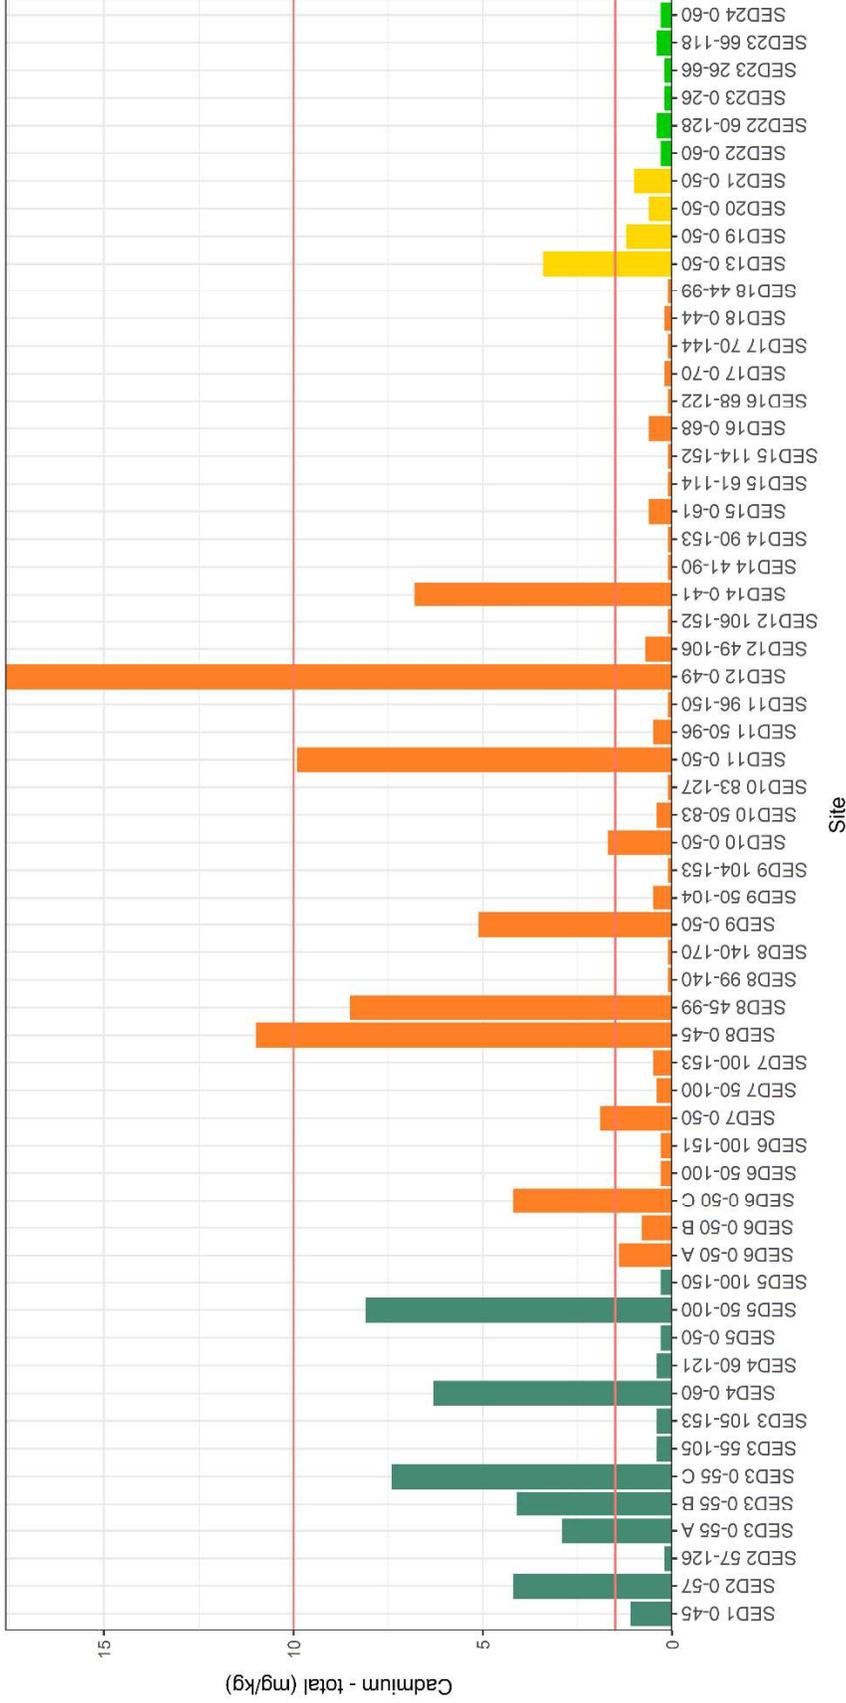
Figure 45. Concentration of total cadmium in sediment. Red lines indicate the SQGV and SQGV-high from ANZECC/ARMCANZ (Simpson and Batley 2016). Sites are approximately ordered from south to north, with dark green in southern corner, orange along the causeway, yellow in the river channel and light green on the north shore of the river channel.

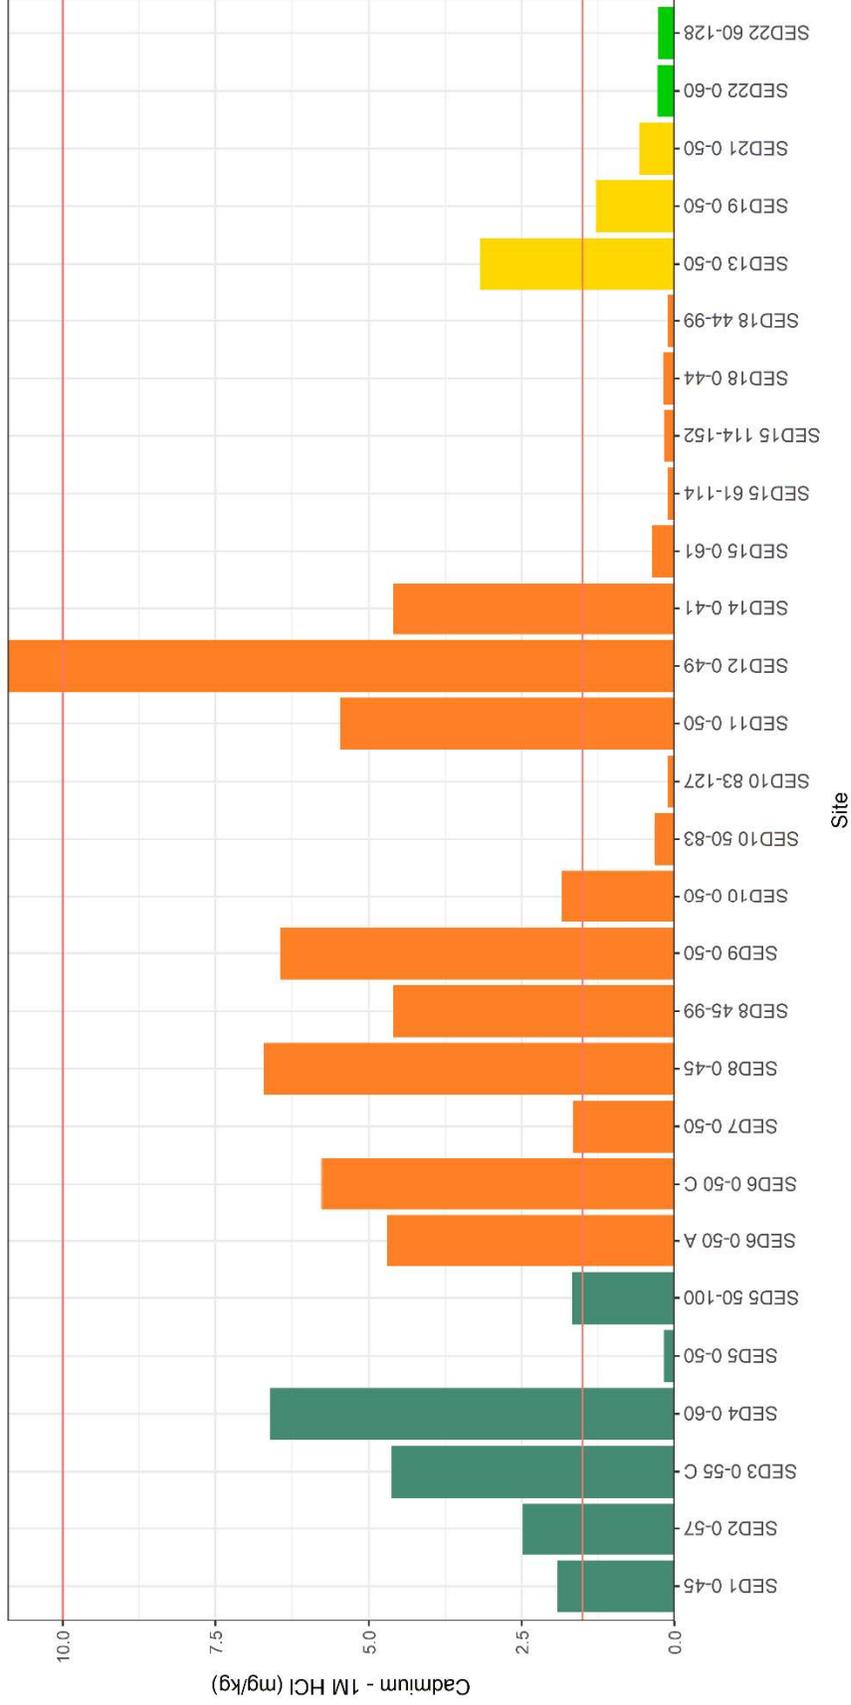
Figure 46. Concentration of bioavailable cadmium according to 1M HCl digest. Red lines indicate the SQGV and SQGV-high from ANZECC/ARMICANZ (Simpson and Batley 2016). Sites are approximately ordered from south to north, with dark green in southern corner, orange along the causeway, yellow in the river channel and light green on the north shore of the river channel.
