4.5 SEDIMENT

This section describes the condition of sediment in the potential footprint of the proposed New Bridgewater Bridge. The description includes a review of available information combined with a broad-scale sampling of shallow sediments to around 2.5 m below sediment-water interface to characterise their condition prior to commencement of construction works. In conjunction with hydrodynamic modelling, this information will be used to determine the risk of suspended sediment to the adjacent estuarine ecosystem and to identify appropriate controls to mitigate risk. The information will also be used by pitt&sherry to guide the appropriate handling and treatment of material removed from the water during construction.

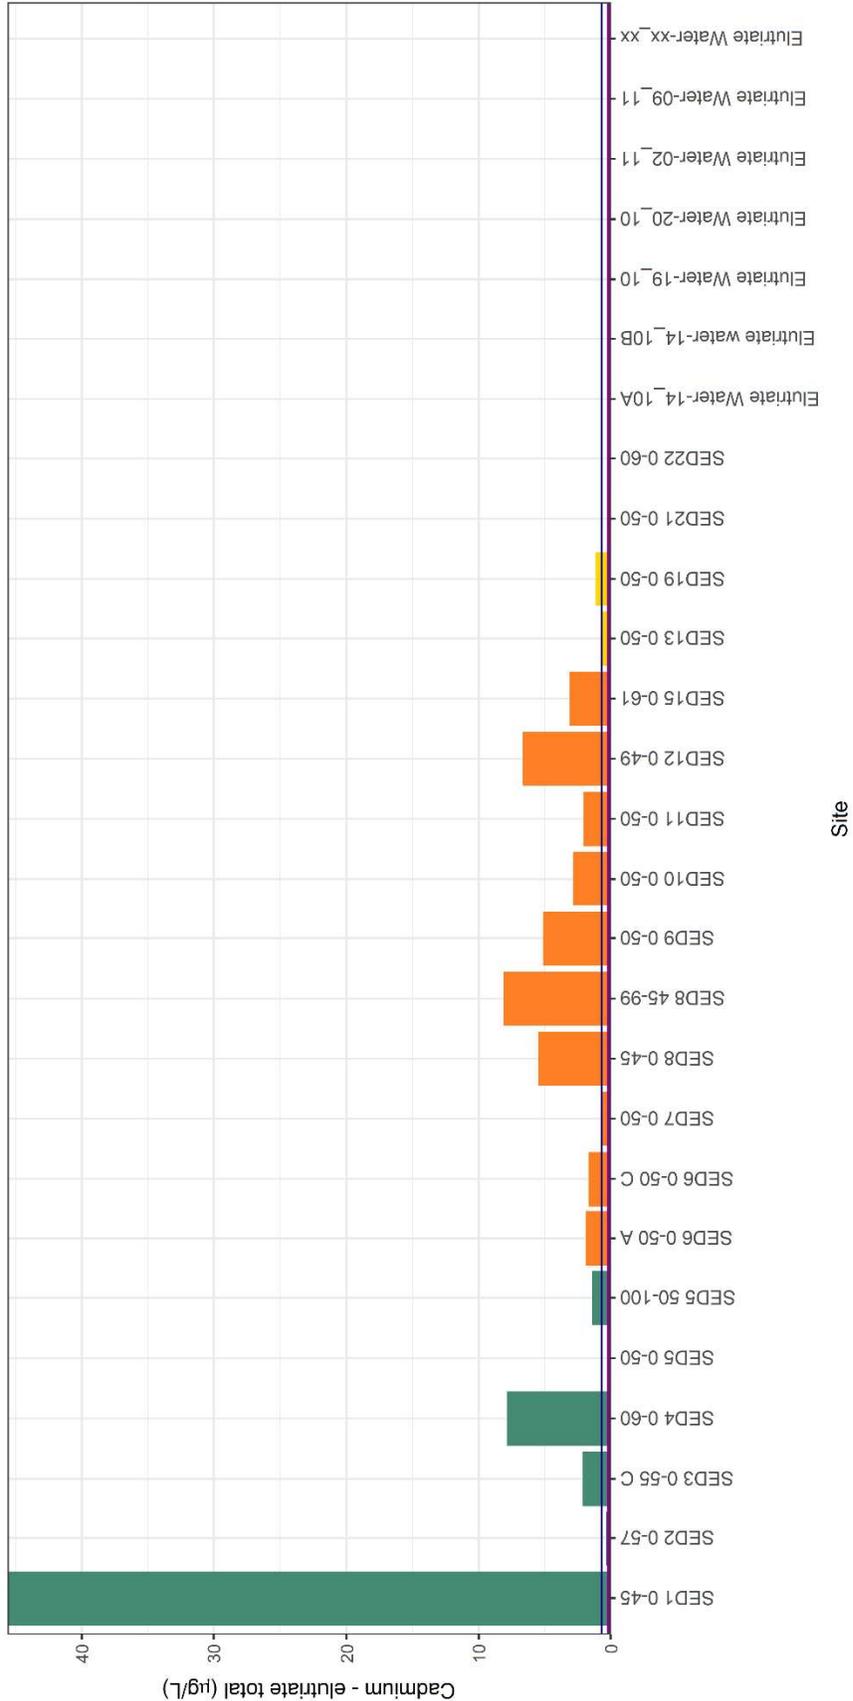
Figure 47. Concentration of total cadmium resulting from elutriate testing. DGVs for cadmium in fresh and marine water are shown in dark magenta and blue respectively. Sites are approximately ordered from south to north, with dark green in southern corner, orange along the causeway and light green on the north shore of the river channel.

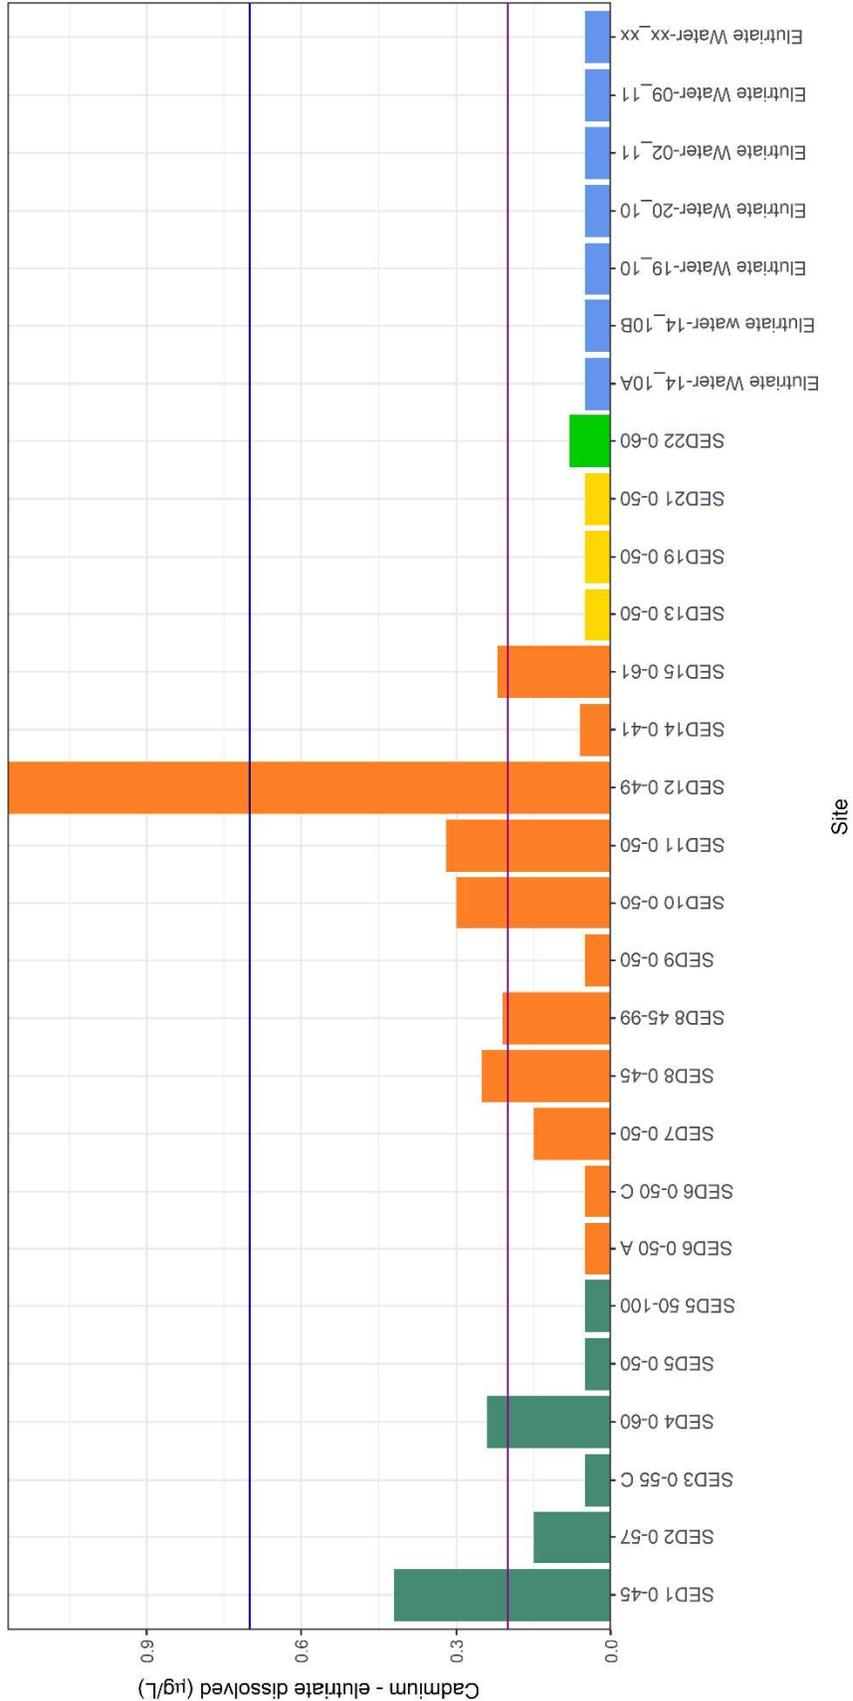
Figure 48. Concentration of dissolved cadmium resulting from elutriate testing. DGVs for cadmium in fresh and marine water are shown in dark magenta and blue respectively. Sites are approximately ordered from south to north, with dark green in southern corner, orange along the causeway and light green on the north shore of the river channel.

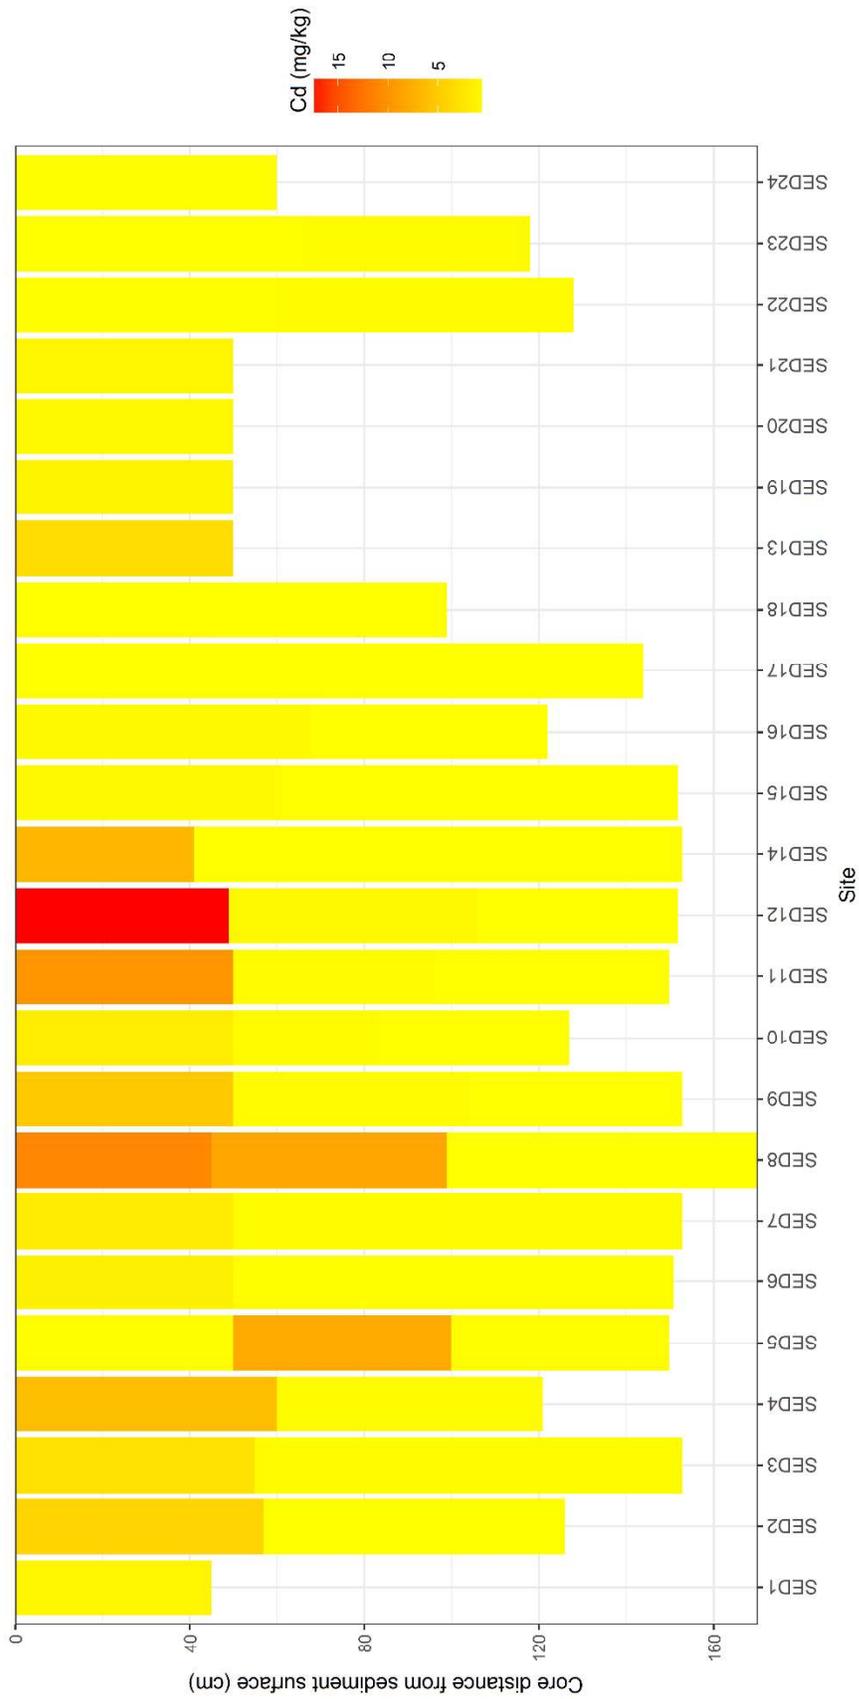
Figure 49. Vertical variation of total cadmium in sediment along cores. ANZECC SQGV is 1.5 mg / kg, with high SQGV of 10 mg / kg.

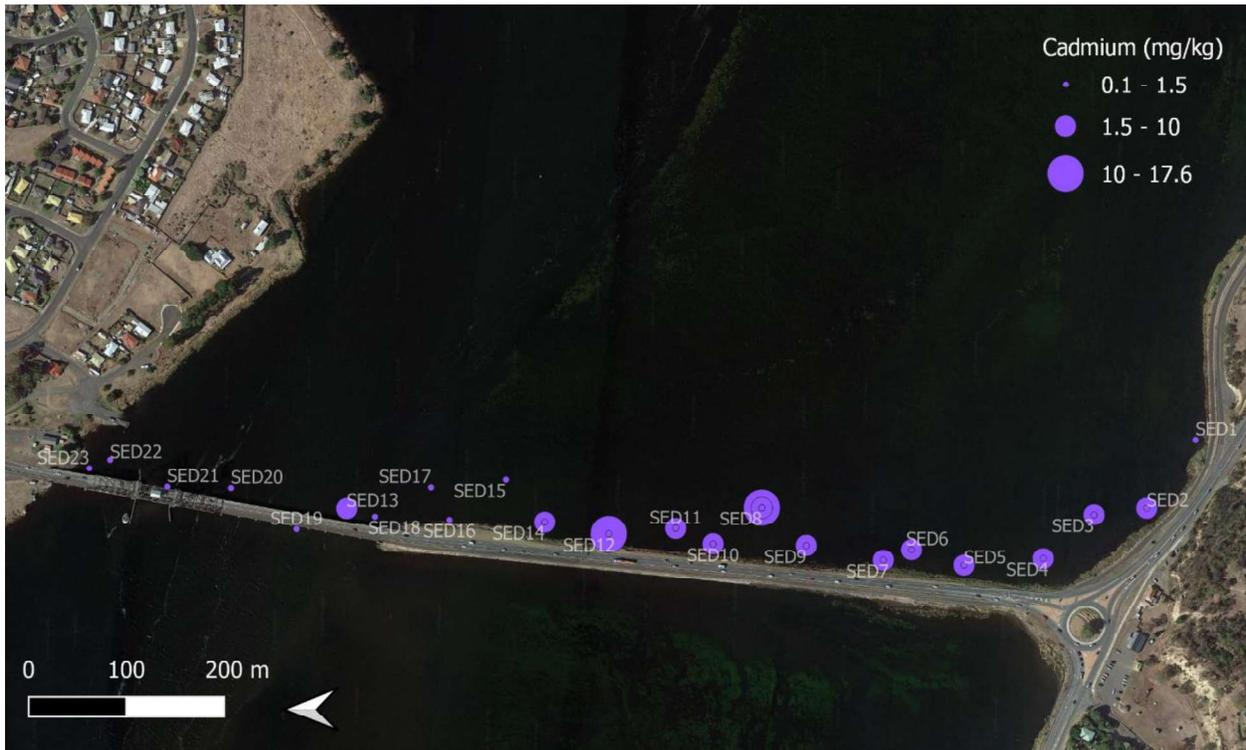
Figure 50. Map of total cadmium concentrations in sediment.

High in southern corner and along causeway. Below SQGV in river channel and north shore of channel, except SED13 on southern edge of river channel (Figure 50).

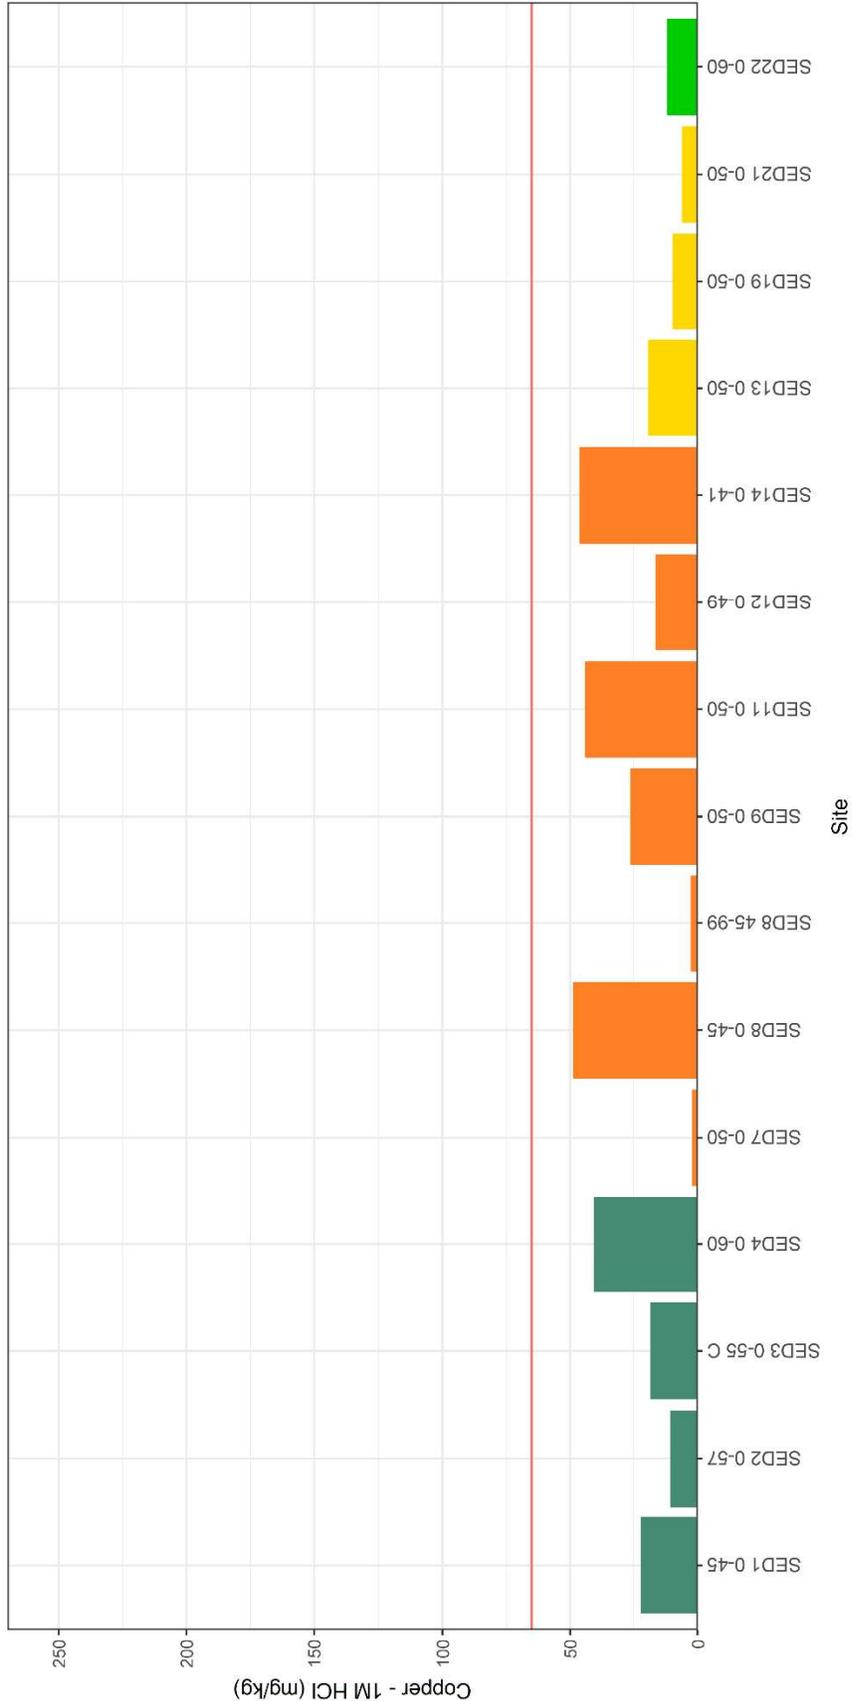
Figure 53. Concentration of bioavailable copper according to 1M HCl digest. Red lines indicate the SQGV and SQGV-high from ANZECC/ARMCANZ (Simpson and Batley 2016). Sites are approximately ordered from south to north, with dark green in southern corner, orange along the causeway, yellow in the river channel and light green on the north shore of the river channel.

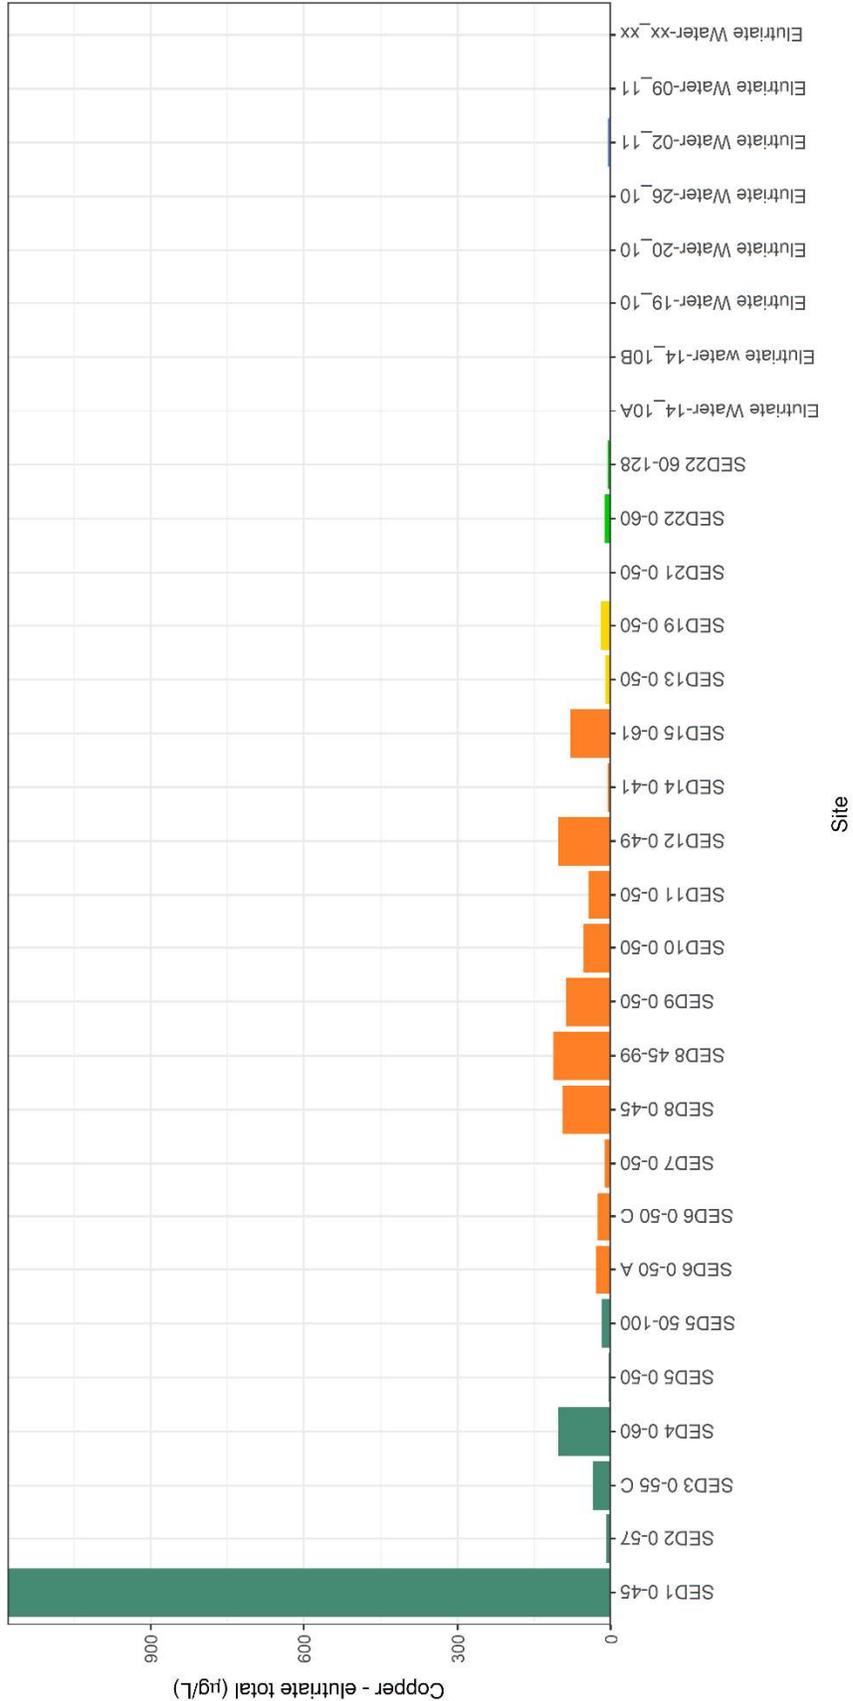
Figure 54. Concentration of total copper resulting from elutriate testing. DGVs for copper in fresh and marine water are shown in dark magenta and blue respectively. Sites are approximately ordered from south to north, with dark green in southern corner, orange along the causeway and light green on the north shore of the river channel.

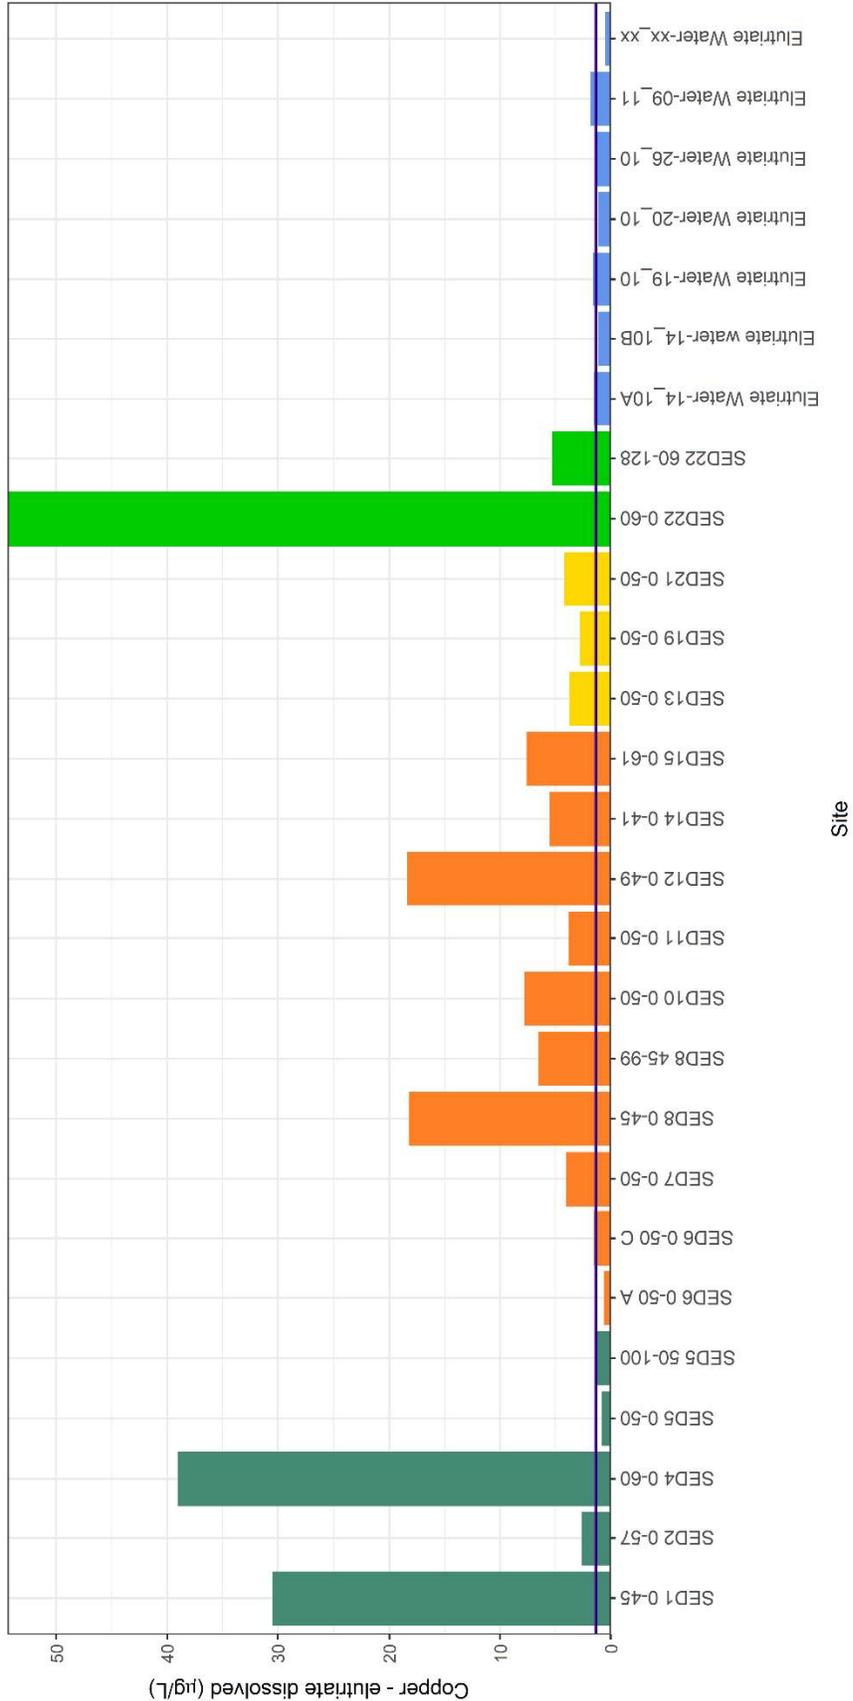
Figure 55. Concentration of dissolved copper resulting from elutriate testing. DGVs for copper in fresh and marine water are shown in dark magenta and blue respectively. Sites are approximately ordered from south to north, with dark green in southern corner, orange along the causeway and light green on the north shore of the river channel.

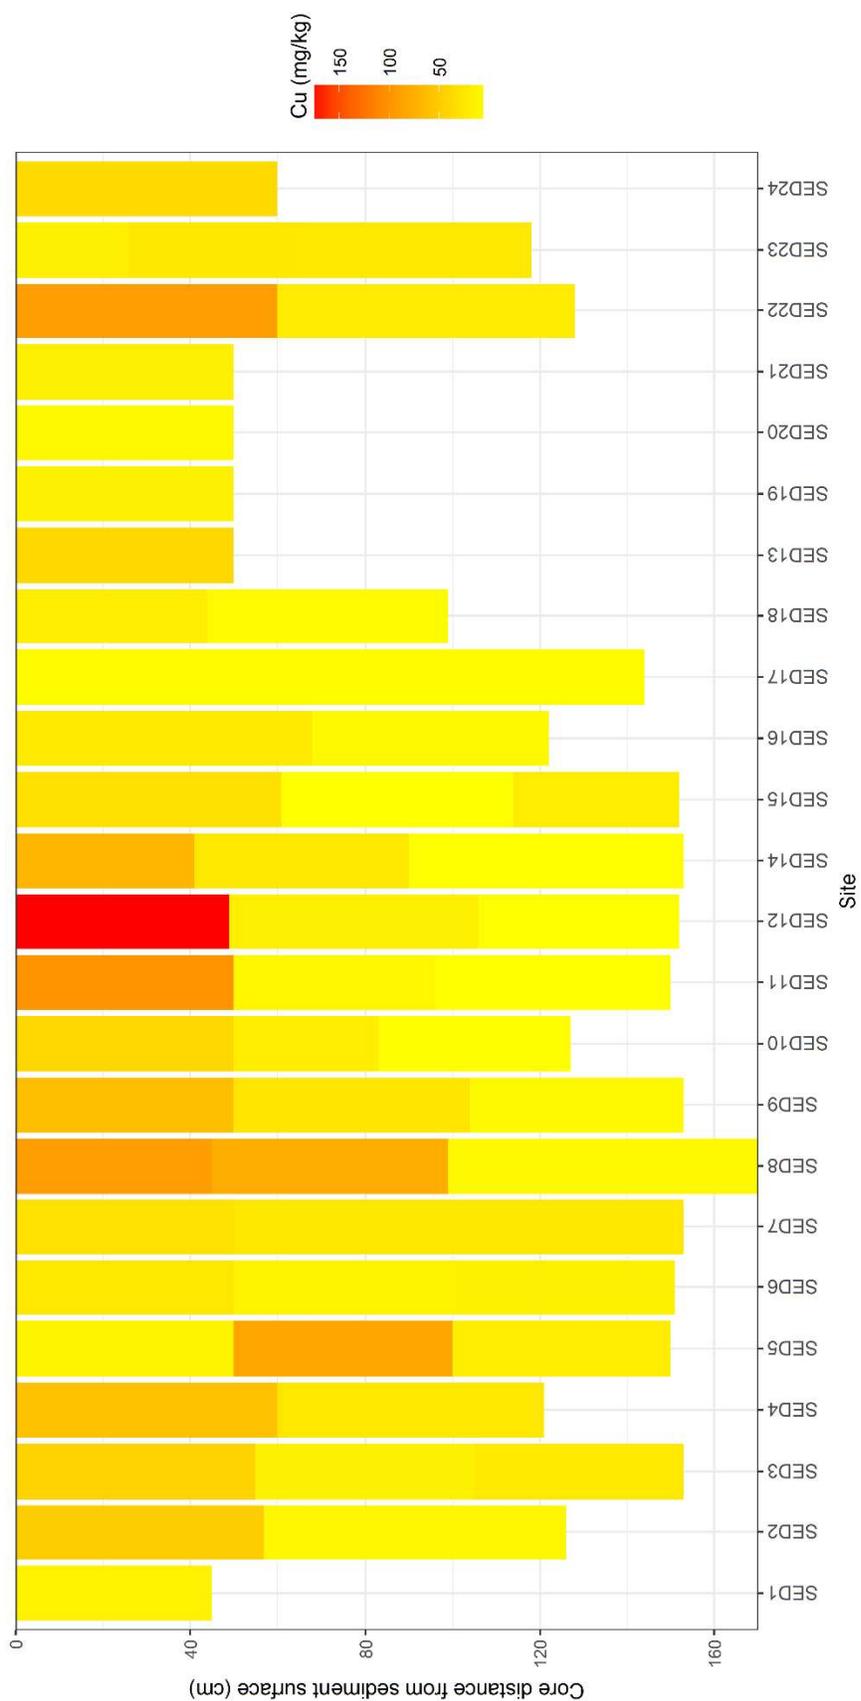
Figure 56. Vertical variation of total copper in sediment along cores. ANZECC SQGV is 1.5 mg / kg, with high SQGV of 10 mg / kg.

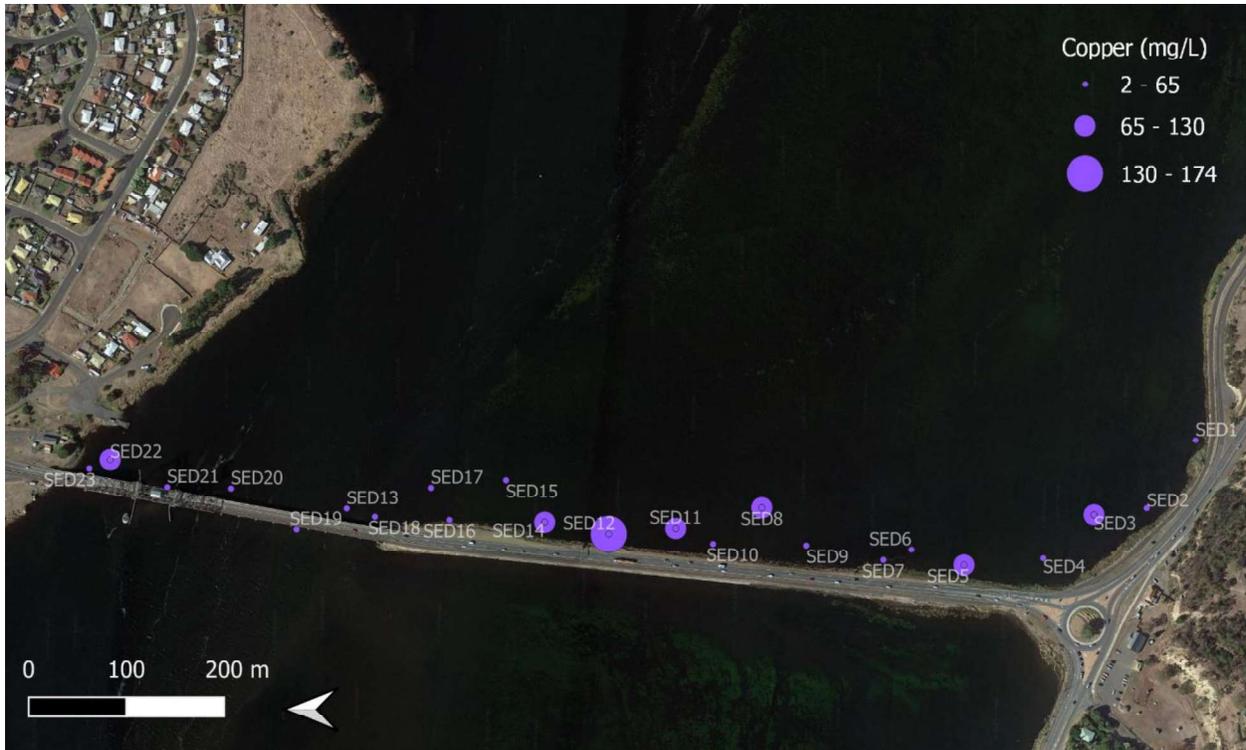
Figure 57. Map of total copper concentrations in sediment.

High in the southern corner and along causeway. Mostly below SQGV in channel and north shore of channel, except SED22 on the northern shore (Figure 57).

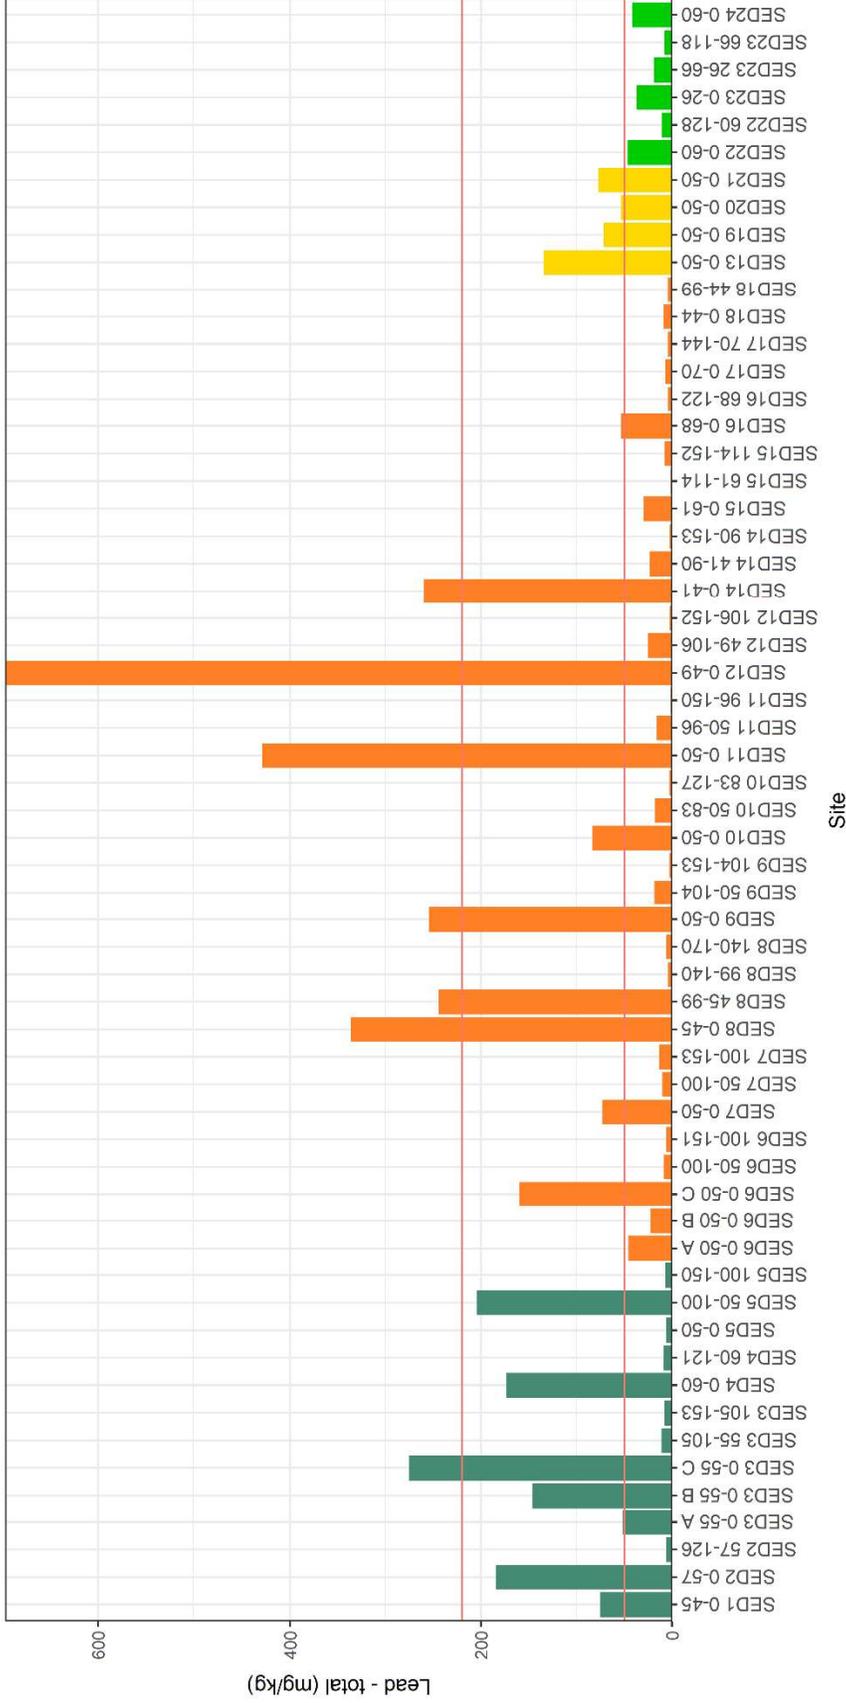
Figure 59. Concentration of total lead in sediment. Red lines indicate the SQGV and SQGV-high from ANZECC/ARMCANZ (Simpson and Batley 2016). Sites are approximately ordered from south to north, with dark green in southern corner, orange along the causeway, yellow in the river channel and light green on the north shore of the river channel.

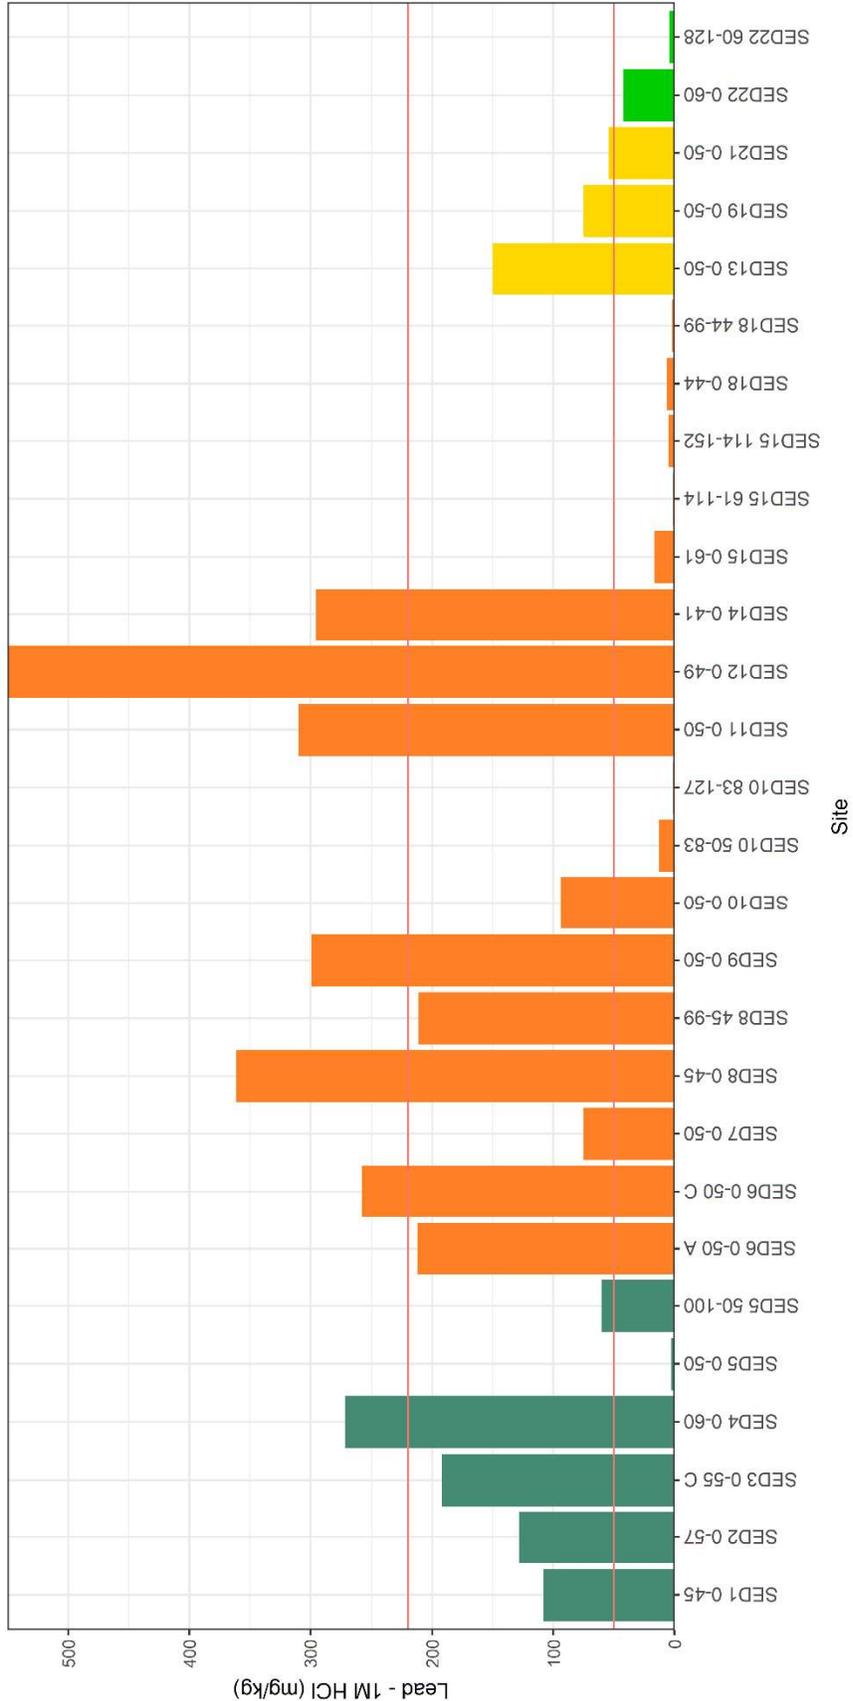
Figure 60. Concentration of bioavailable lead according to 1M HCl digest. Red lines indicate the SQGV and SQGV-high from ANZECC/ARMCANZ (Simpson and Batley 2016). Sites are approximately ordered from south to north, with dark green in southern corner, orange along the causeway, yellow in the river channel and light green on the north shore of the river channel.

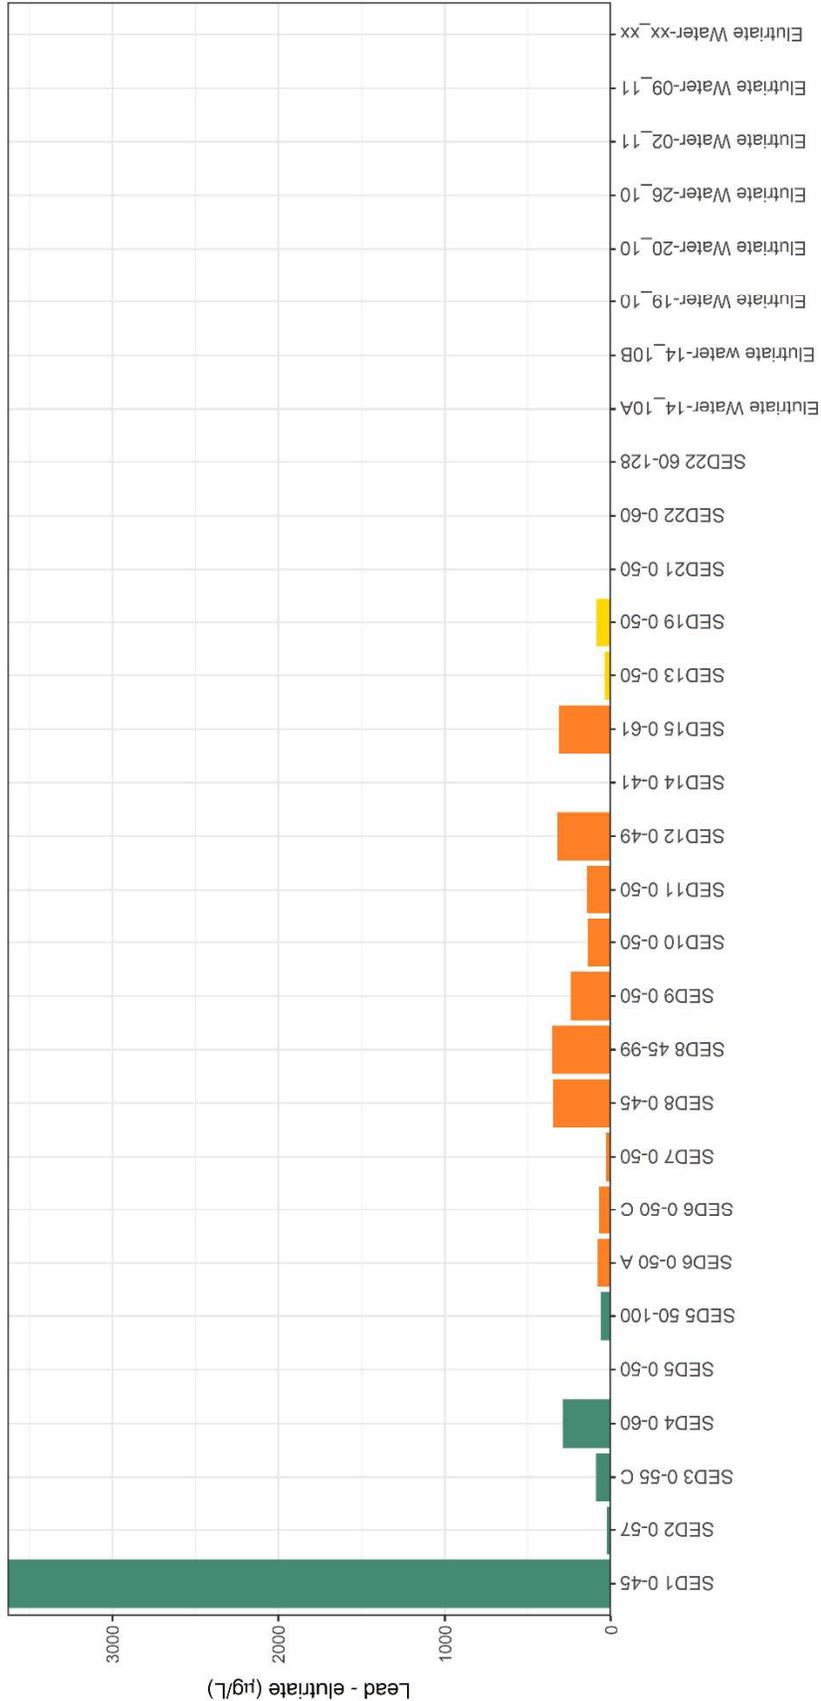
Figure 61. Concentration of total lead resulting from elutriate testing. DGVs for lead in fresh and marine water are low relative to the data and are therefore not visible. Sites are approximately ordered from south to north, with dark green in southern corner, orange along the causeway and light green on the north shore of the river channel.

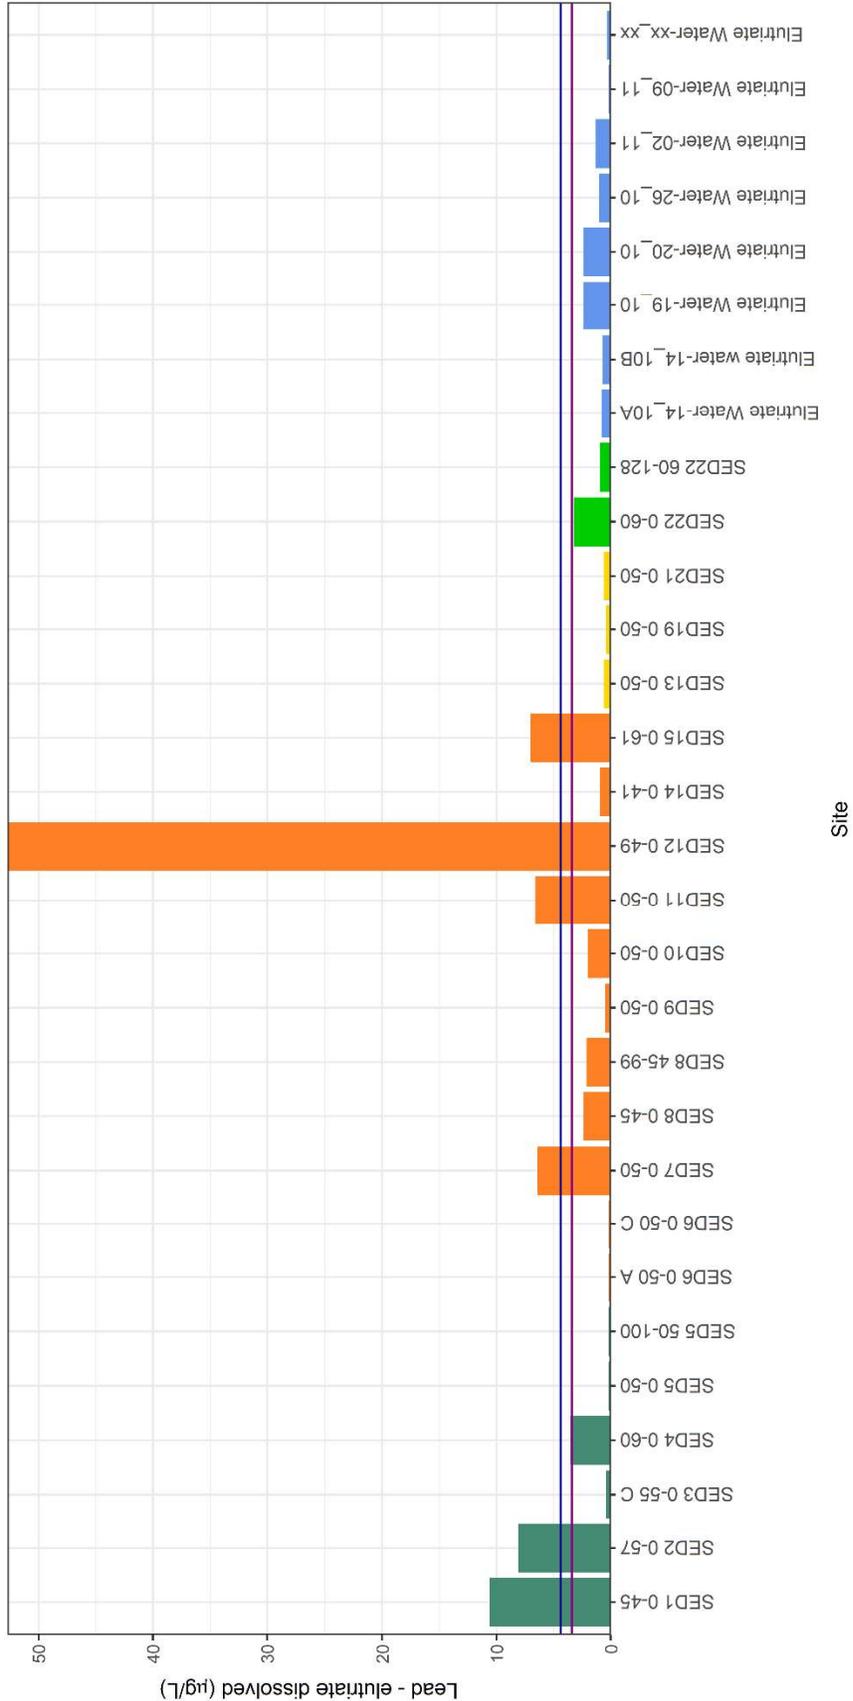
Figure 62. Concentration of dissolved lead resulting from elutriate testing. DGVs for lead in fresh and marine water are shown in dark magenta and blue respectively. Sites are approximately ordered from south to north, with dark green in southern corner, orange along the causeway and light green on the north shore of the river channel.

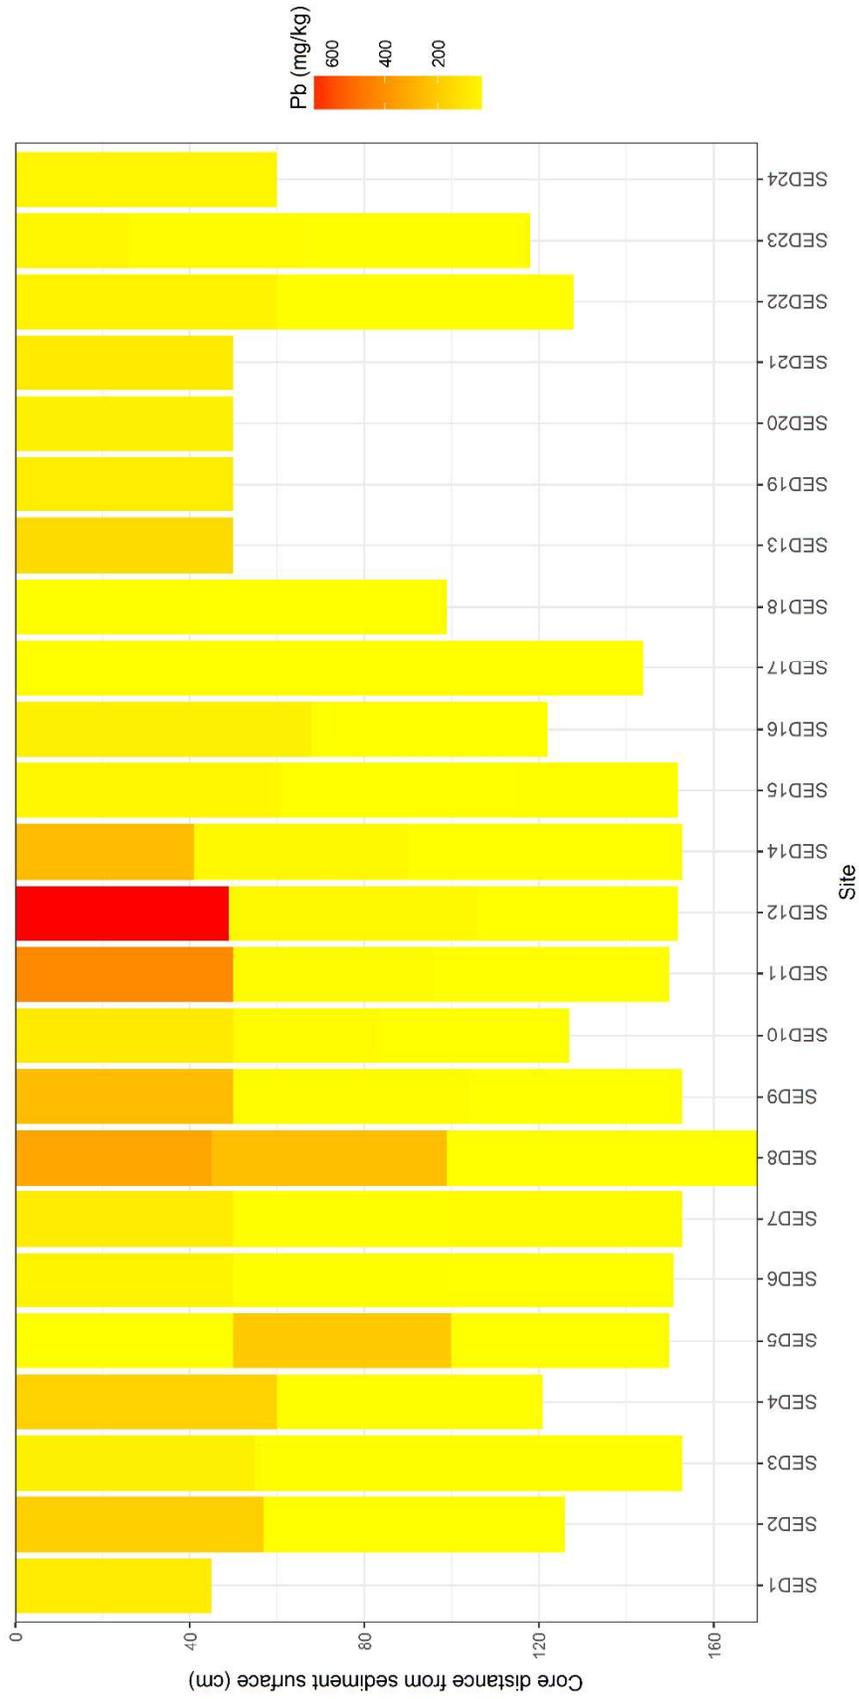
Figure 63. Vertical variation of total lead in sediment along cores. ANZECC SQGV is 1.5 mg / kg, with high SQGV of 10 mg / kg.

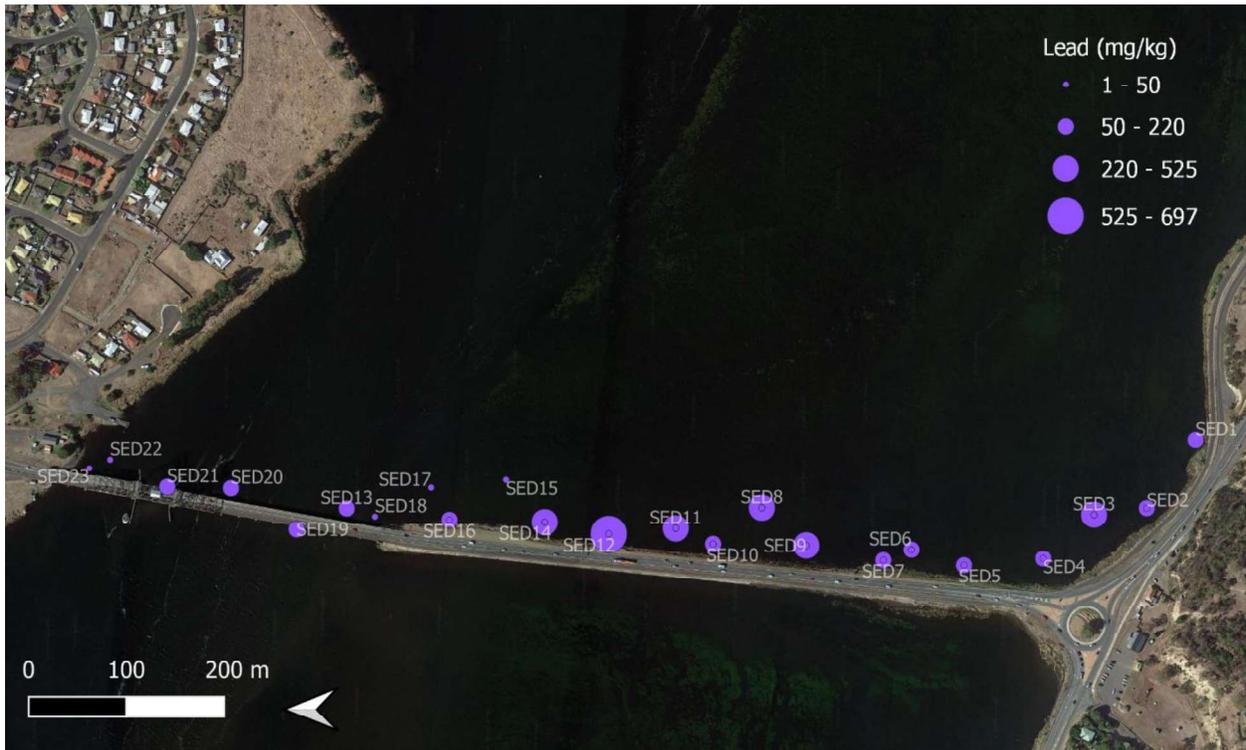
Figure 64. Map of total lead concentrations in sediment.

Highly variable between sites. High concentrations in corner and along causeway, and highest in center causeway. Below high-SQGV in river channel and north shore of channel (Figure 64).

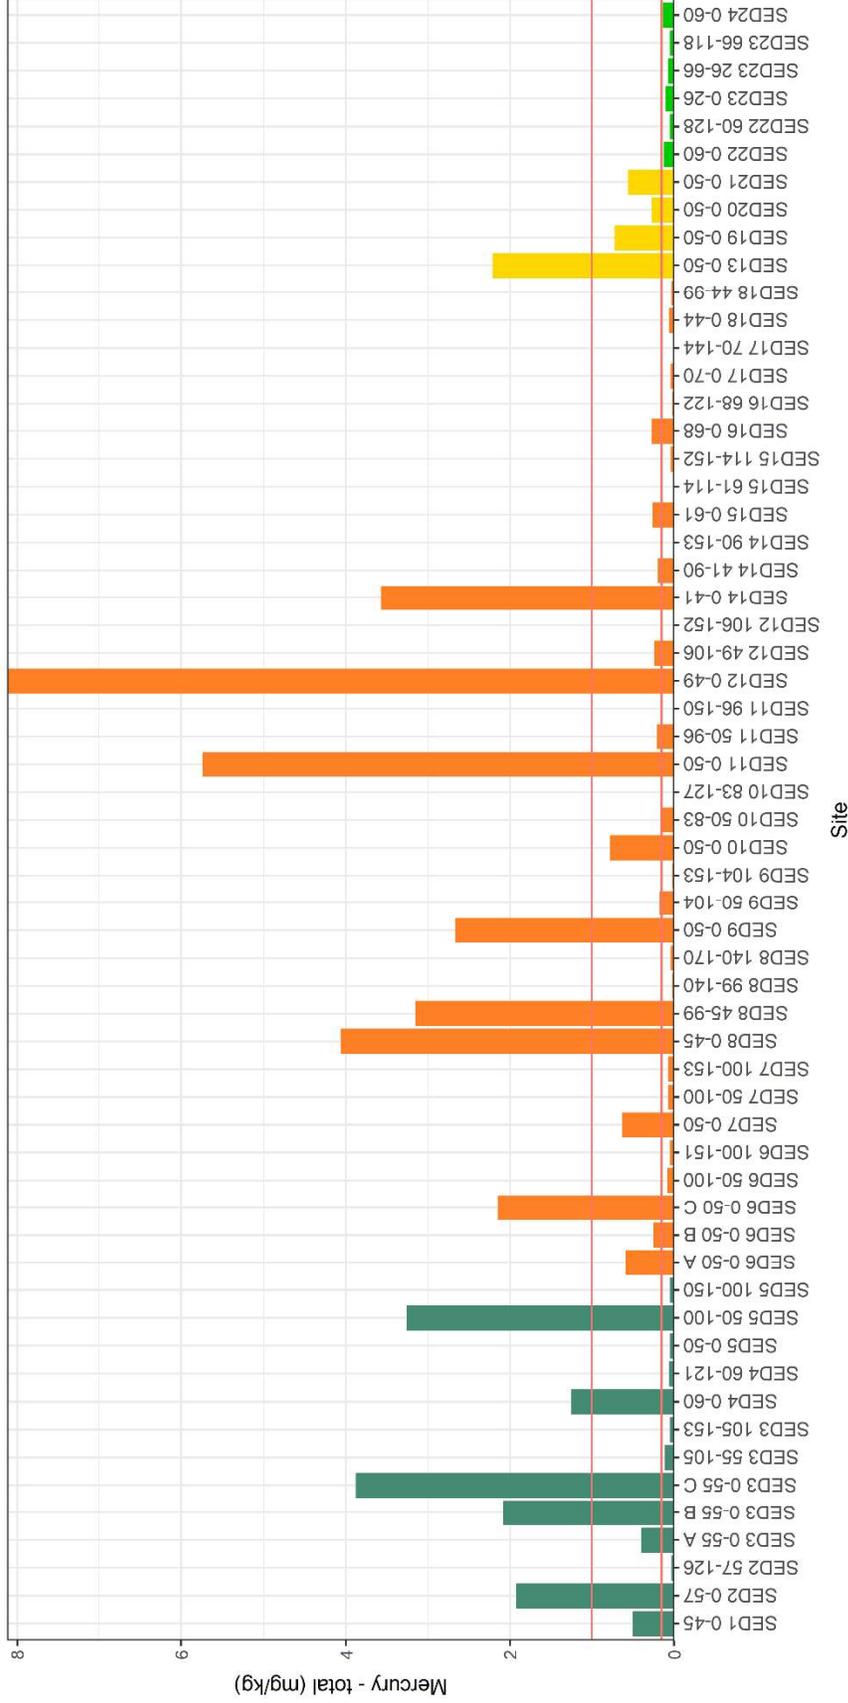
Figure 66. Concentration of total mercury in sediment. Red lines indicate the SQGV and SQGV-high from ANZECC/ARMCANZ (Simpson and Batley 2016). Sites are approximately ordered from south to north, with dark green in southern corner, orange along the causeway, yellow in the river channel and light green on the north shore of the river channel.
