4.5 SEDIMENT

This section describes the condition of sediment in the potential footprint of the proposed New Bridgewater Bridge. The description includes a review of available information combined with a broad-scale sampling of shallow sediments to around 2.5 m below sediment-water interface to characterise their condition prior to commencement of construction works. In conjunction with hydrodynamic modelling, this information will be used to determine the risk of suspended sediment to the adjacent estuarine ecosystem and to identify appropriate controls to mitigate risk. The information will also be used by pitt&sherry to guide the appropriate handling and treatment of material removed from the water during construction.

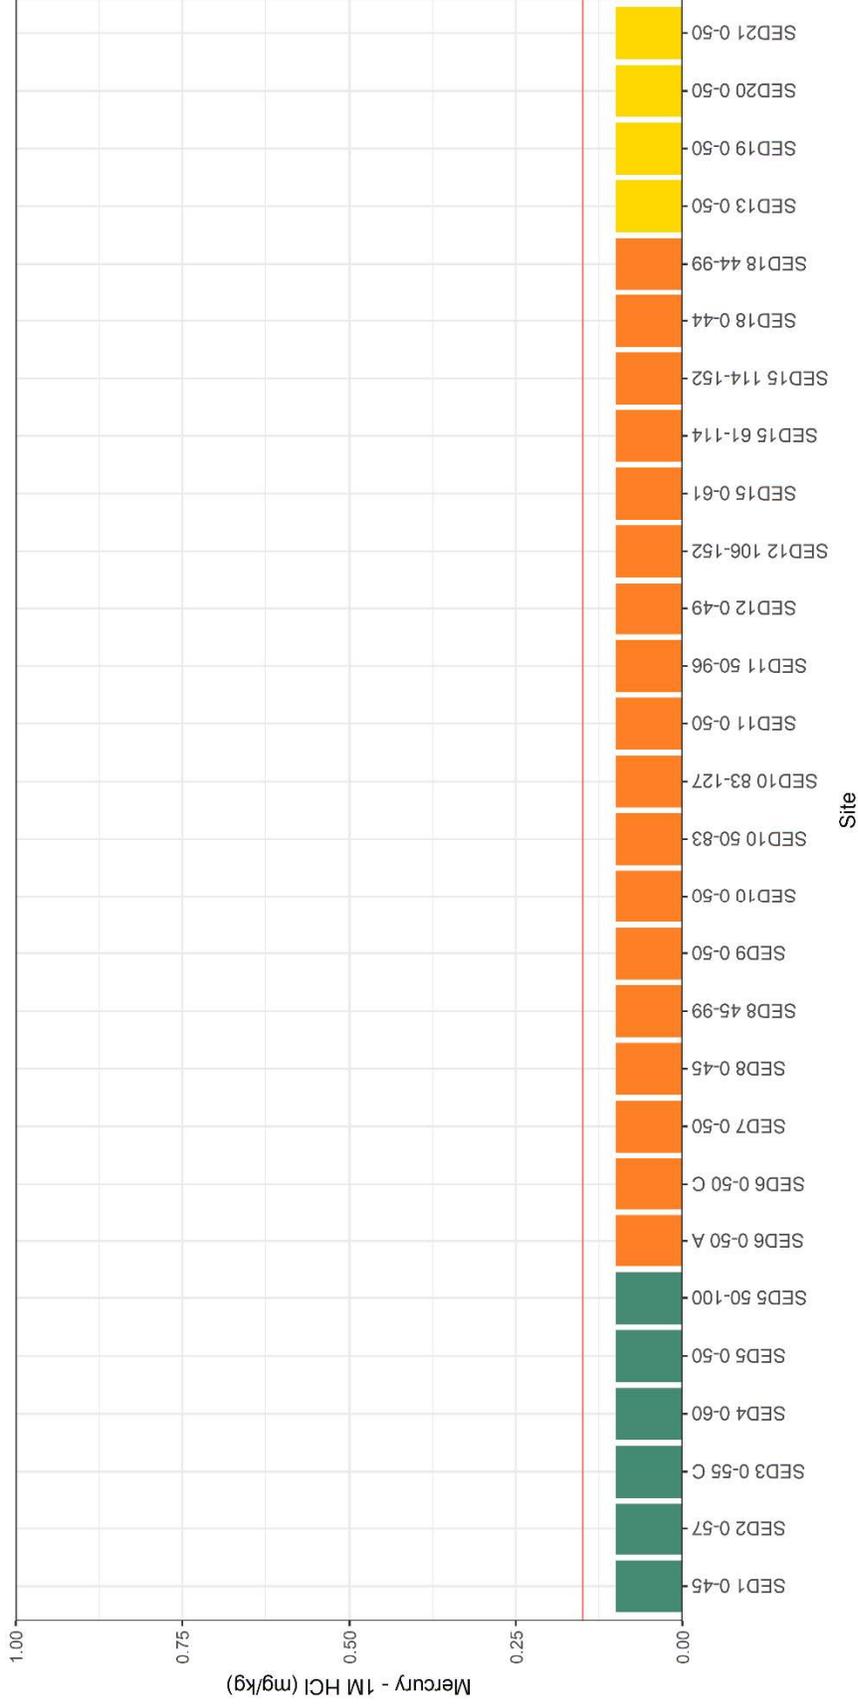
Figure 67. Concentration of bioavailable mercury according to 1M HCl digest. Red lines indicate the SQGV and SQGV-high from ANZECC/ARMICANZ (Simpson and Batley 2016). Sites are approximately ordered from south to north, with dark green in southern corner, orange along the causeway, yellow in the river channel and light green on the north shore of the river channel.

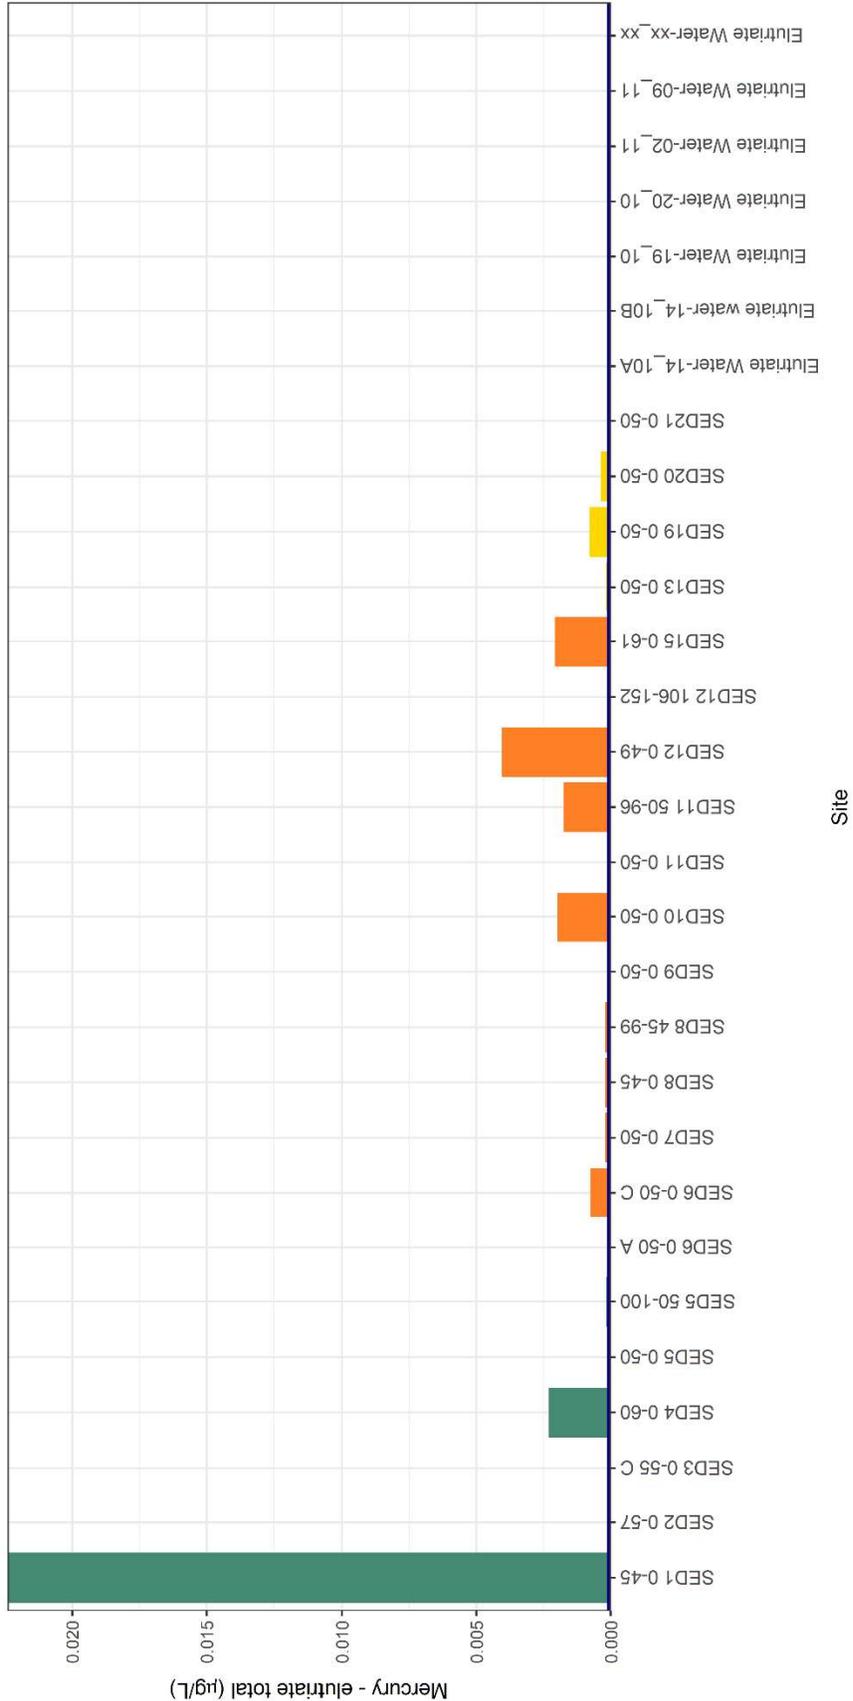
Figure 68. Concentration of total mercury resulting from elutriate testing. DGVs for mercury in fresh and marine water are shown in dark magenta and blue respectively. Sites are approximately ordered from south to north, with dark green in southern corner, orange along the causeway and light green on the north shore of the river channel.

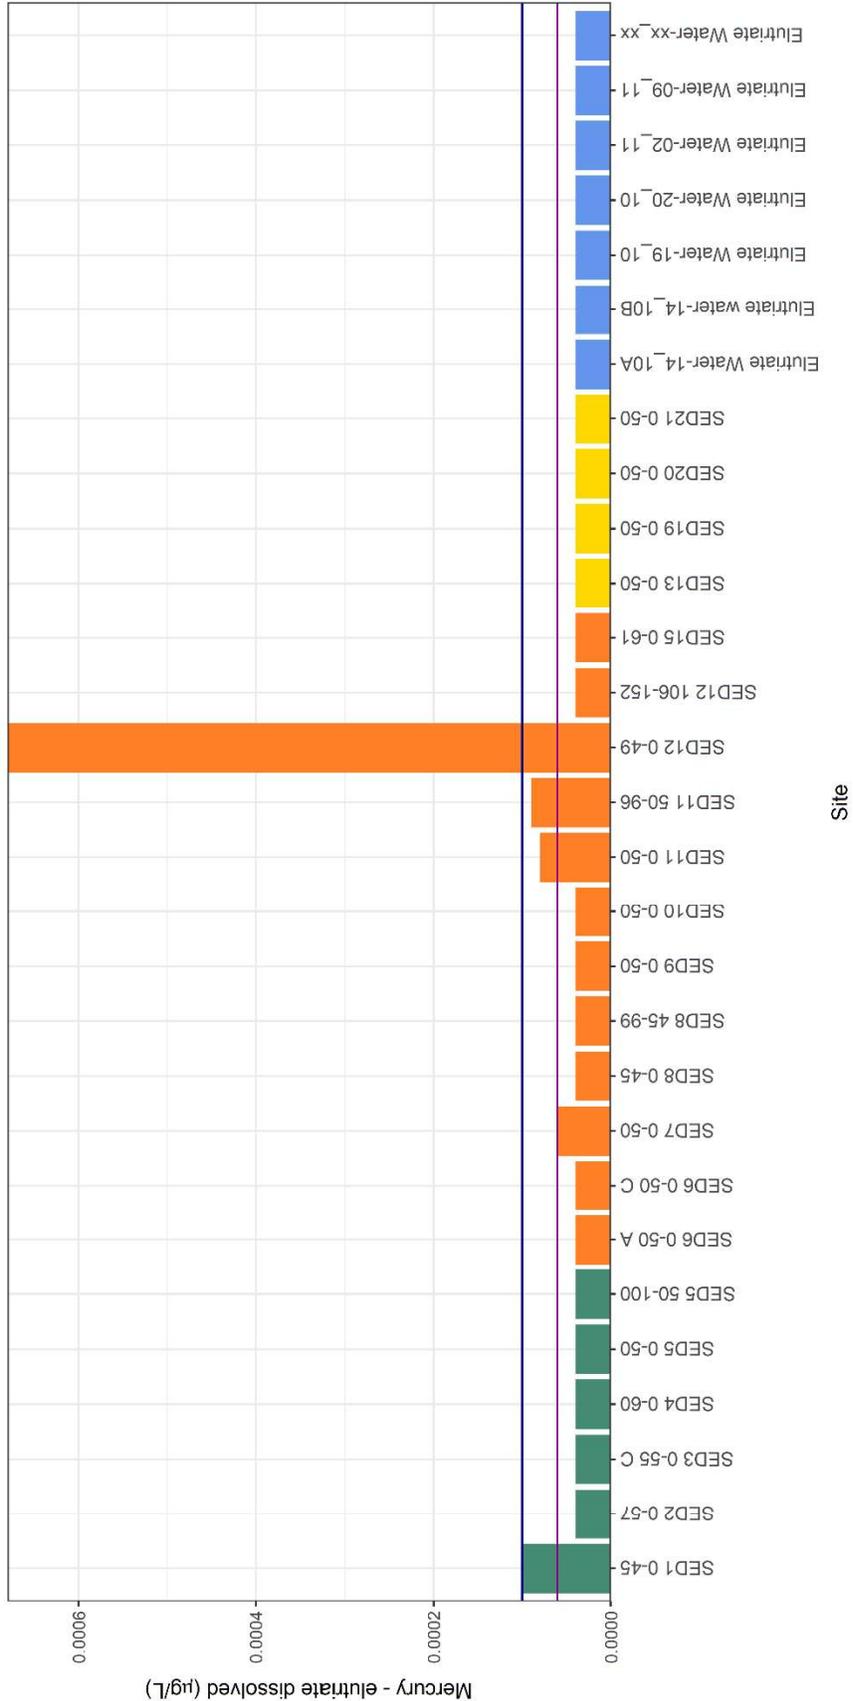
Figure 69. Concentration of dissolved mercury resulting from elutriate testing. DGVs for mercury in fresh and marine water are shown in dark magenta and blue respectively. Sites are approximately ordered from south to north, with dark green in southern corner, orange along the causeway and light green on the north shore of the river channel.

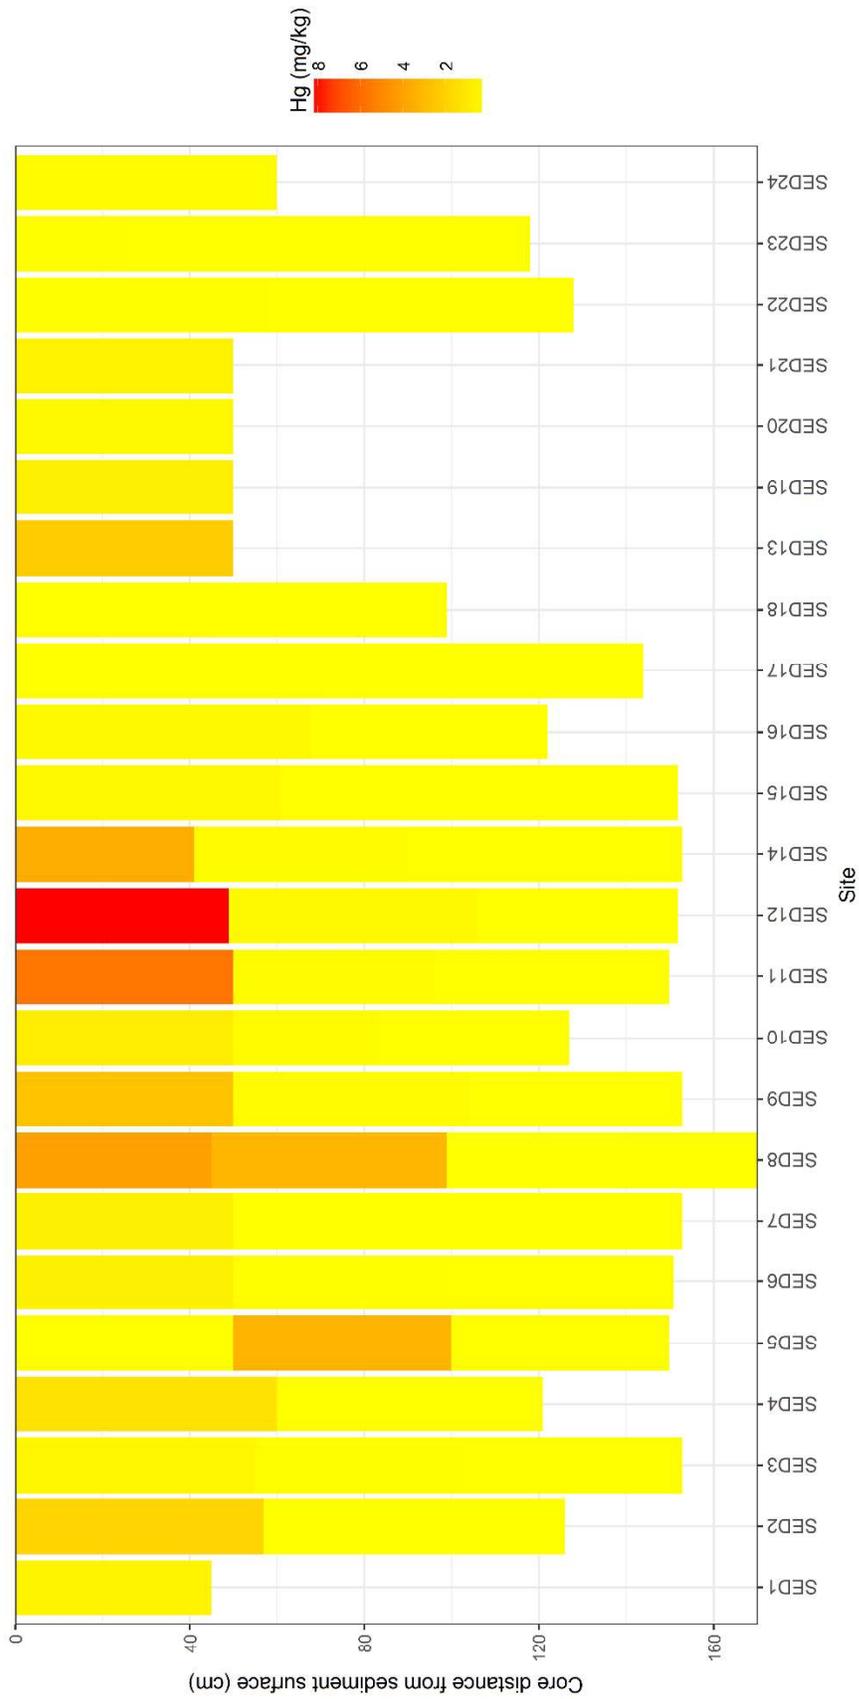
Figure 70. Vertical variation of total mercury in sediment along cores. ANZECC SQGV is 1.5 mg / kg, with high SQGV of 10 mg / kg.

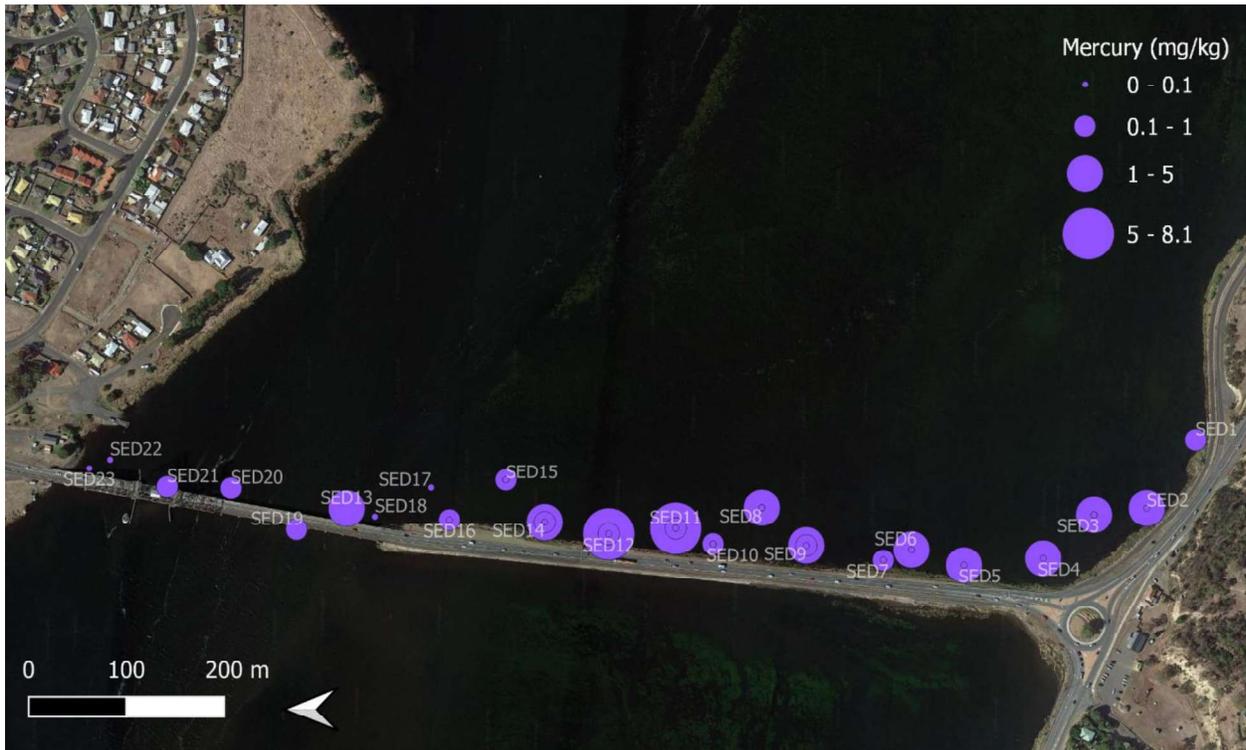
Figure 71. Map of total mercury concentrations in sediment.

High in corner and along causeway. All below SQGV on the north shore of the river channel (Figure 71).

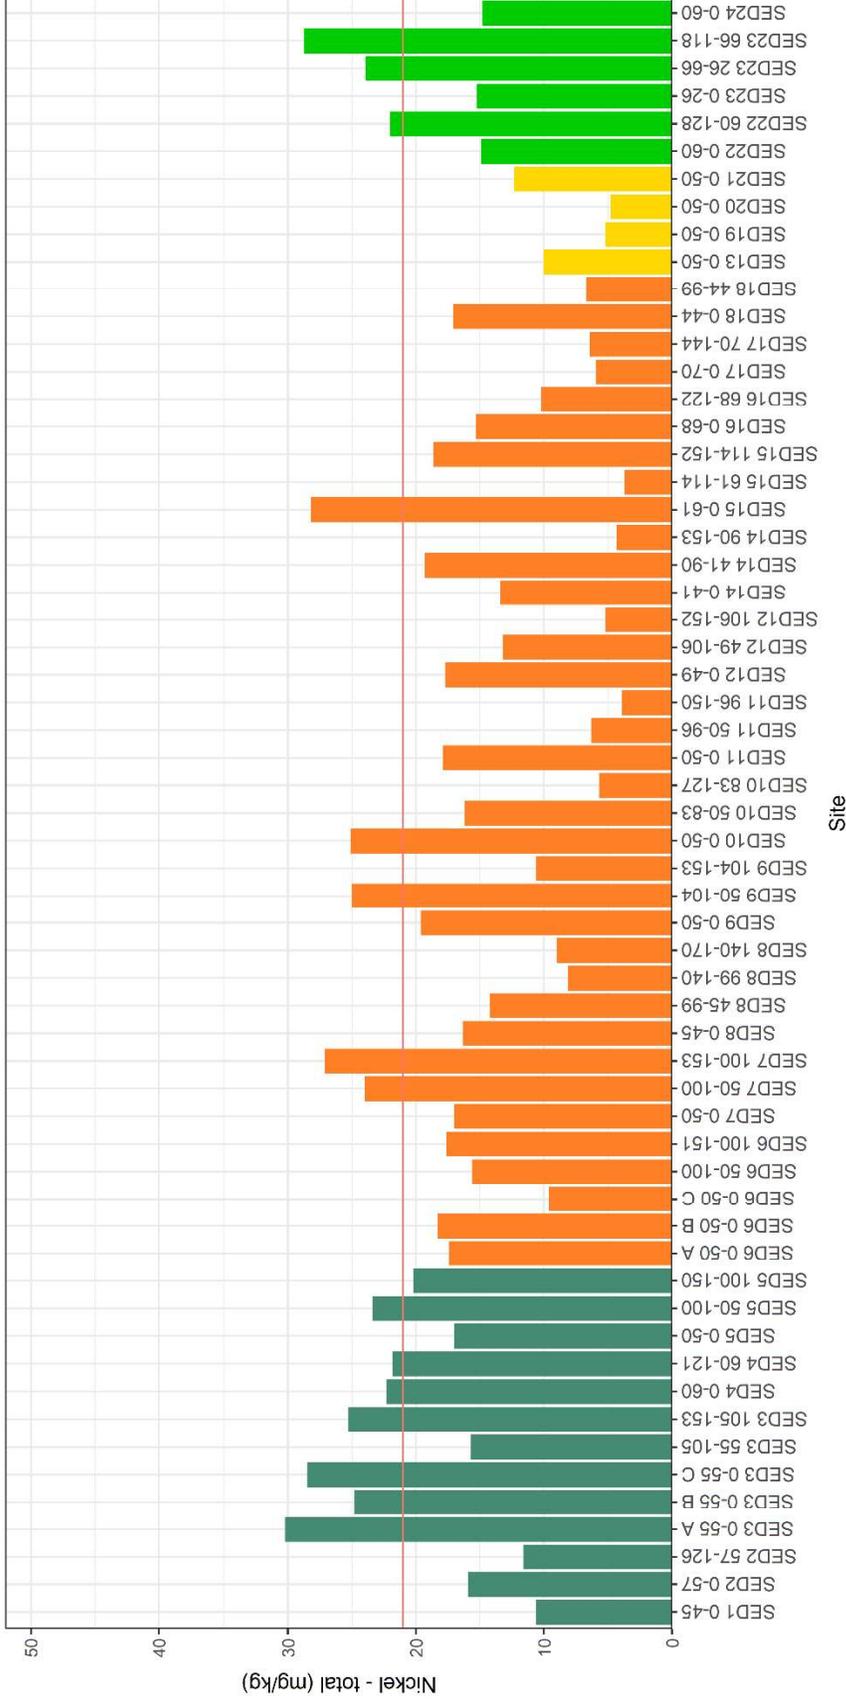
Figure 73. Concentration of total nickel in sediment. Red lines indicate the SQGV and SQGV-high from ANZECC/ARMCANZ (Simpson and Batley 2016). Sites are approximately ordered from south to north, with dark green in southern corner, orange along the causeway, yellow in the river channel and light green on the north shore of the river channel.

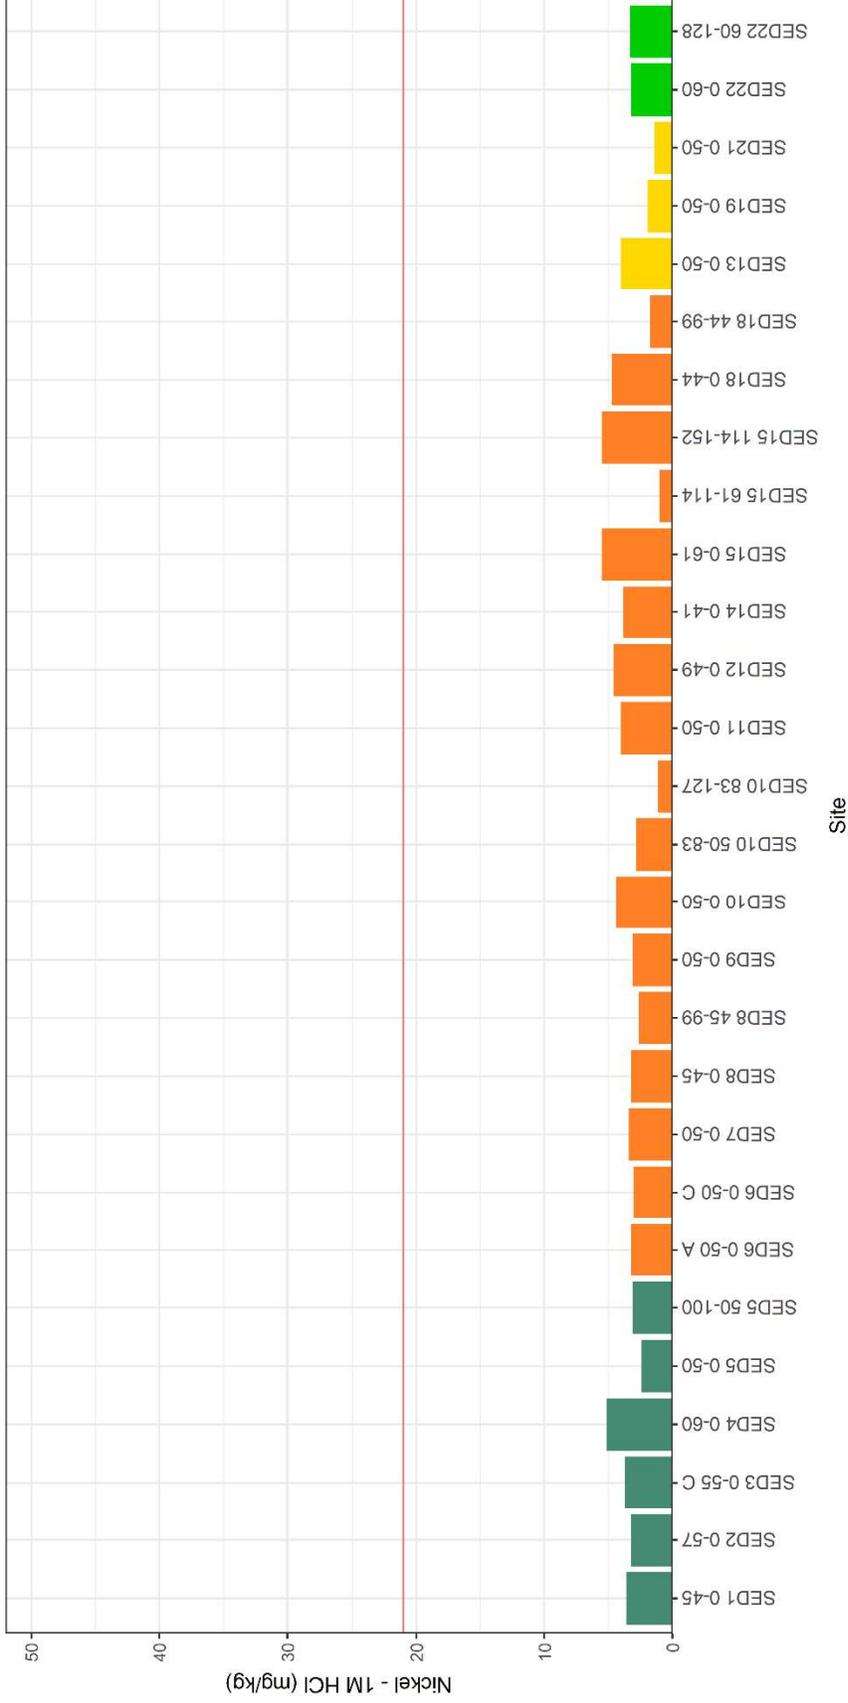
Figure 74. Concentration of bioavailable nickel according to 1M HCl digest. Red lines indicate the SQGV and SQGV-high from ANZECC/ARMCANZ (Simpson and Batley 2016). Sites are approximately ordered from south to north, with dark green in southern corner, orange along the causeway, yellow in the river channel and light green on the north shore of the river channel.

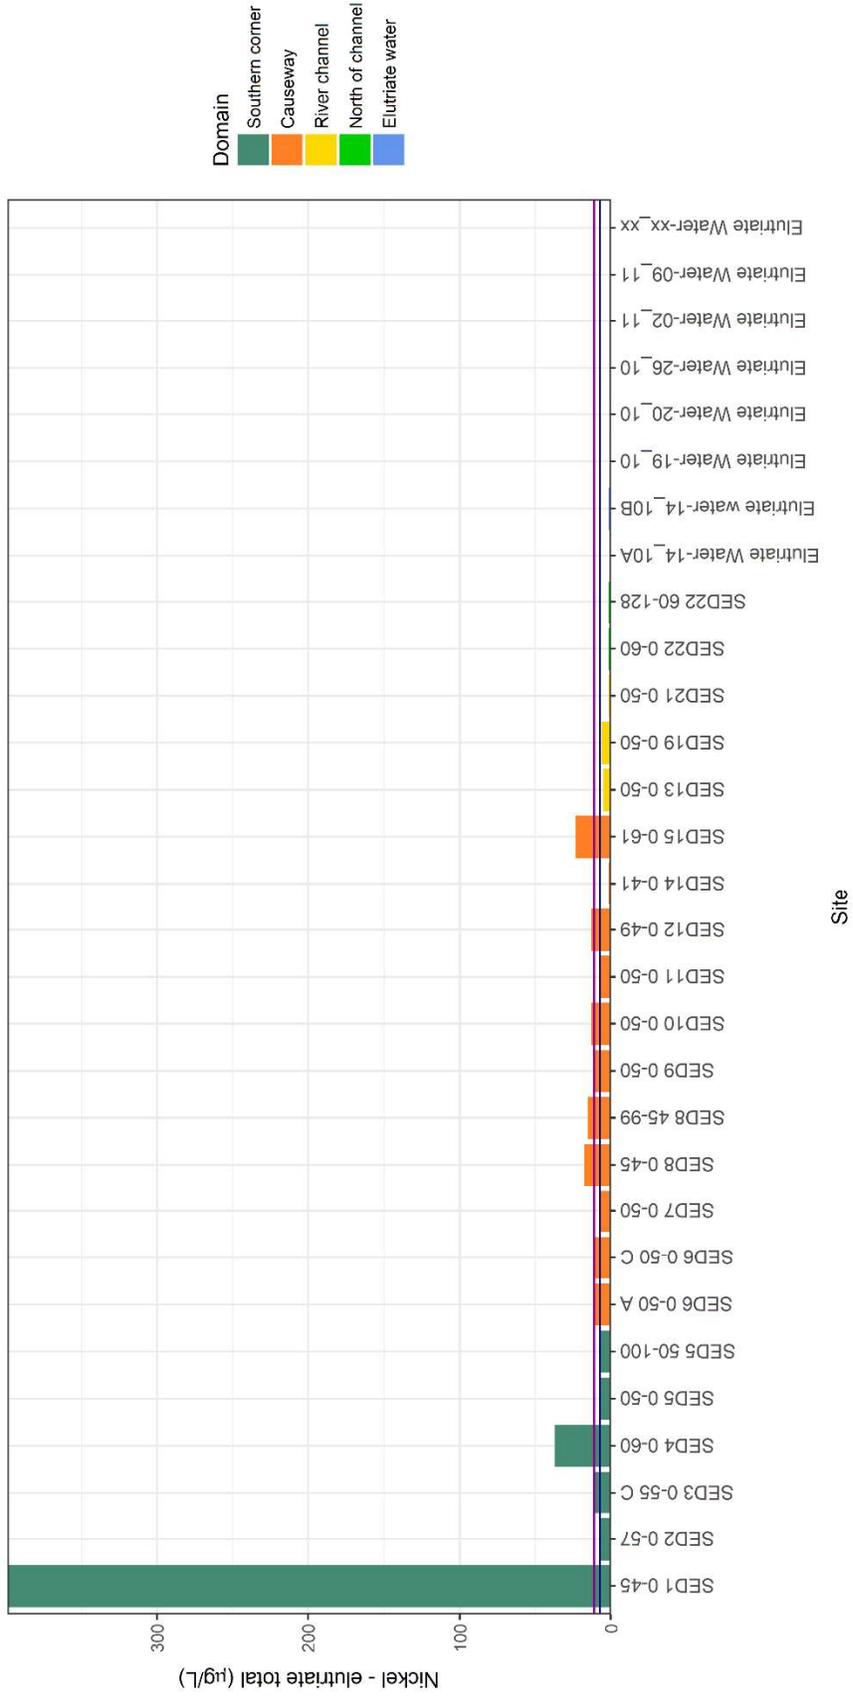
Figure 75. Concentration of total nickel resulting from elutriate testing. DGVs for nickel in fresh and marine water are shown in dark magenta and blue respectively. Sites are approximately ordered from south to north, with dark green in southern corner, orange along the causeway and light green on the north shore of the river channel.

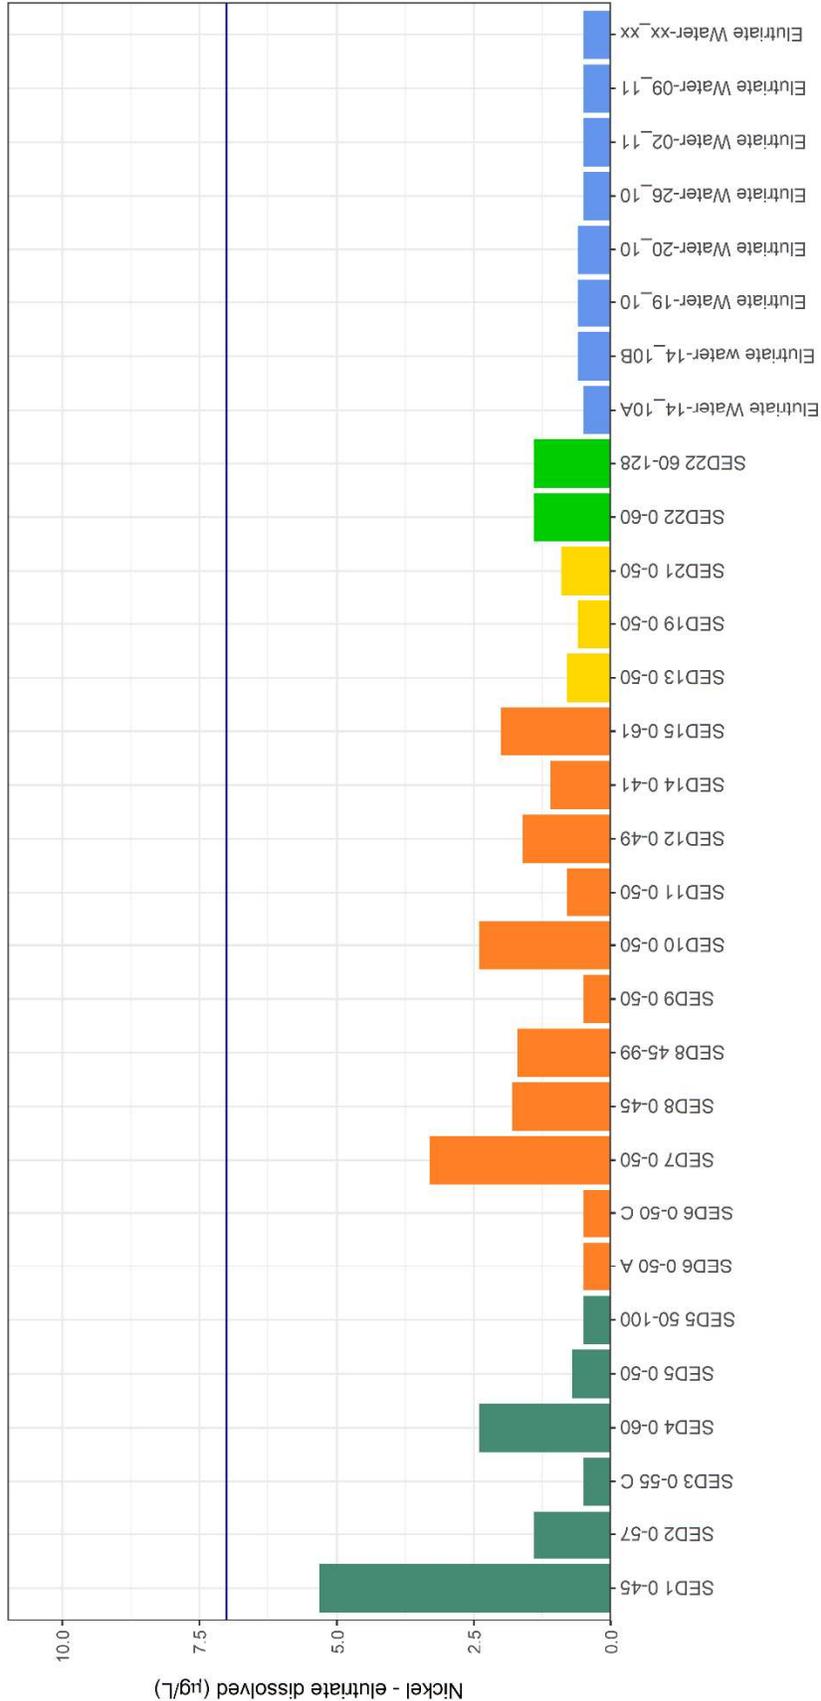
Figure 76. Concentration of dissolved nickel resulting from elutriate testing. DGVs for nickel in fresh and marine water are shown in dark magenta and blue respectively. Sites are approximately ordered from south to north, with dark green in southern corner, orange along the causeway and light green on the north shore of the river channel.

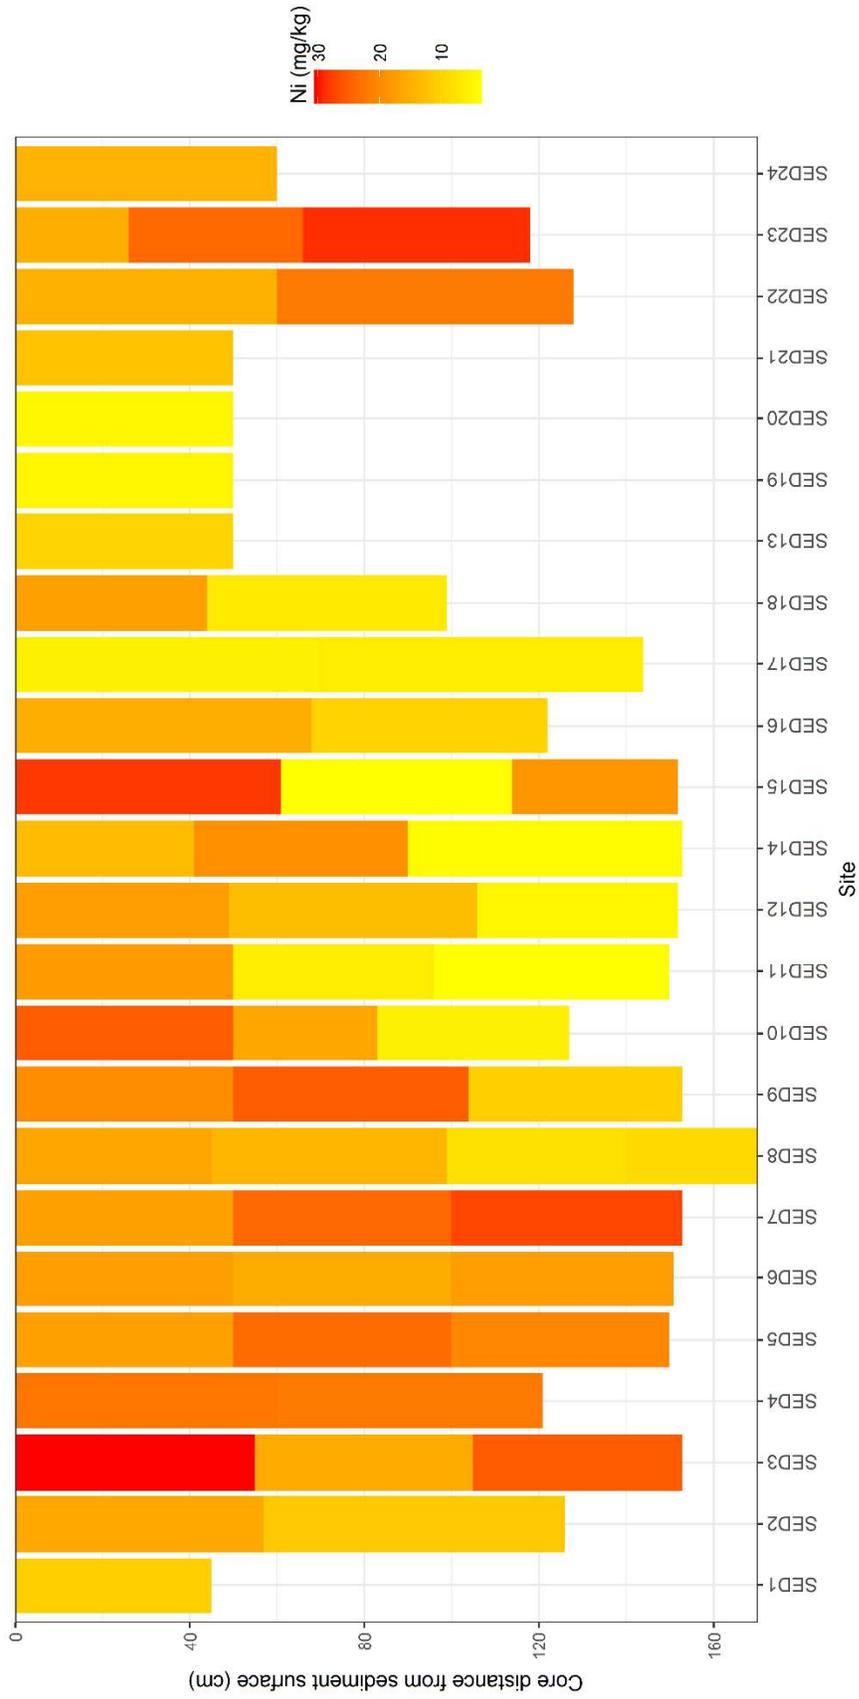
Figure 77. Vertical variation of total nickel in sediment along cores. ANZECC SQGV is 1.5 mg / kg, with high SQGV of 10 mg / kg.

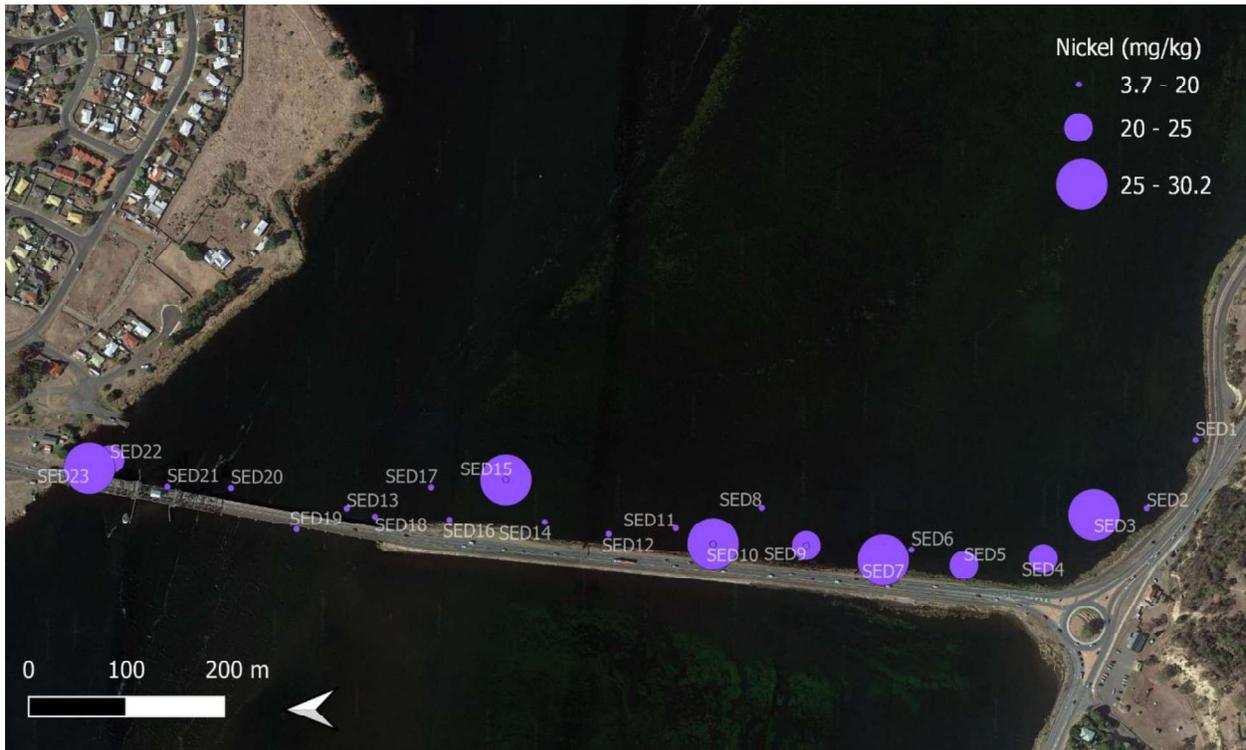
Figure 78. Map of total nickel concentrations in sediment.

High in southern corner, along causeway and on the north shore of the river channel. Below SQGV in river channel (Figure 78).

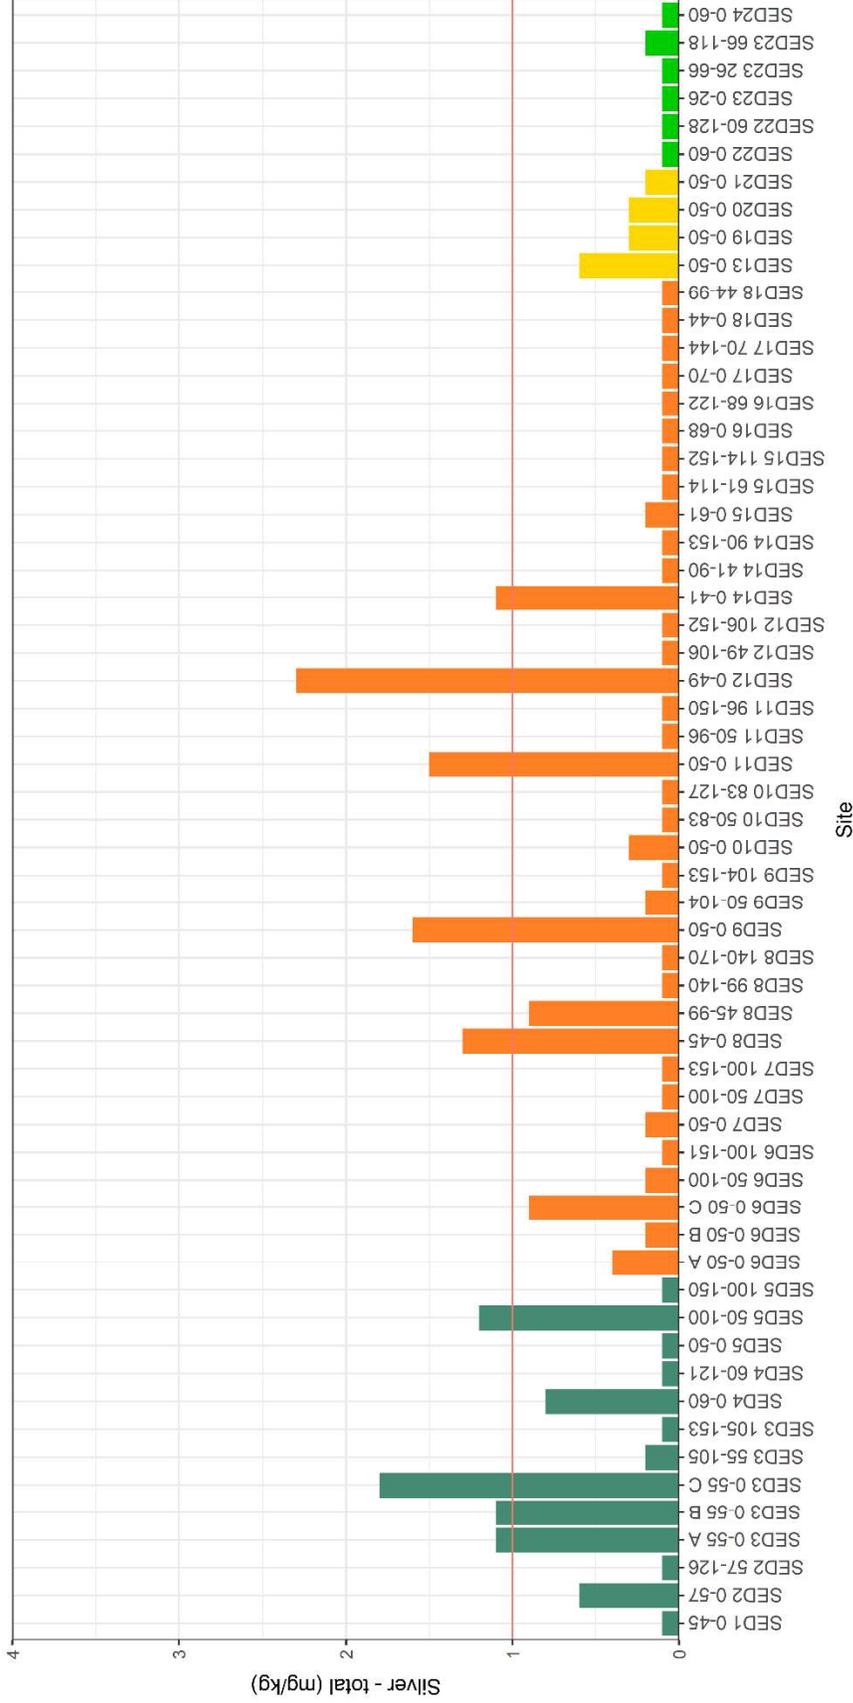
Figure 79. Concentration of total silver in sediment. Red lines indicate the SQGV and SQGV-high from ANZECC/ARMCANZ (Simpson and Batley 2016). Sites are approximately ordered from south to north, with dark green in southern corner, orange along the causeway, yellow in the river channel and light green on the north shore of the river channel.

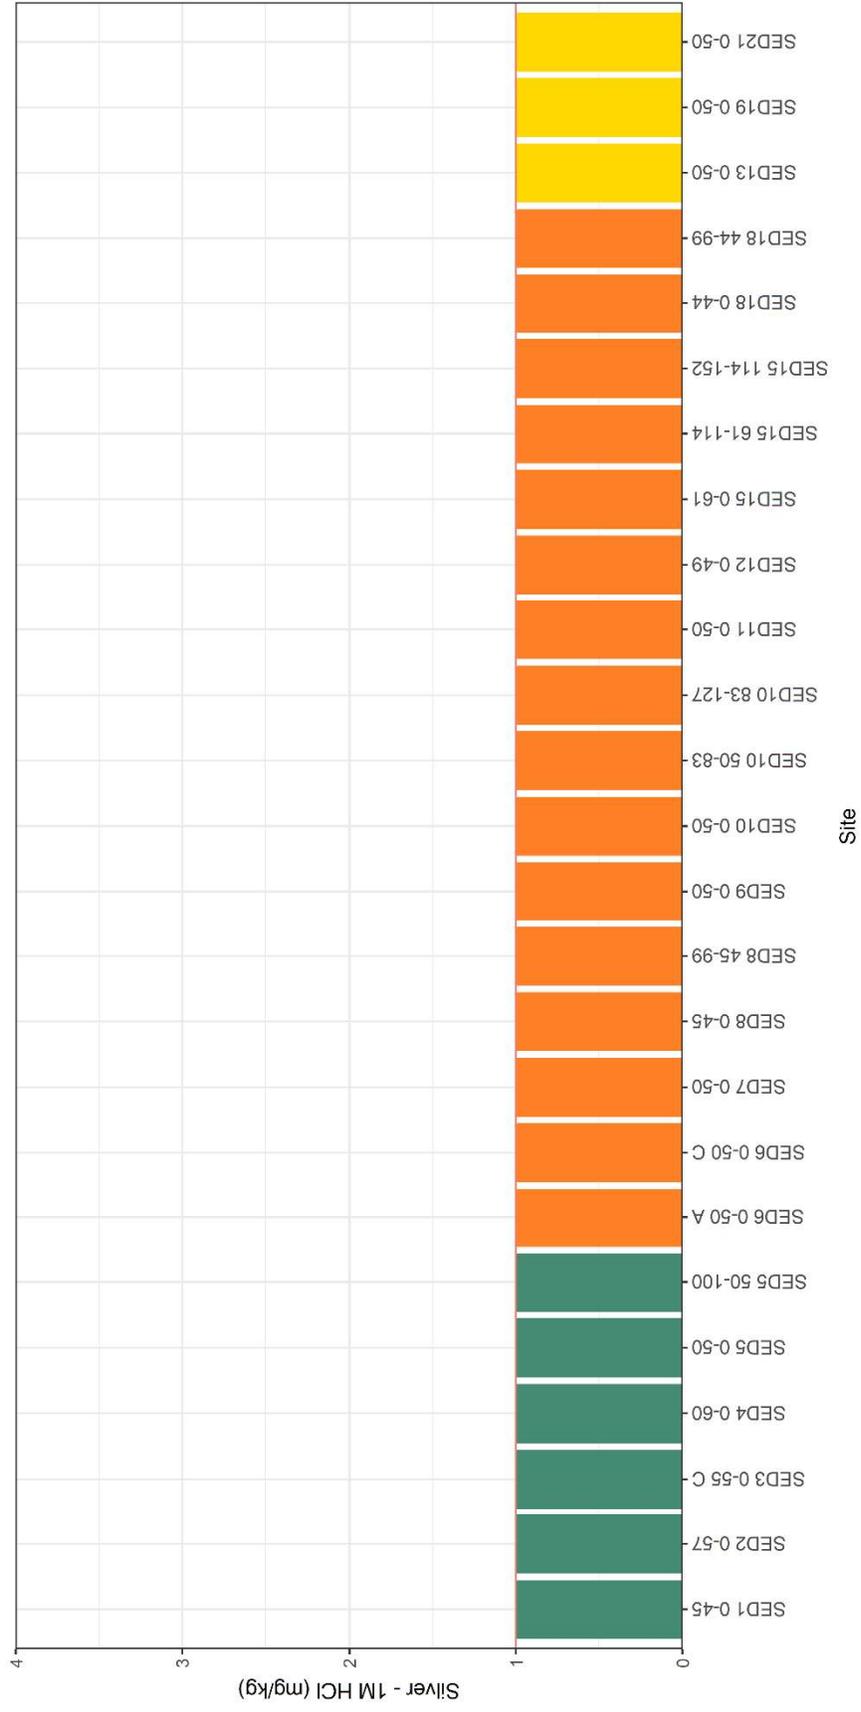
Figure 80. Concentration of bioavailable silver according to 1M HCl digest. Red lines indicate the SQGV and SQGV-high from ANZECC/ARMCANZ (Simpson and Batley 2016). Sites are approximately ordered from south to north, with dark green in southern corner, orange along the causeway, yellow in the river channel and light green on the north shore of the river channel.

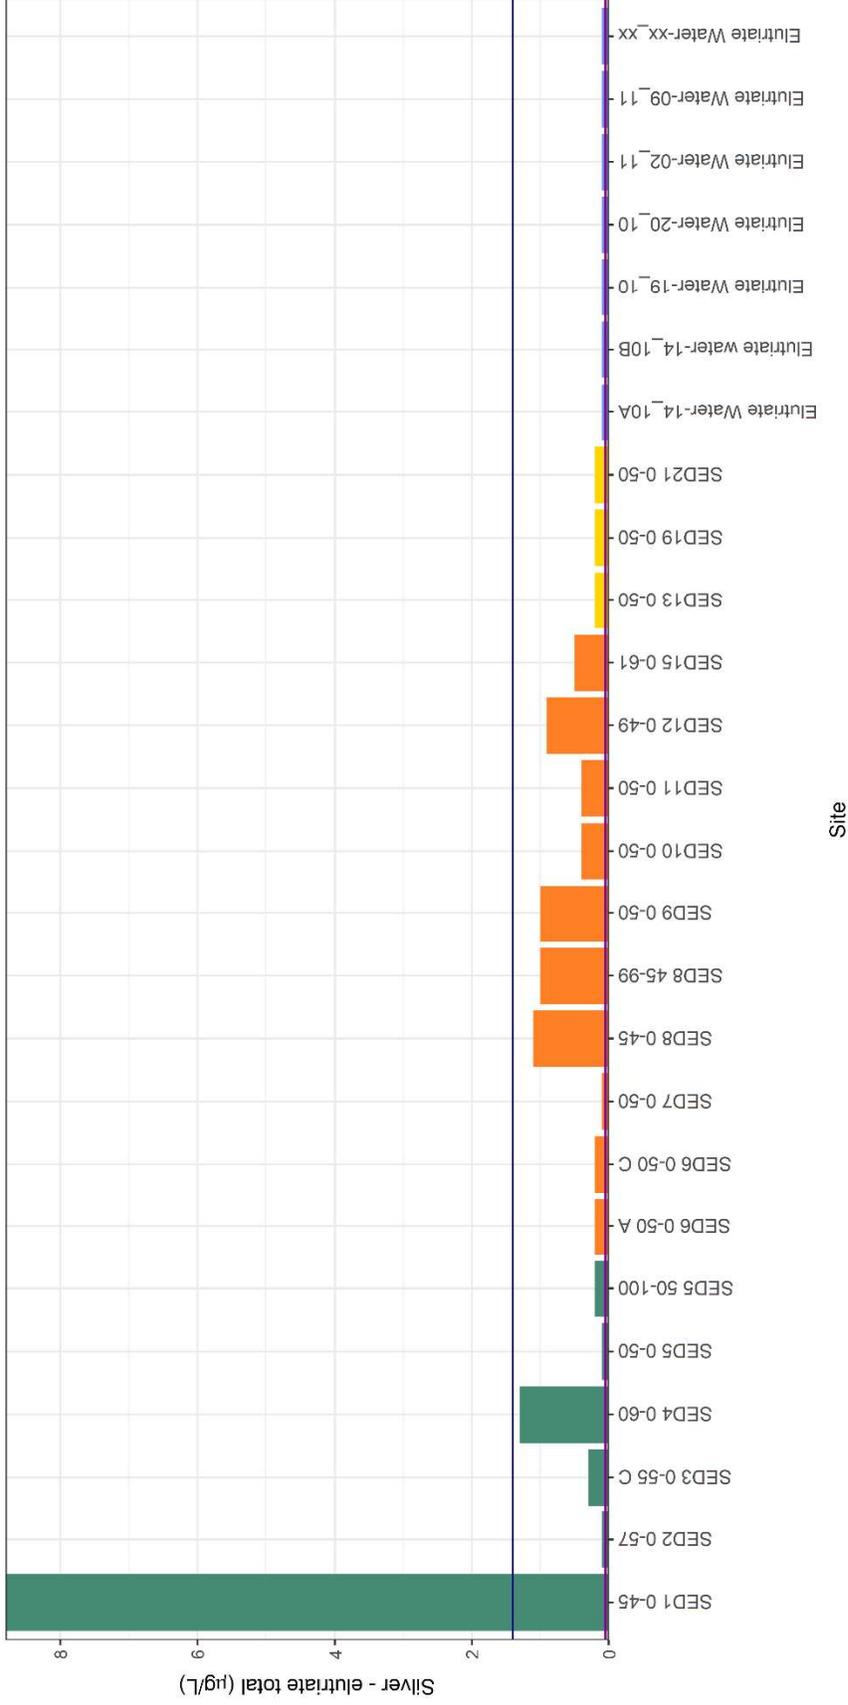
Figure 81. Concentration of total silver resulting from elutriate testing. DGVs for silver in fresh and marine water are shown in dark magenta and blue respectively. Sites are approximately ordered from south to north, with dark green in southern corner, orange along the causeway and light green on the north shore of the river channel.

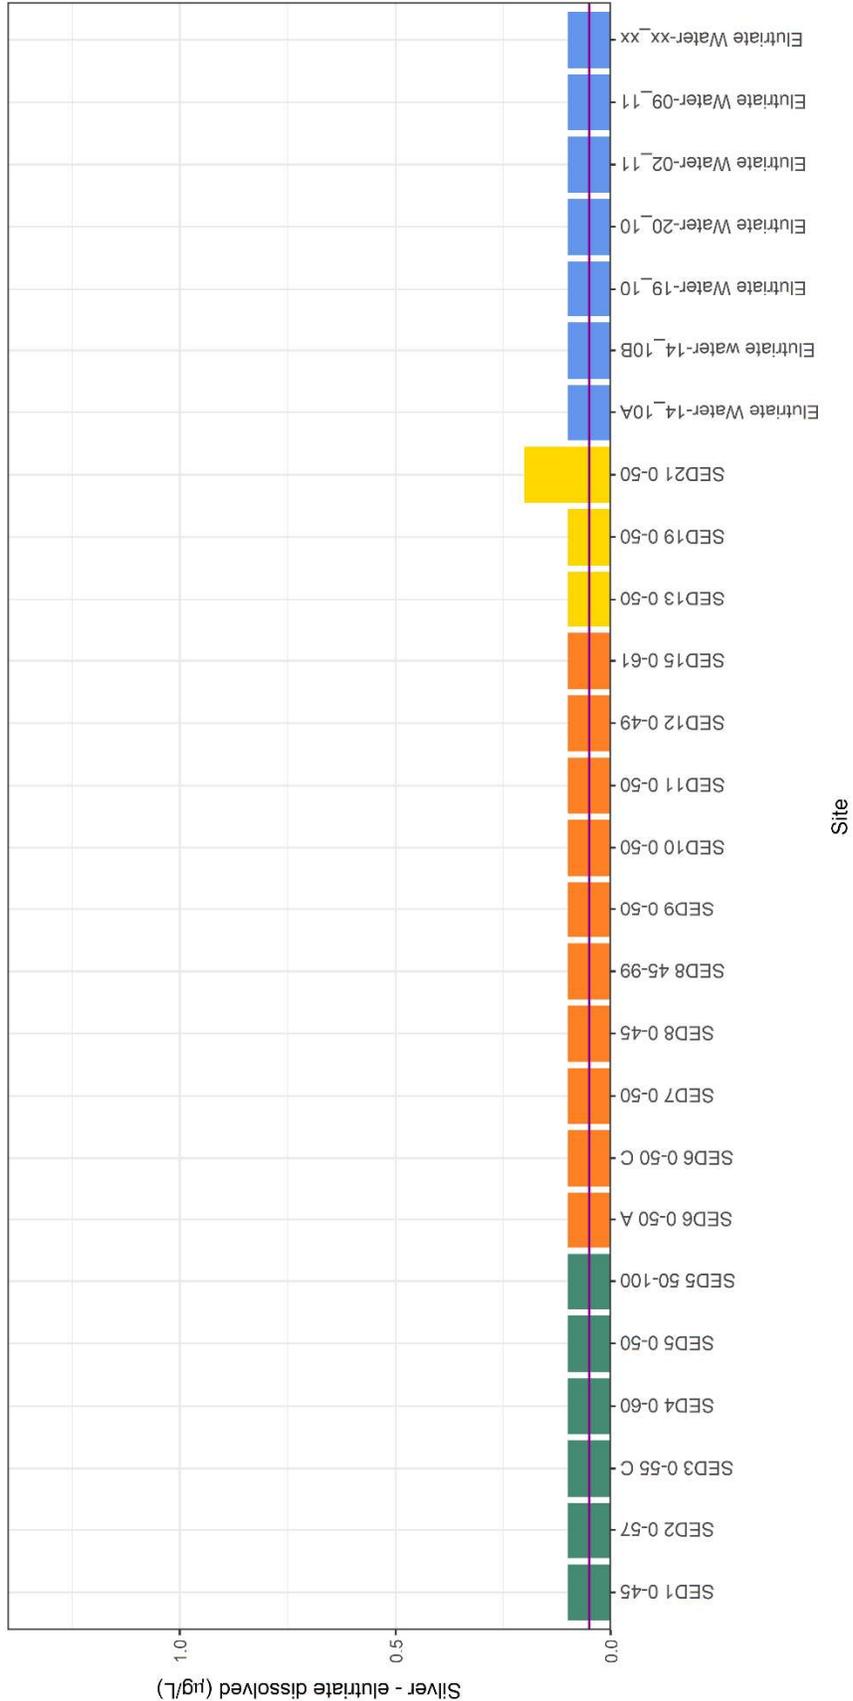
Figure 82. Concentration of dissolved silver resulting from elutriate testing. DGVs for silver in fresh and marine water are shown in dark magenta and blue respectively. Sites are approximately ordered from south to north, with dark green in southern corner, orange along the causeway and light green on the north shore of the river channel.
