4.5 SEDIMENT

This section describes the condition of sediment in the potential footprint of the proposed New Bridgewater Bridge. The description includes a review of available information combined with a broad-scale sampling of shallow sediments to around 2.5 m below sediment-water interface to characterise their condition prior to commencement of construction works. In conjunction with hydrodynamic modelling, this information will be used to determine the risk of suspended sediment to the adjacent estuarine ecosystem and to identify appropriate controls to mitigate risk. The information will also be used by pitt&sherry to guide the appropriate handling and treatment of material removed from the water during construction.

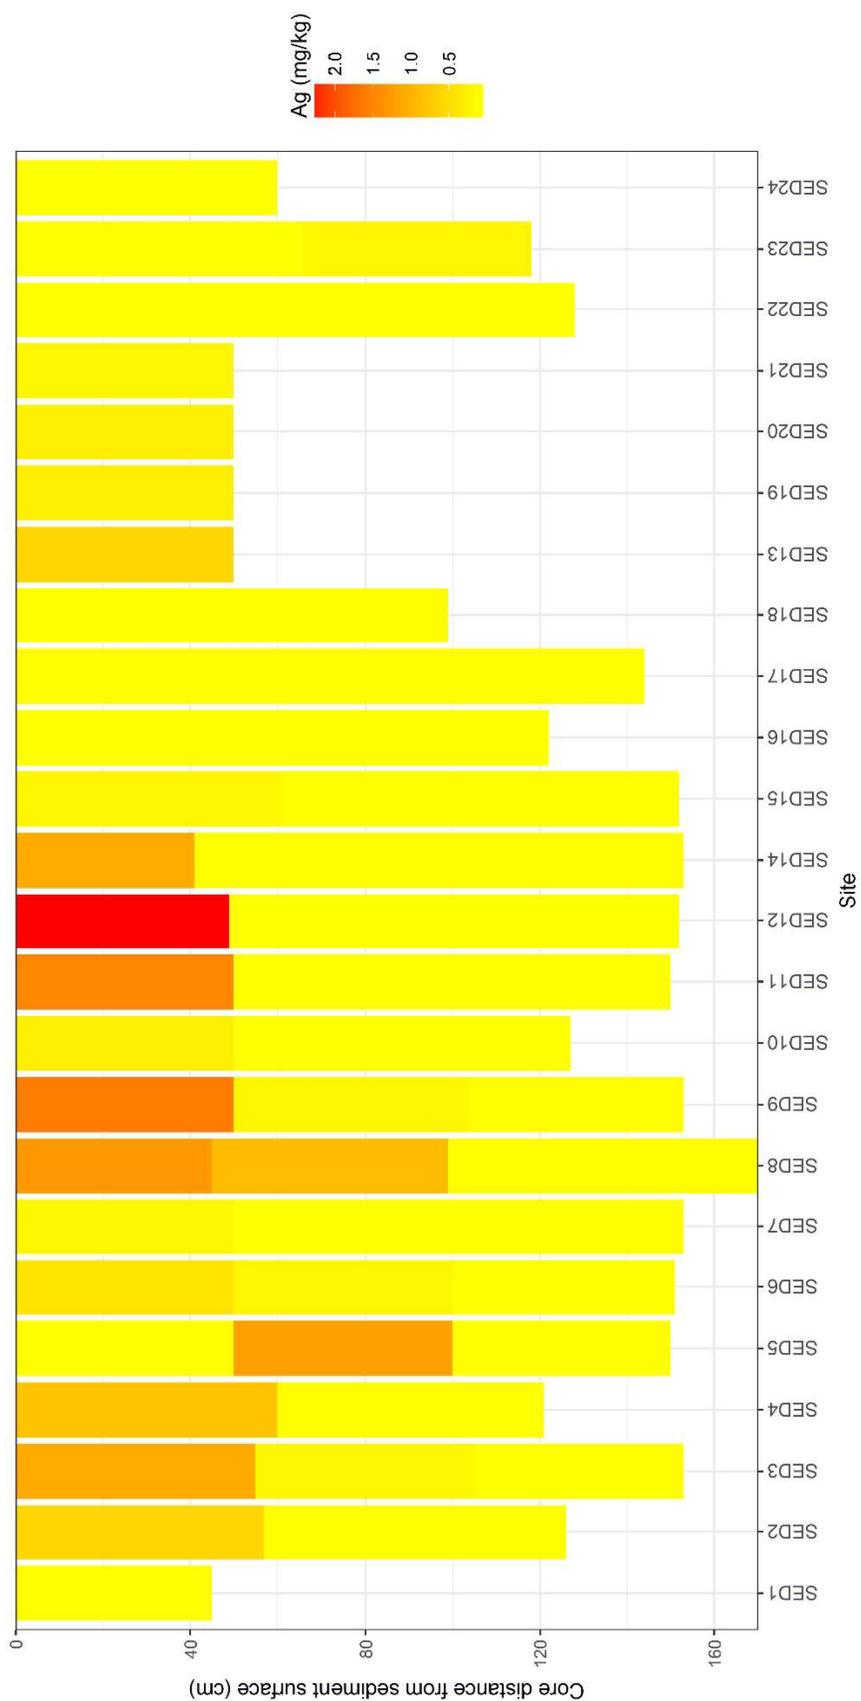
Figure 83. Vertical variation of total silver in sediment along cores. ANZECC SQGV is 1.5 mg / kg, with high SQGV of 10 mg / kg.

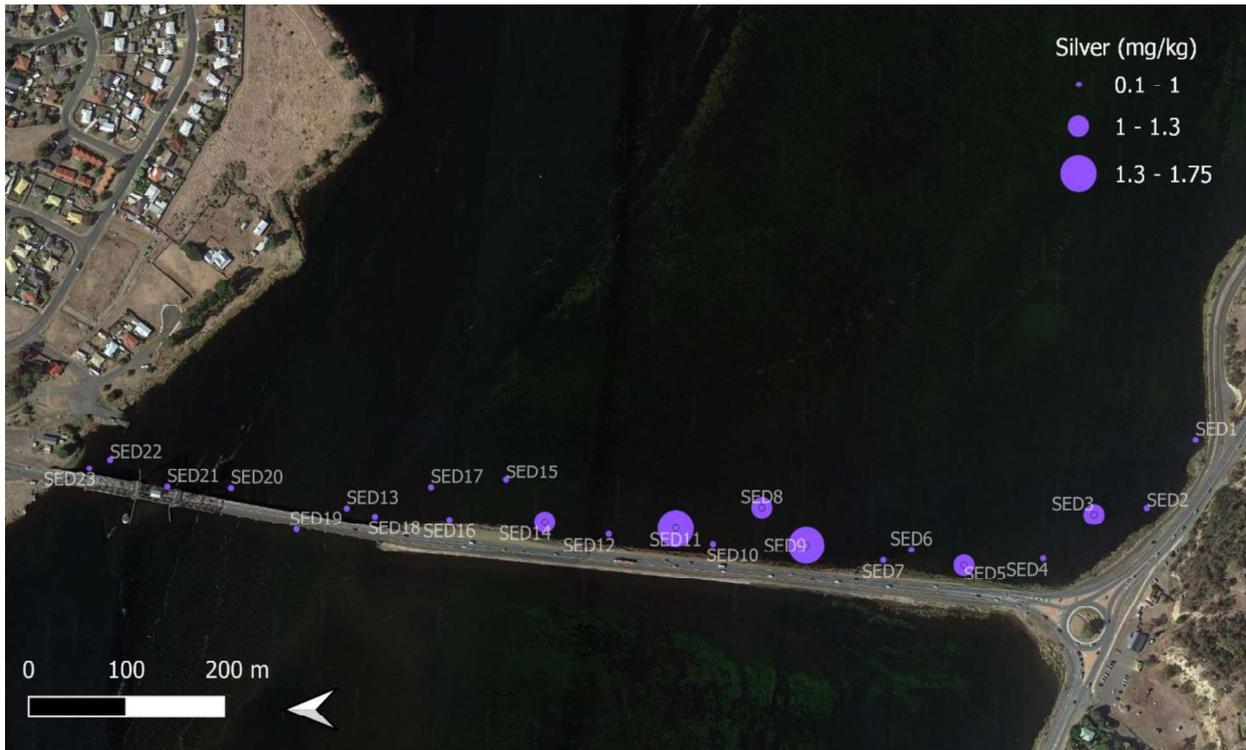
Figure 84. Map of total silver concentrations in sediment.

High in corner and along causeway, and highest in center causeway. Below SQGV in channel and north shore of channel (Figure 84).

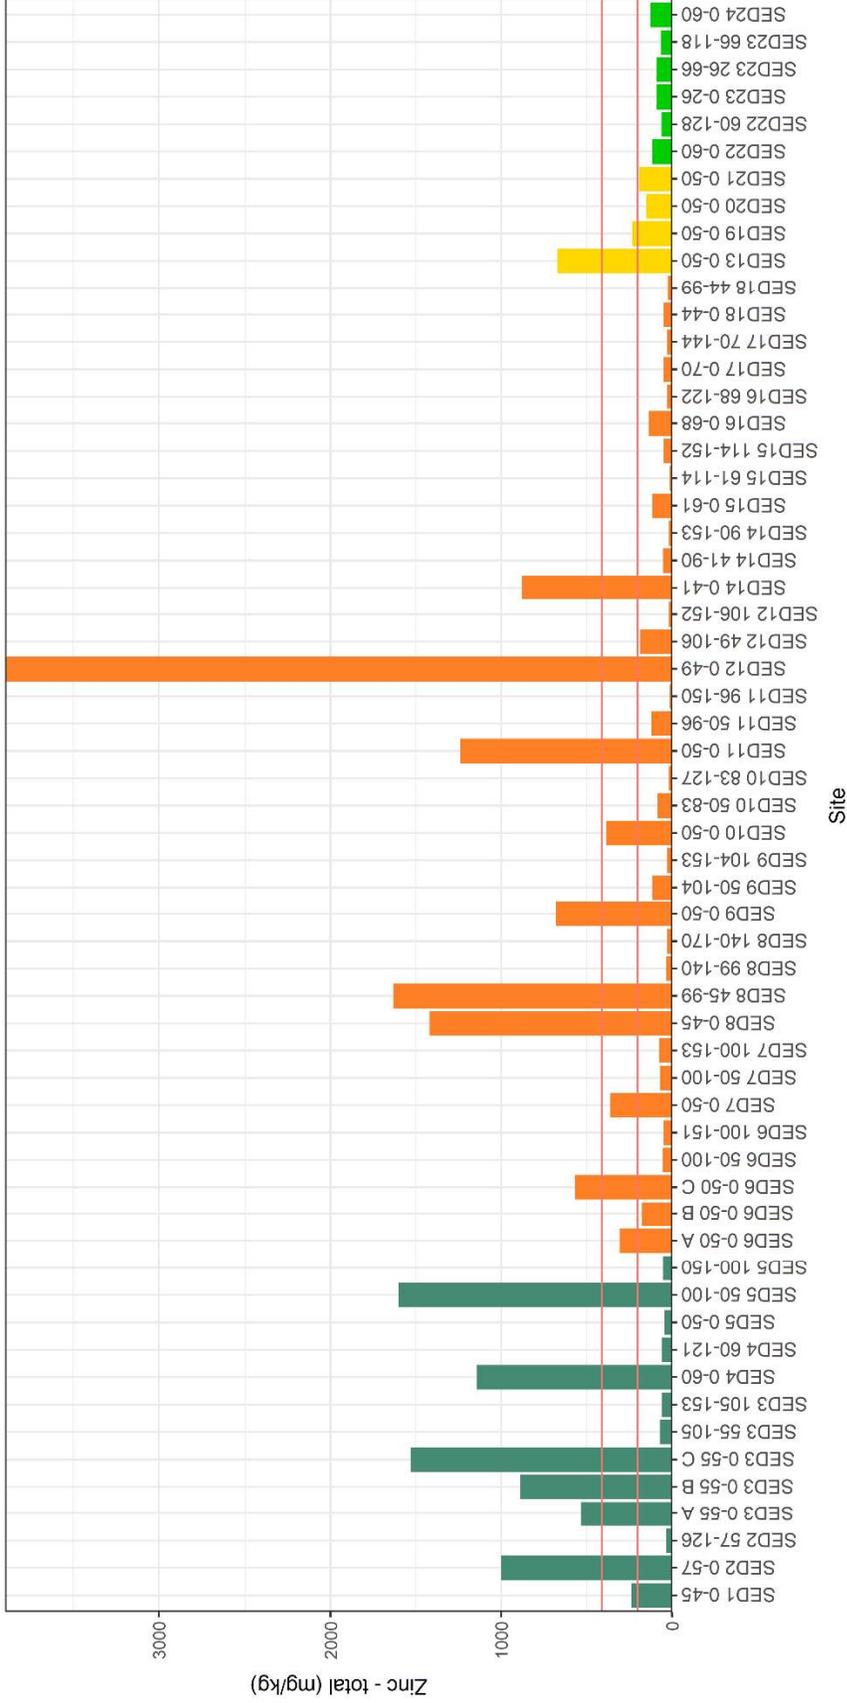
Figure 85. Concentration of total zinc in sediment. Red lines indicate the SQGV and SQGV-high from ANZECC/ARMCANZ (Simpson and Batley 2016). Sites are approximately ordered from south to north, with dark green in southern corner, orange along the causeway, yellow in the river channel and light green on the north shore of the river channel.

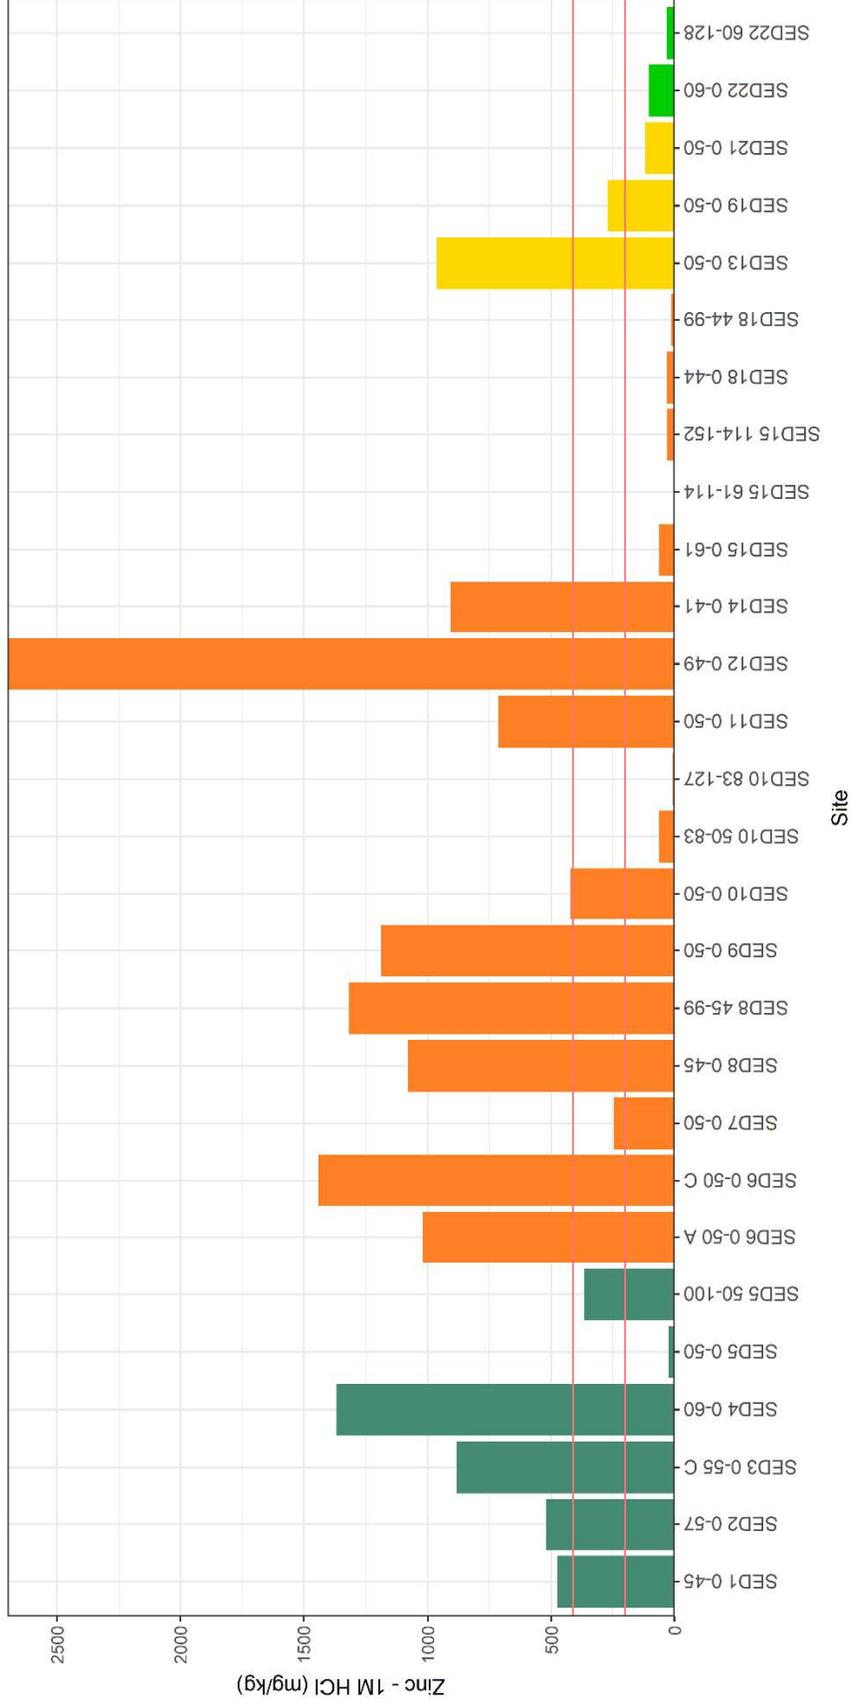
Figure 86. Concentration of bioavailable zinc according to 1M HCl digest. Red lines indicate the SQGV and SQGV-high from ANZECC/ARMCANZ (Simpson and Batley 2016). Sites are approximately ordered from south to north, with dark green in southern corner, orange along the causeway, yellow in the river channel and light green on the north shore of the river channel.

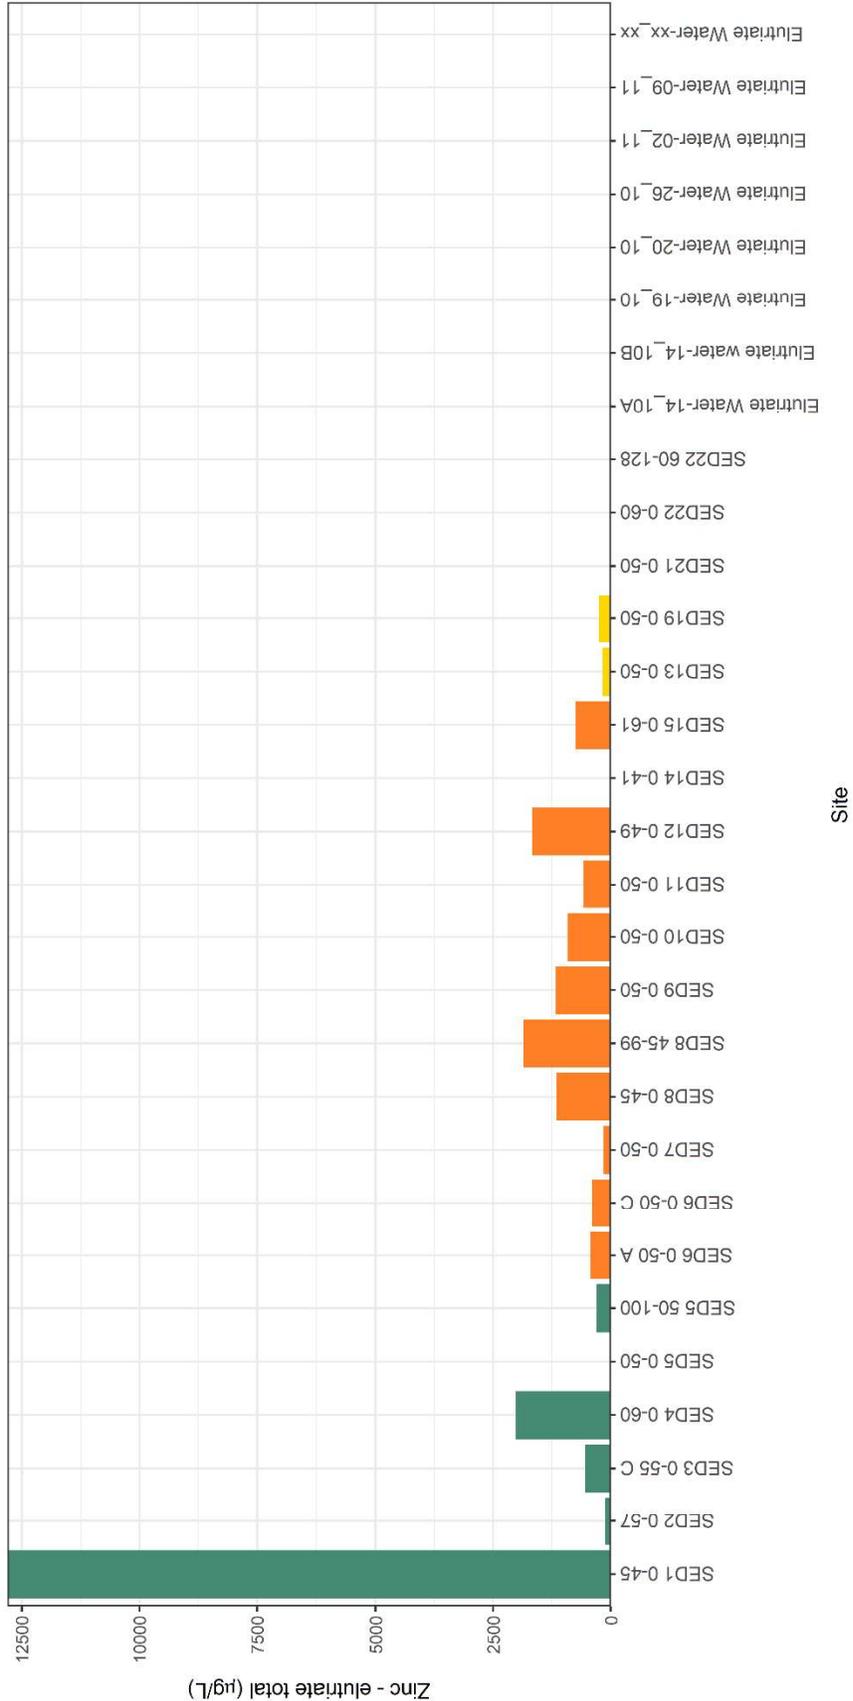
Figure 87. Concentration of total zinc resulting from elutriate testing. DGVs for zinc in fresh and marine water are shown in dark magenta and blue respectively. Sites are approximately ordered from south to north, with dark green in southern corner, orange along the causeway and light green on the north shore of the river channel.

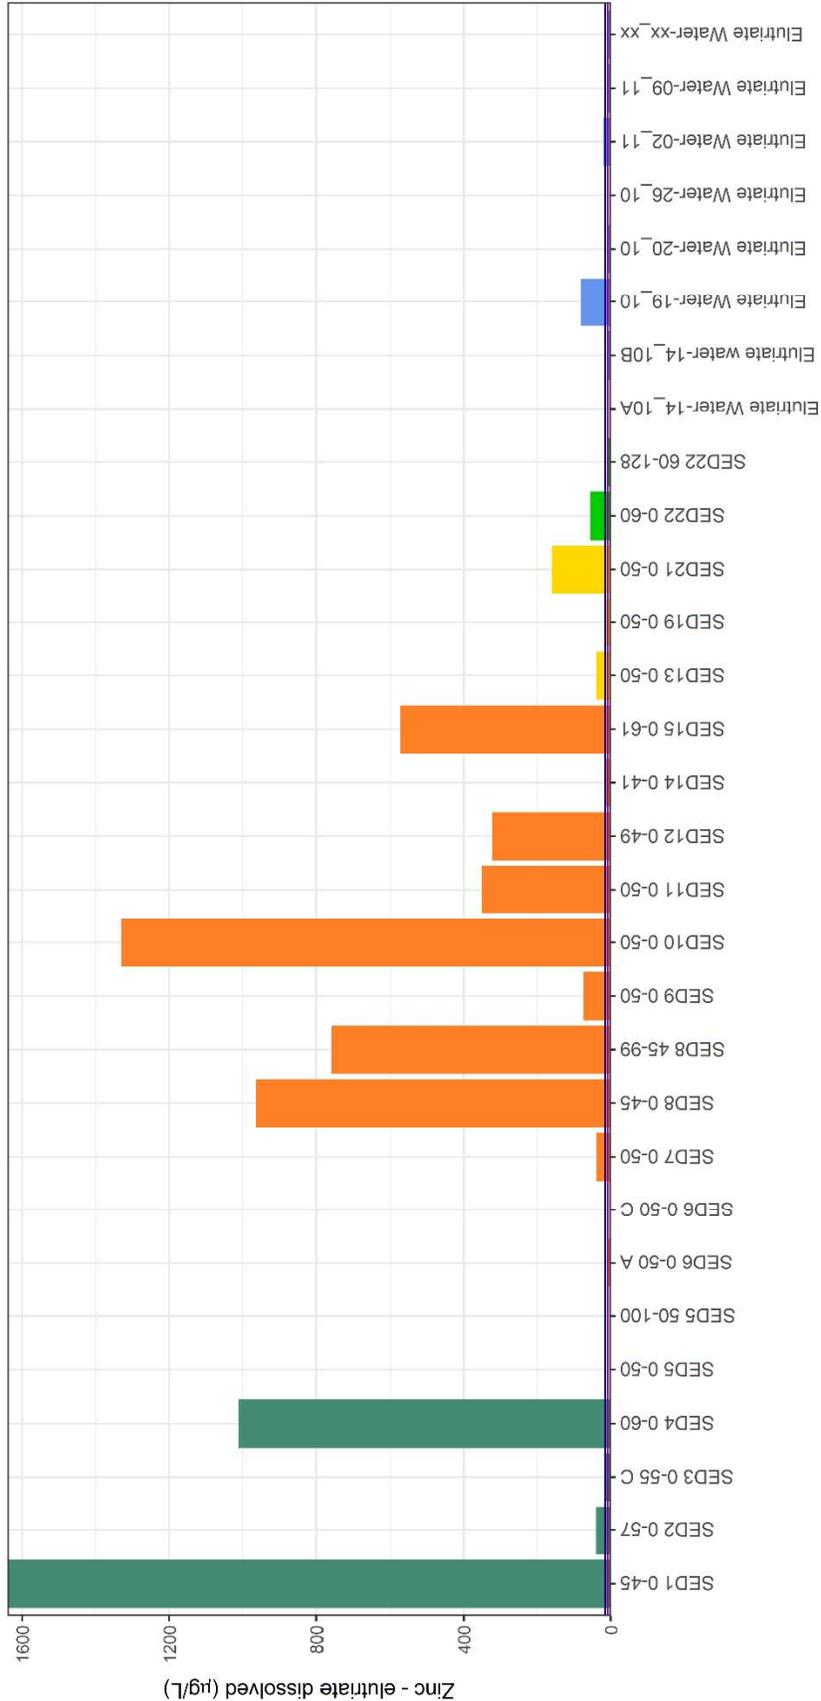
Figure 88. Concentration of dissolved zinc resulting from elutriate testing. DGVs for zinc in fresh and marine water are shown in dark magenta and blue respectively. Sites are approximately ordered from south to north, with dark green in southern corner, orange along the causeway and light green on the north shore of the river channel.

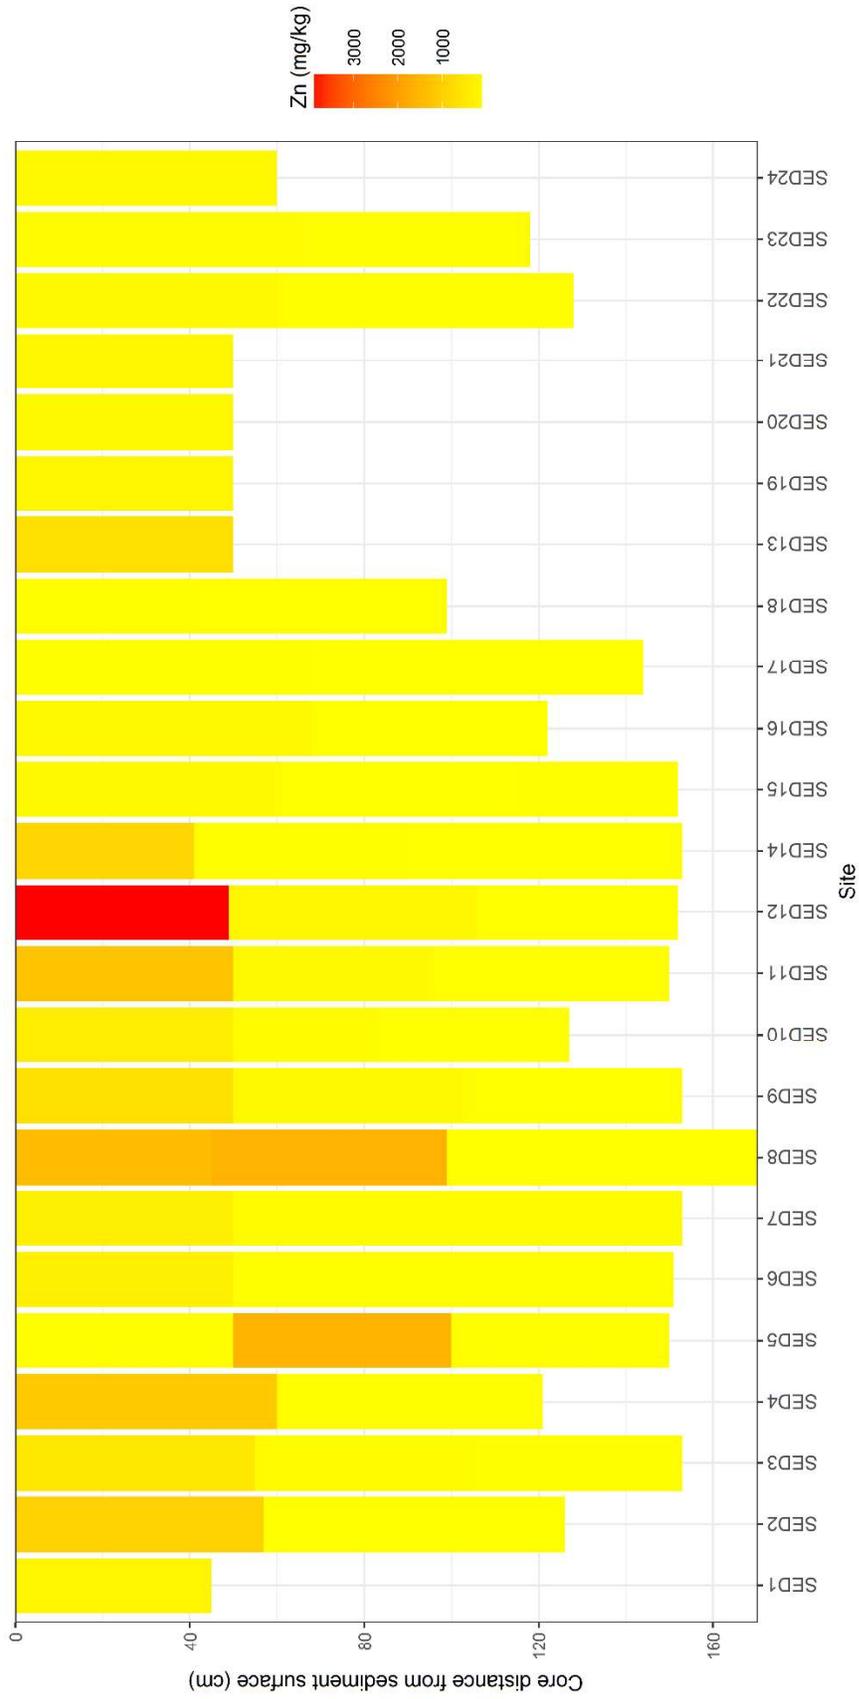
Figure 89. Vertical variation of total zinc in sediment along cores. ANZECC SQGV is 1.5 mg / kg, with high SQGV of 10 mg / kg.

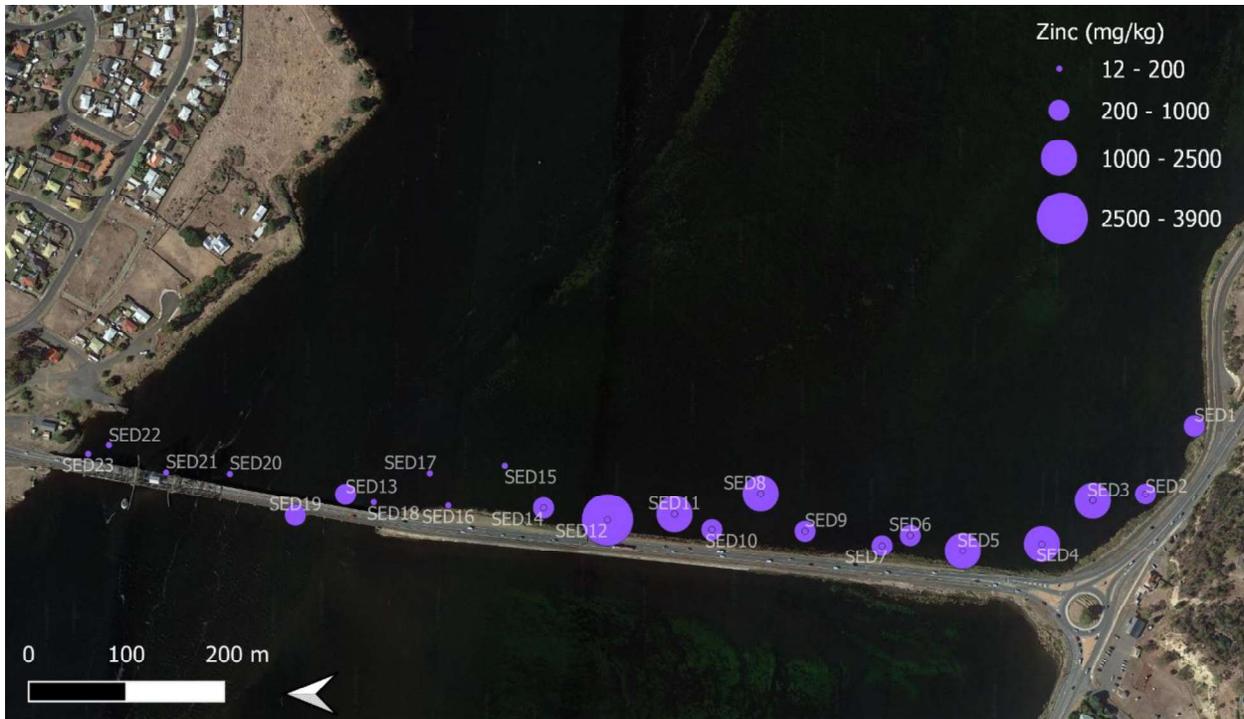
Figure 90. Map of total zinc concentrations in sediment.

High in southern corner and along causeway. Mostly below SQGV in river channel and north shore of channel, except SED19 and SED13 on the southern edge of the river channel (Figure 90).

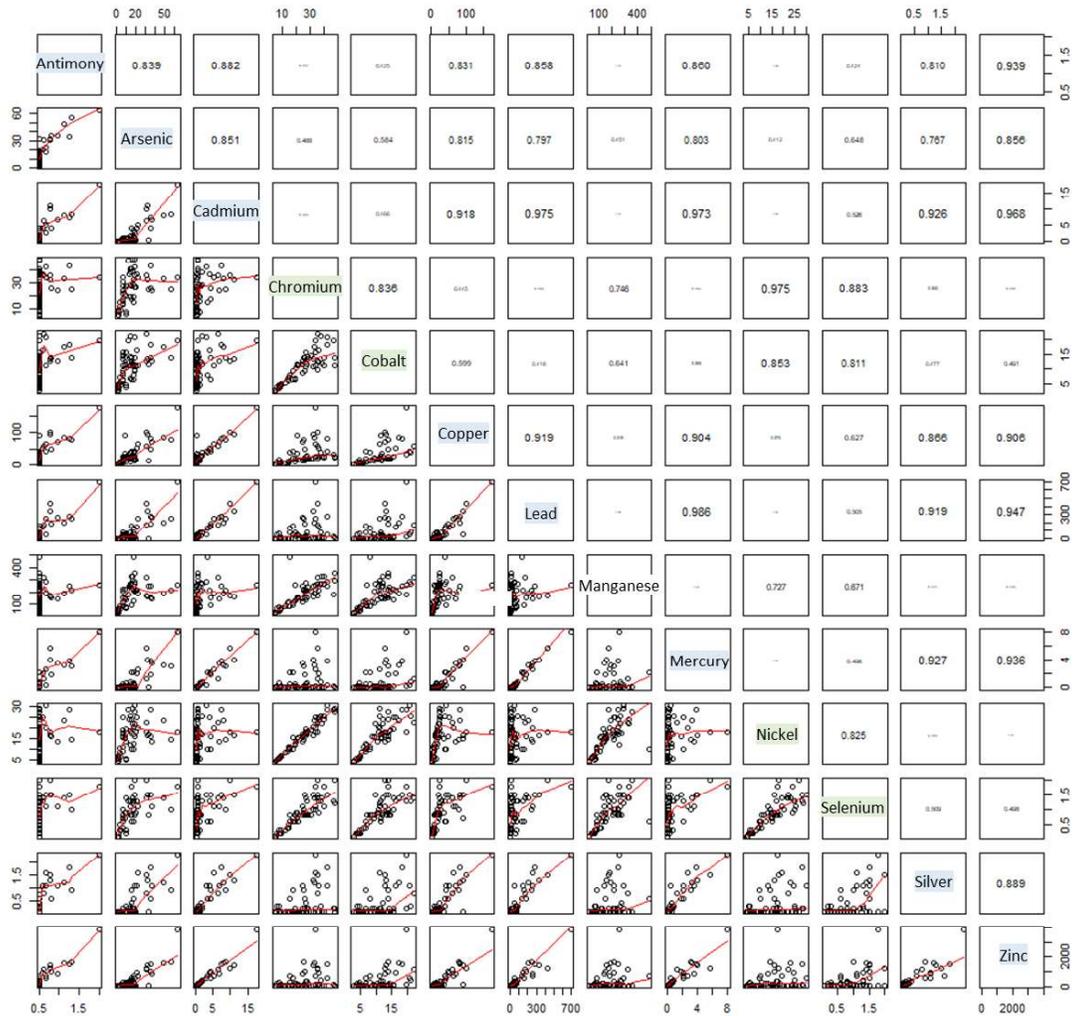
Figure 92. Intercorrelations between metals and metalloids.

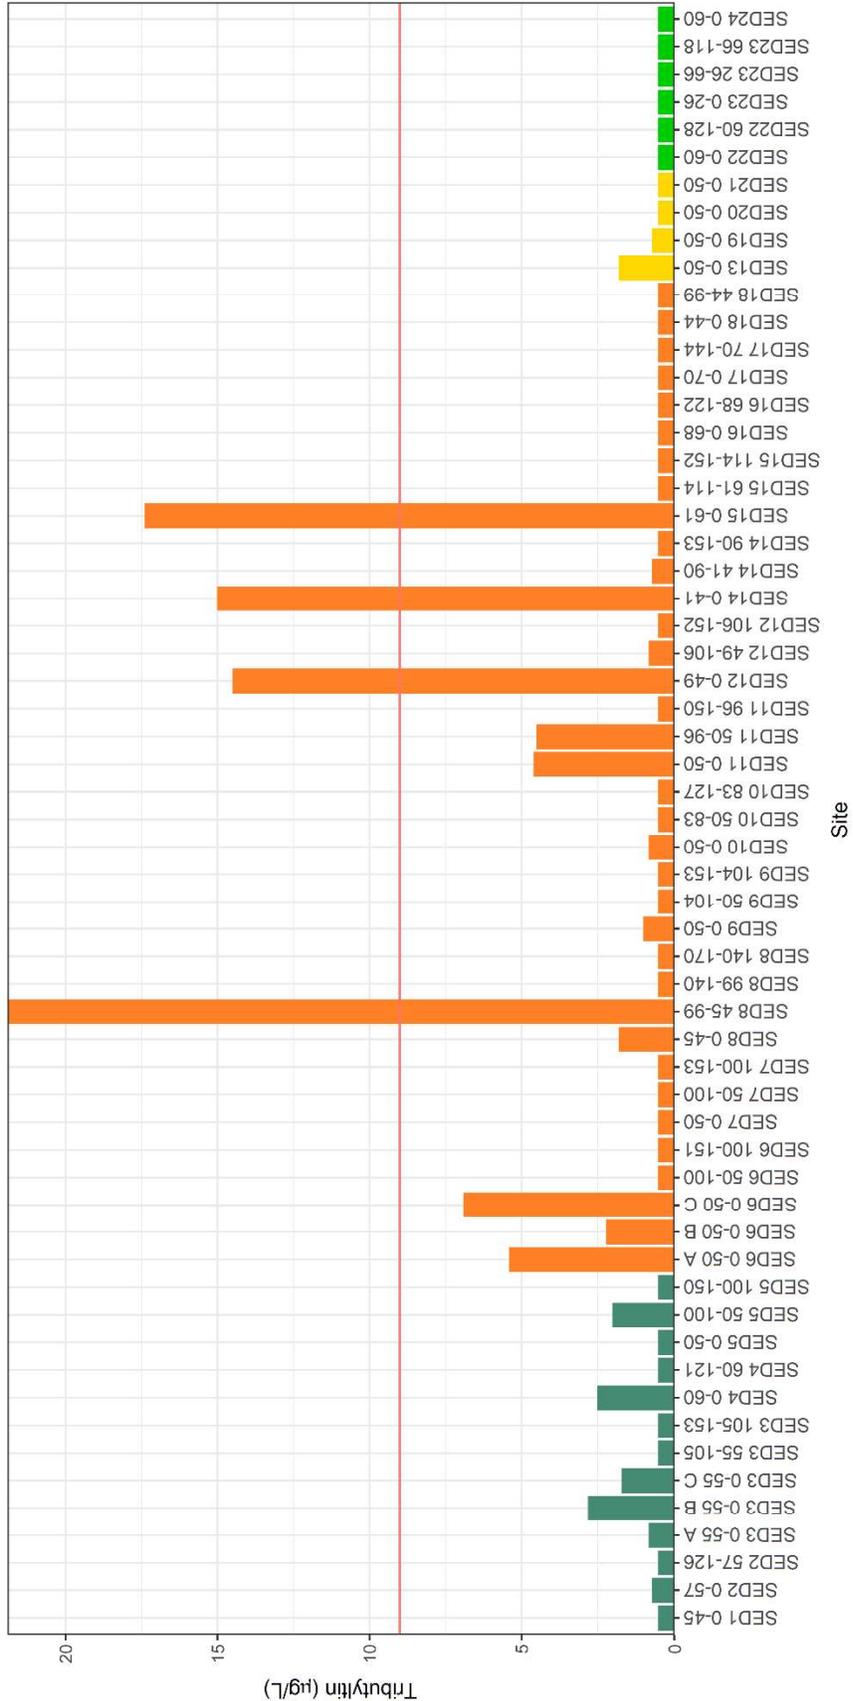
Figure 93. Raw concentrations of TBT in sediment. Red lines indicate SQGV from ANZECC/ARMCANZ (Simpson and Batley 2016). Sites are approximately ordered from south to north, with dark green in southern corner, orange along the causeway, yellow in the river channel and light green on the north shore of the river channel. Normalised concentrations of TBT are shown in Figure 94.

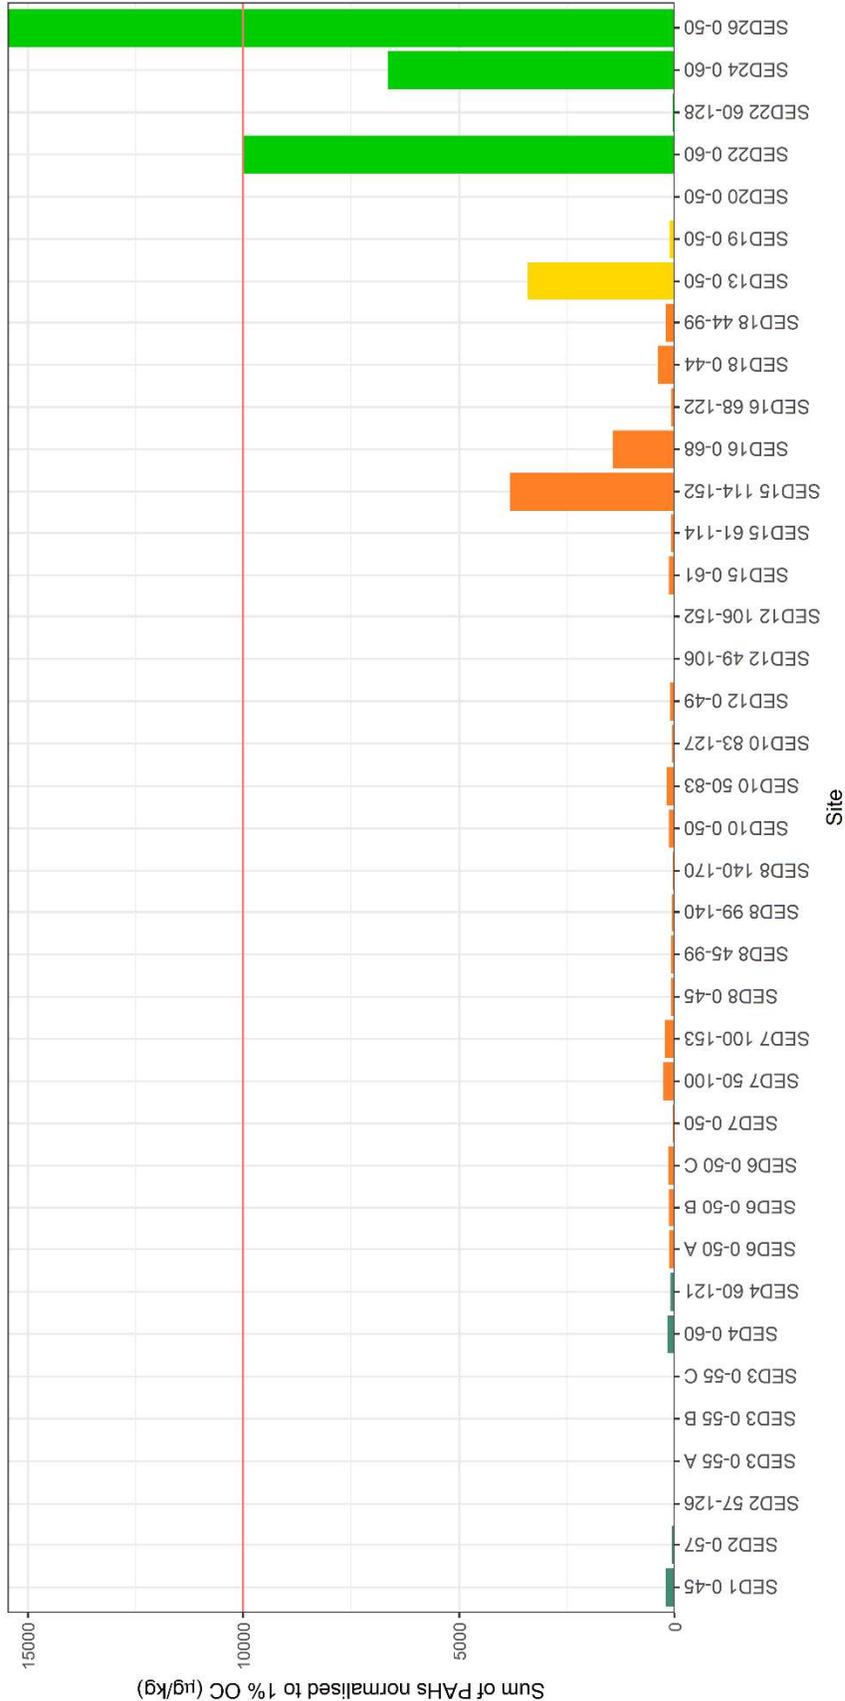
Figure 95. Concentrations of sum of PAHs normalised to 1% organic carbon. Red lines indicate the SQGV and SQGV-high from ANZECC/ARMCANZ (Simpson and Batley 2016). Sites are approximately ordered from south to north, with dark green in southern corner, orange along the causeway, yellow in the river channel and light green on the north shore of the river channel.

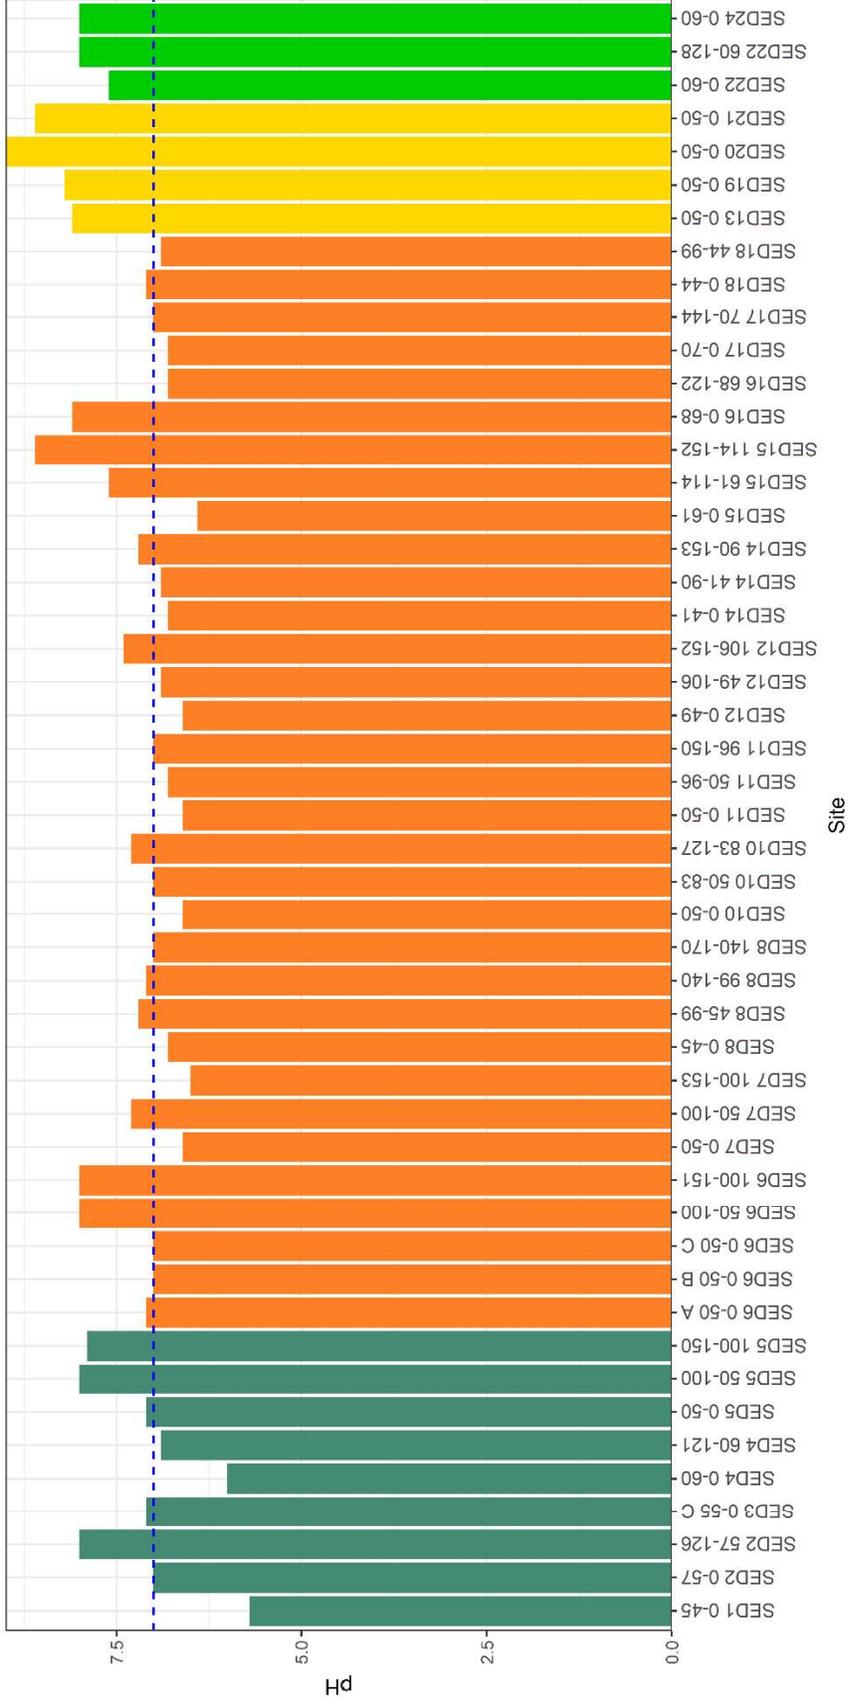
Figure 96. Actual acidity in terms of pH KCl. Dashed blue line indicates pH neutral (pH 7).

Actual acidity of the sediment was generally close to neutral, with average 7.2 and 50% of samples between 6.8 and 7.9 (Figure 96). Two samples with lower pH of 5.7 and 6 were located in the southern corner of the causeway. Samples in the river channel and northern shore of the river were all alkaline, over pH 7.5, with one sample reaching pH 9.

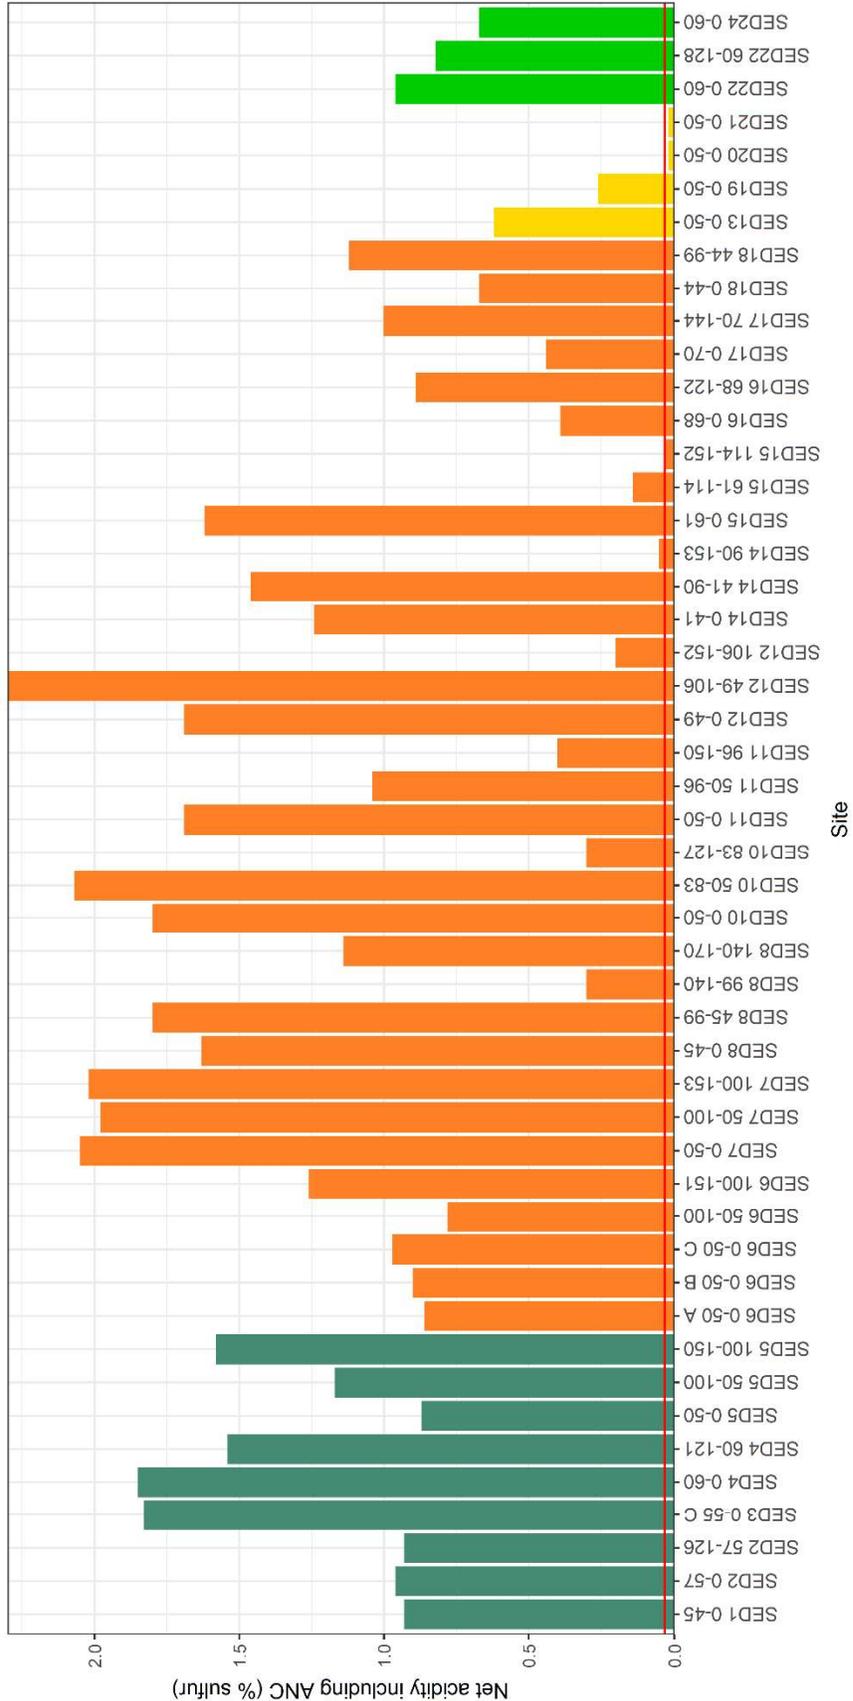
Figure 97. Net acidity including ANC. Net acidity excluding ANC. The action criteria of 0.03% from DPIPWE (2009) is indicated by the red line.

Consistently high potential acidity in the southern corner and southern end of the causeway (Figure 97). More variable on the northern half of the causeway, with some lower concentrations of sulfur in samples from deeper core sections.

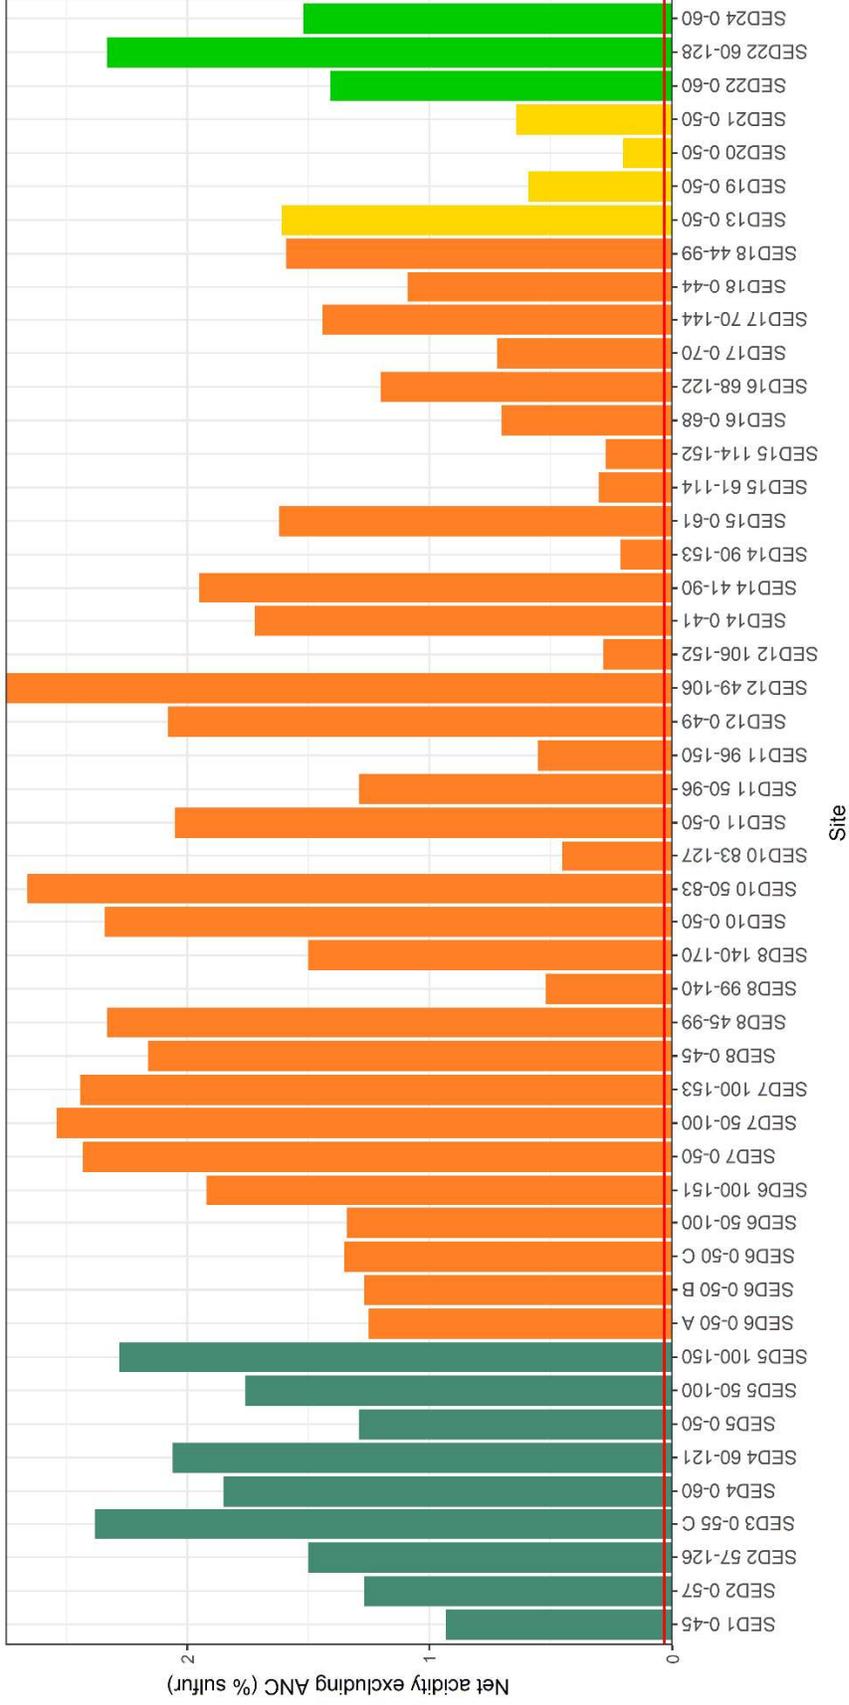
Figure 98. Net acidity excluding ANC. The action criteria of 0.03% from DPIPWE (2009) is indicated by the red line.

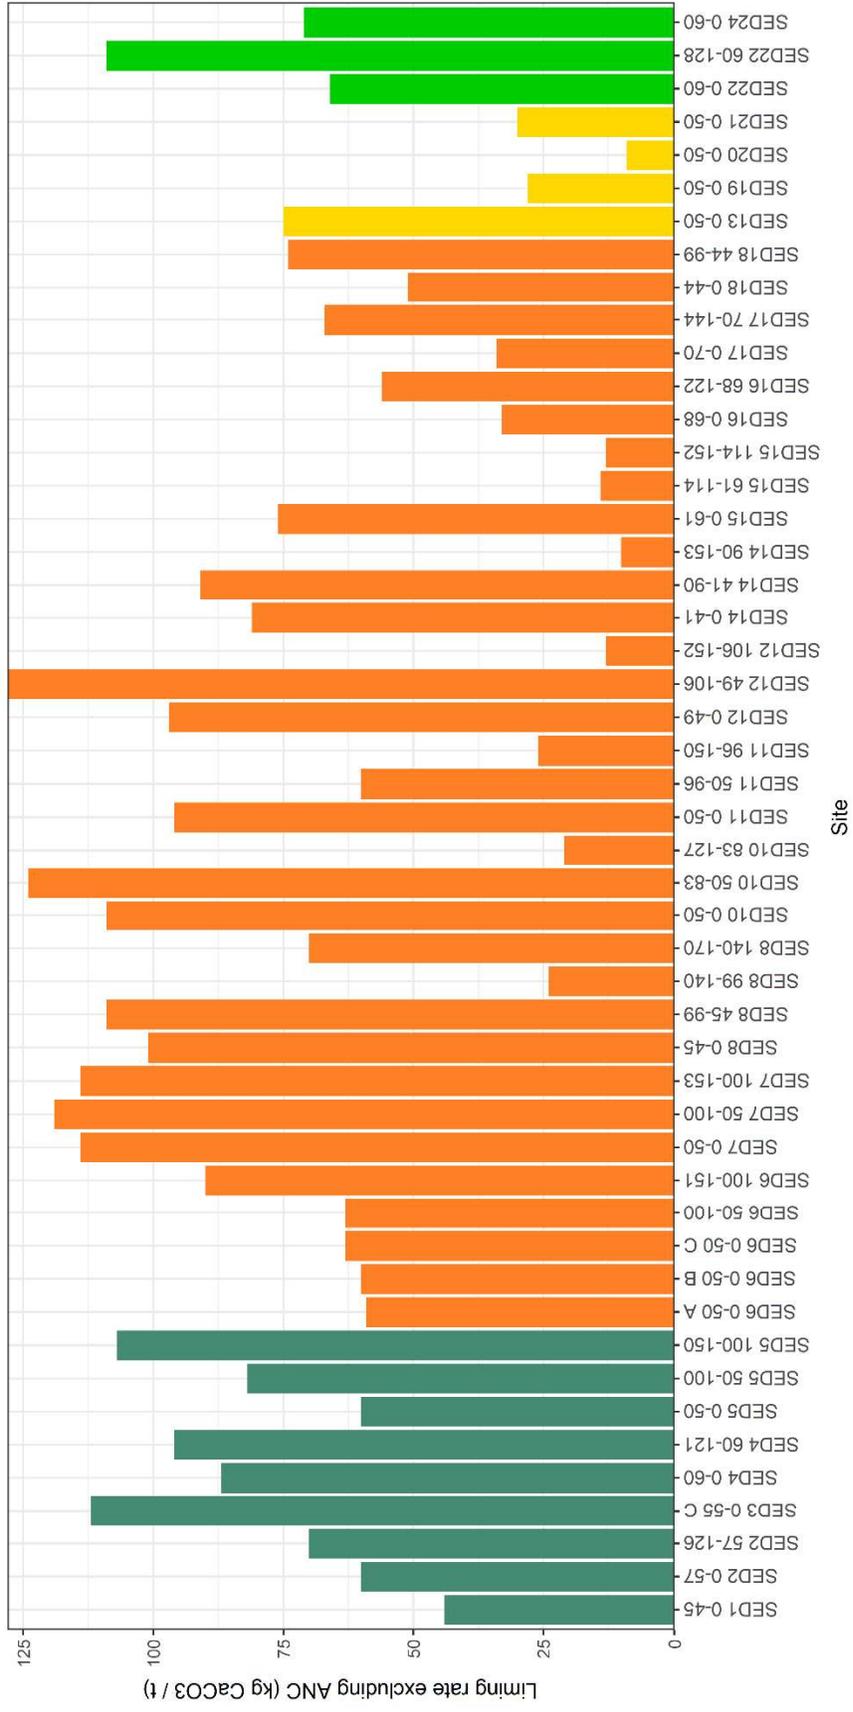
Figure 99. Liming rate excluding ANC.

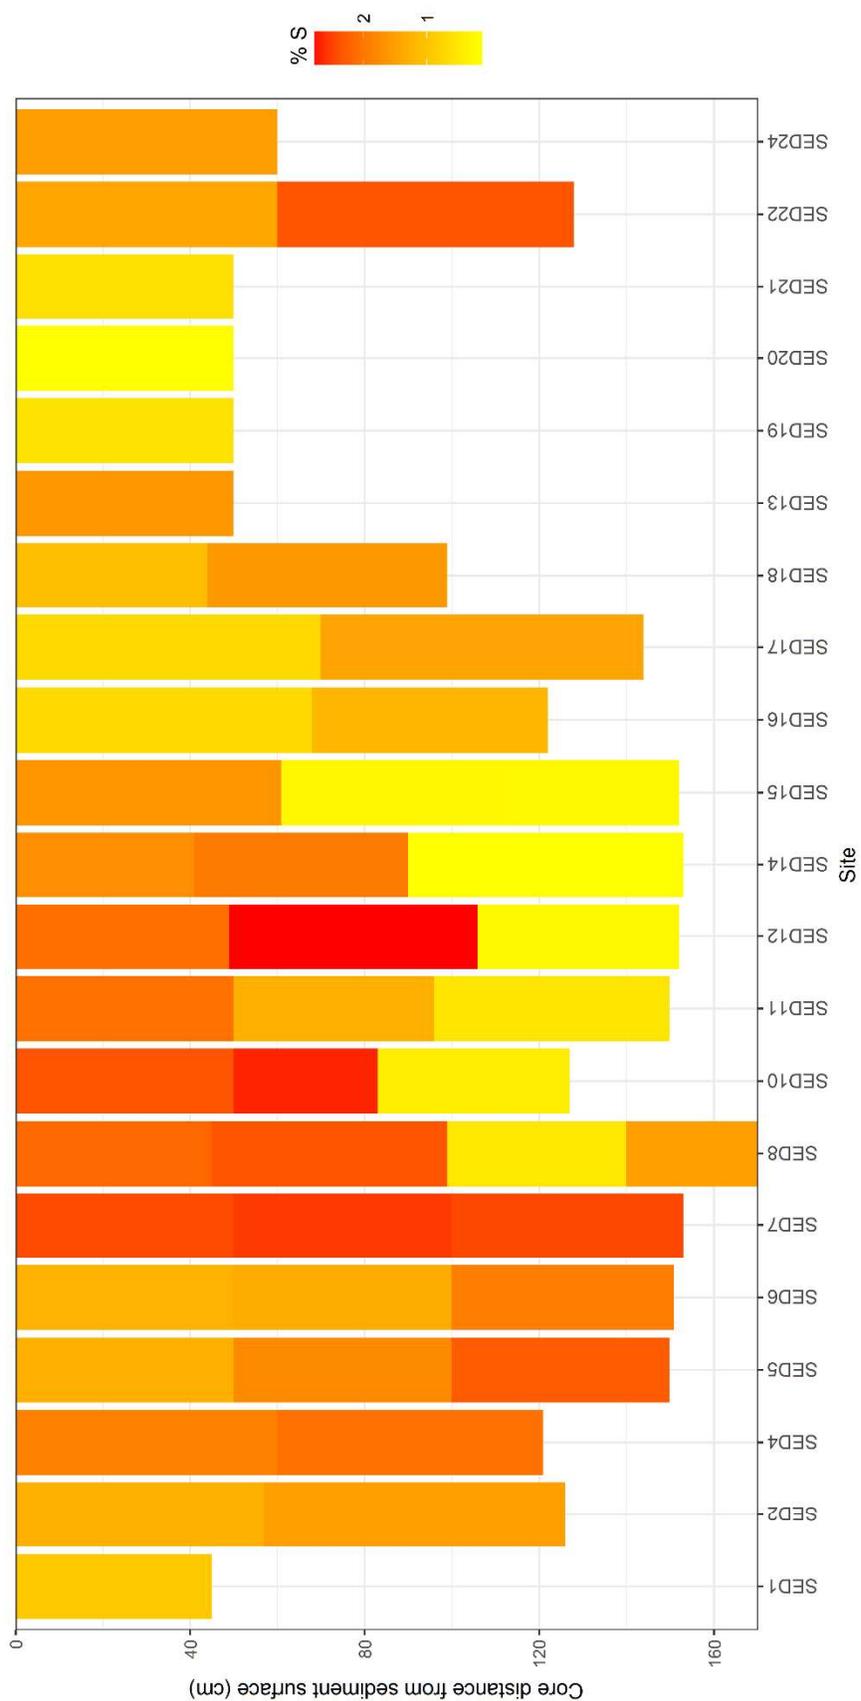
Figure 100. Vertical variation of PASS in terms of %S (excluding ANC) with distance along core.
