4.5 SEDIMENT

This section describes the condition of sediment in the potential footprint of the proposed New Bridgewater Bridge. The description includes a review of available information combined with a broad-scale sampling of shallow sediments to around 2.5 m below sediment-water interface to characterise their condition prior to commencement of construction works. In conjunction with hydrodynamic modelling, this information will be used to determine the risk of suspended sediment to the adjacent estuarine ecosystem and to identify appropriate controls to mitigate risk. The information will also be used by pitt&sherry to guide the appropriate handling and treatment of material removed from the water during construction.

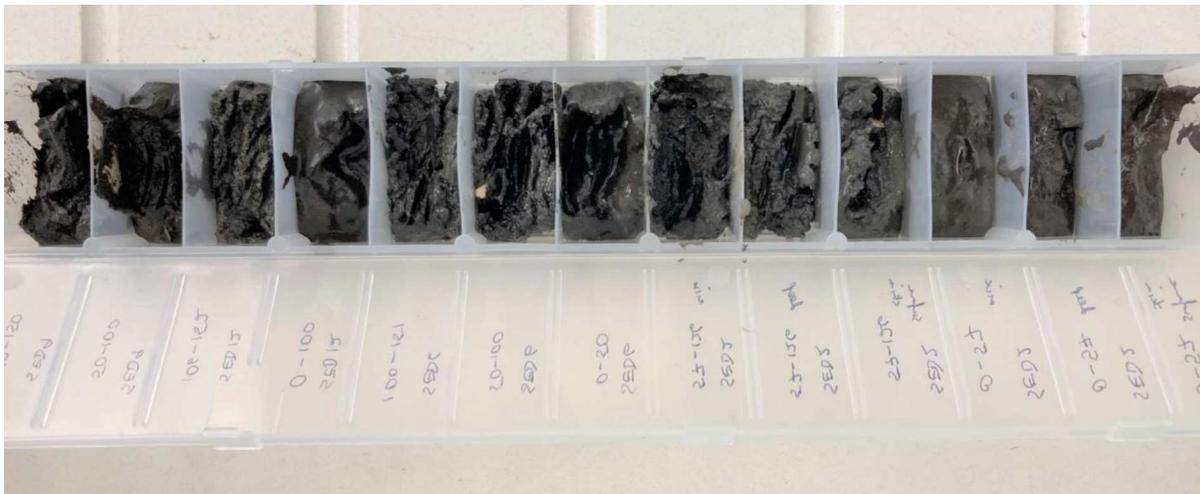
Figure 101. Chip-tray incubation of acid sulfate sediment.

A chip-tray incubation was conducted according to Sullivan et al (2018). Sediment from a selection of sites and depths was distributed among the compartments of a chip-tray in order to track the pH of air-exposed sediments through time (Figure 101). Note that SED2 0-57 may have been exposed to air prior to commencing the experiment, resulting in the lower initial pH. Samples were maintained with a slightly higher moisture content than recommended by Sullivan et al (2018) for the first month, potentially resulting in a slower rate of oxidation (slower decrease in pH).

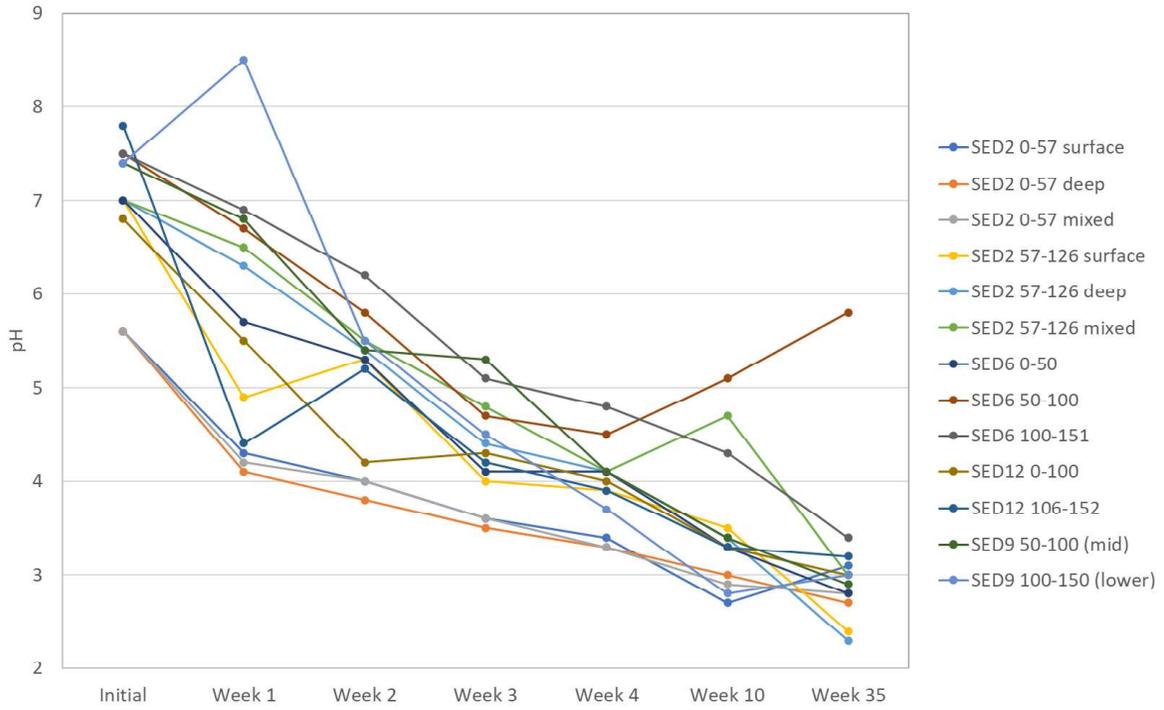
Figure 102. Results of chip-tray incubation of sediment to empirically determine potential acidity.

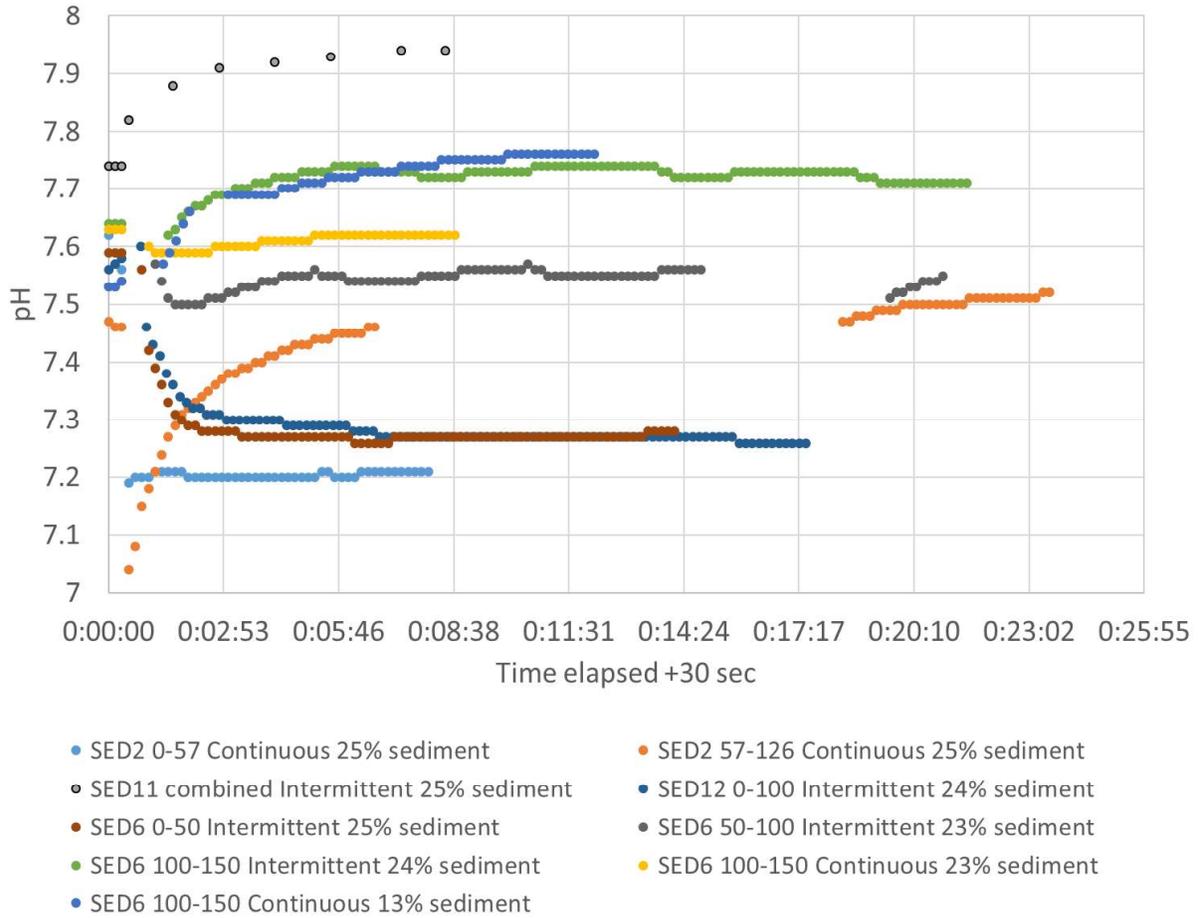
Figure 111. Variation in pH in sediment:water experiments.
