<u>Stage 1</u> – <u>Lilydale</u> (starting at <u>21.1 km</u>, clear of the 'Station Road' Level Crossing, and about 300 metres on the Launceston side of the Station platform) **through to** <u>Wyena</u> (finishing at <u>37.5 km</u>, about 600 metres ahead of the Wyena Station platform, and about 150 metres short of the 'Shepherds Rivulet' Trestle Bridge).

Sleeper replacement and Rail-Joint Rehabilitation:

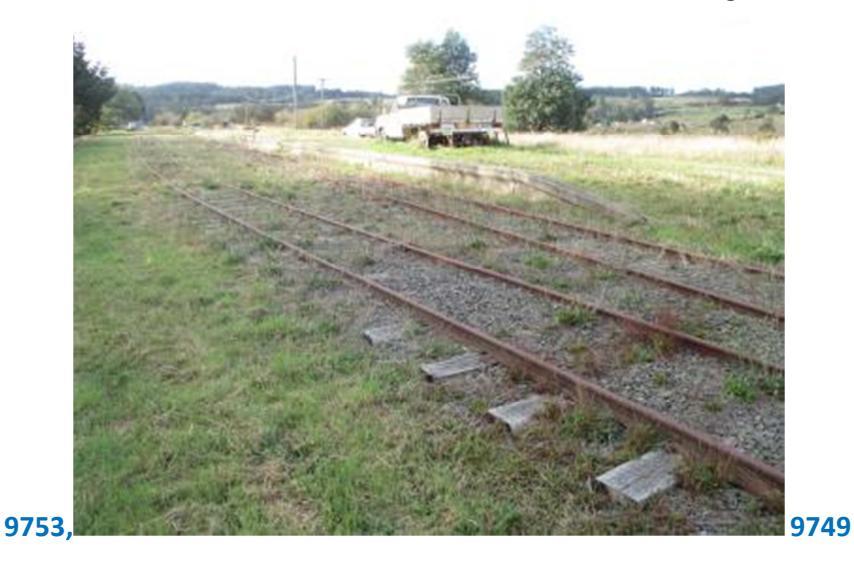
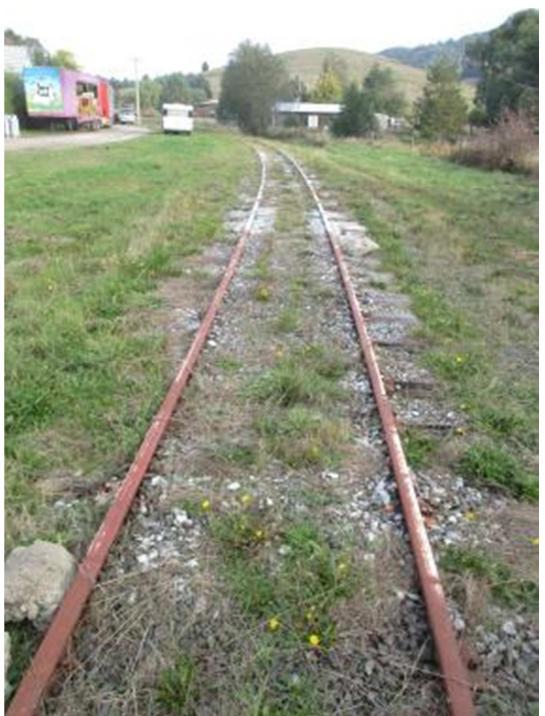
At <u>Lilydale</u> there are already two tracks through the Station's yard, connected to the mainlines at both ends by way of turnouts. This arrangement enables rolling-stock items to be re-arranged by shunting, or temporarily parked clear of the Station's platform track. These abilities will aid track-based restoration of future Stages located both sides of Lilydale.

At the township end of Lilydale yard, towards

Station Road, at least 120 metres of the future-extended mainline single track (clear of the existing turnout) is available for train shunting activities and/or temporary parking of rolling-stock items.
