# Memo

## RE: HB13604 Macquarie Heads Development Road Upgrade – Additional test pitting at Mill Bay

Project No.: HB13604

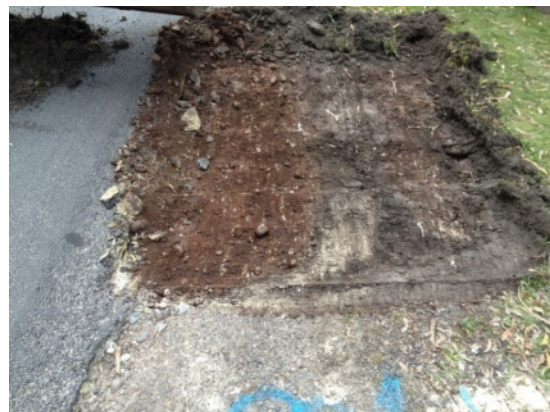
Sketch

**OBR\_3**

GP	GRAVEL; coarse grained, quartzite, rounded to sub rounded, with coarse sand fines, none plastic, brown. (Pavement and Shoulder material)	40	D-M	MD		
	0.5		SP-SM	silty SAND; fine grained, with some coarse, rounded, quartzite gravels, grey.  Excavation collapsing around water main discontinued pit at 1.1m	25				
	1.0								
	1.5			Hole terminated at 1.10m at target depth
