Report for West Tamar Highway,
Near Brady's Lookout

Submission to Parliamentary
Standing Committee on Public
Works

October 2011

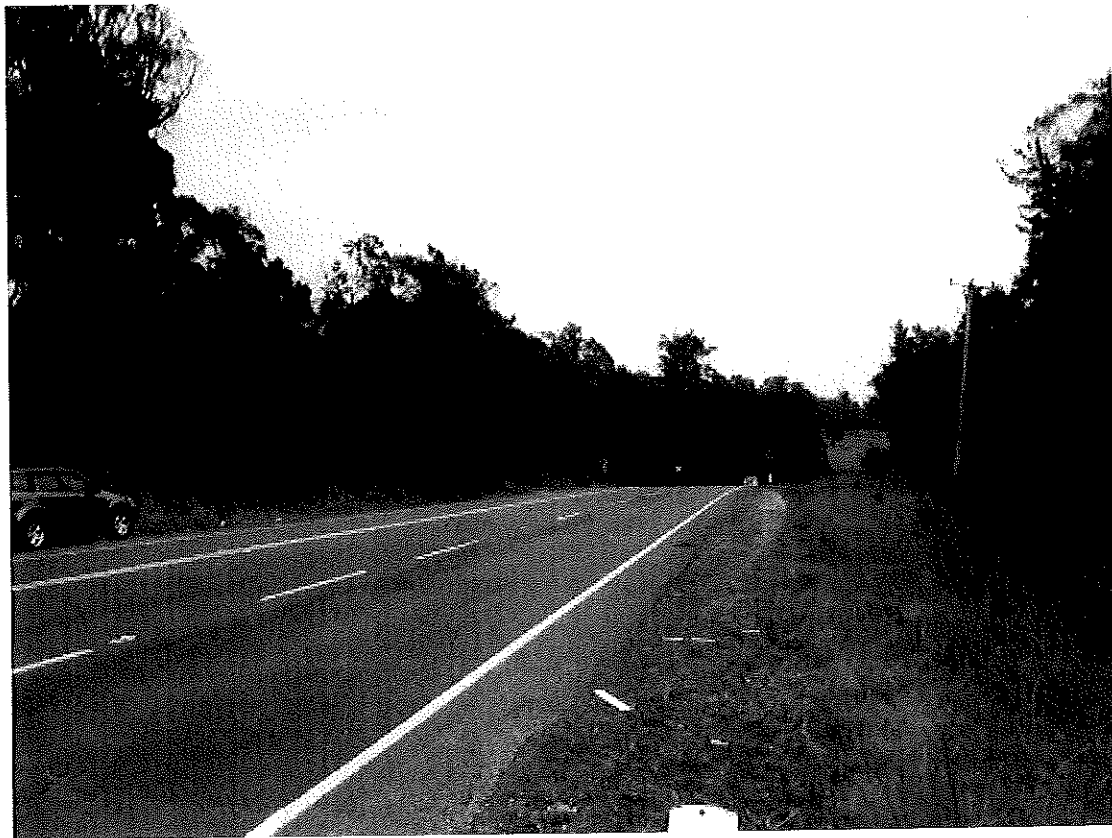
Figure 3 Crest North of Masons Road

The Masons Road junction is located approximately 70m south of an existing crest in the West Tamar Highway that significantly impedes sight distance. This crest is shown in Figure 3.

The project includes some trimming of this crest to provide Stopping Sight Distance (SSD) along the West Tamar Highway. This has necessitated the extensive use of retaining walls immediately north of Masons Road.

Safe Intersection Sight Distance (SISD) is the minimum required at junctions and is significantly more onerous than SSD. Whilst it can be provided to the south of Masons Road, providing it to the north would require the West Tamar Highway to be lowered significantly, including at Masons Road which

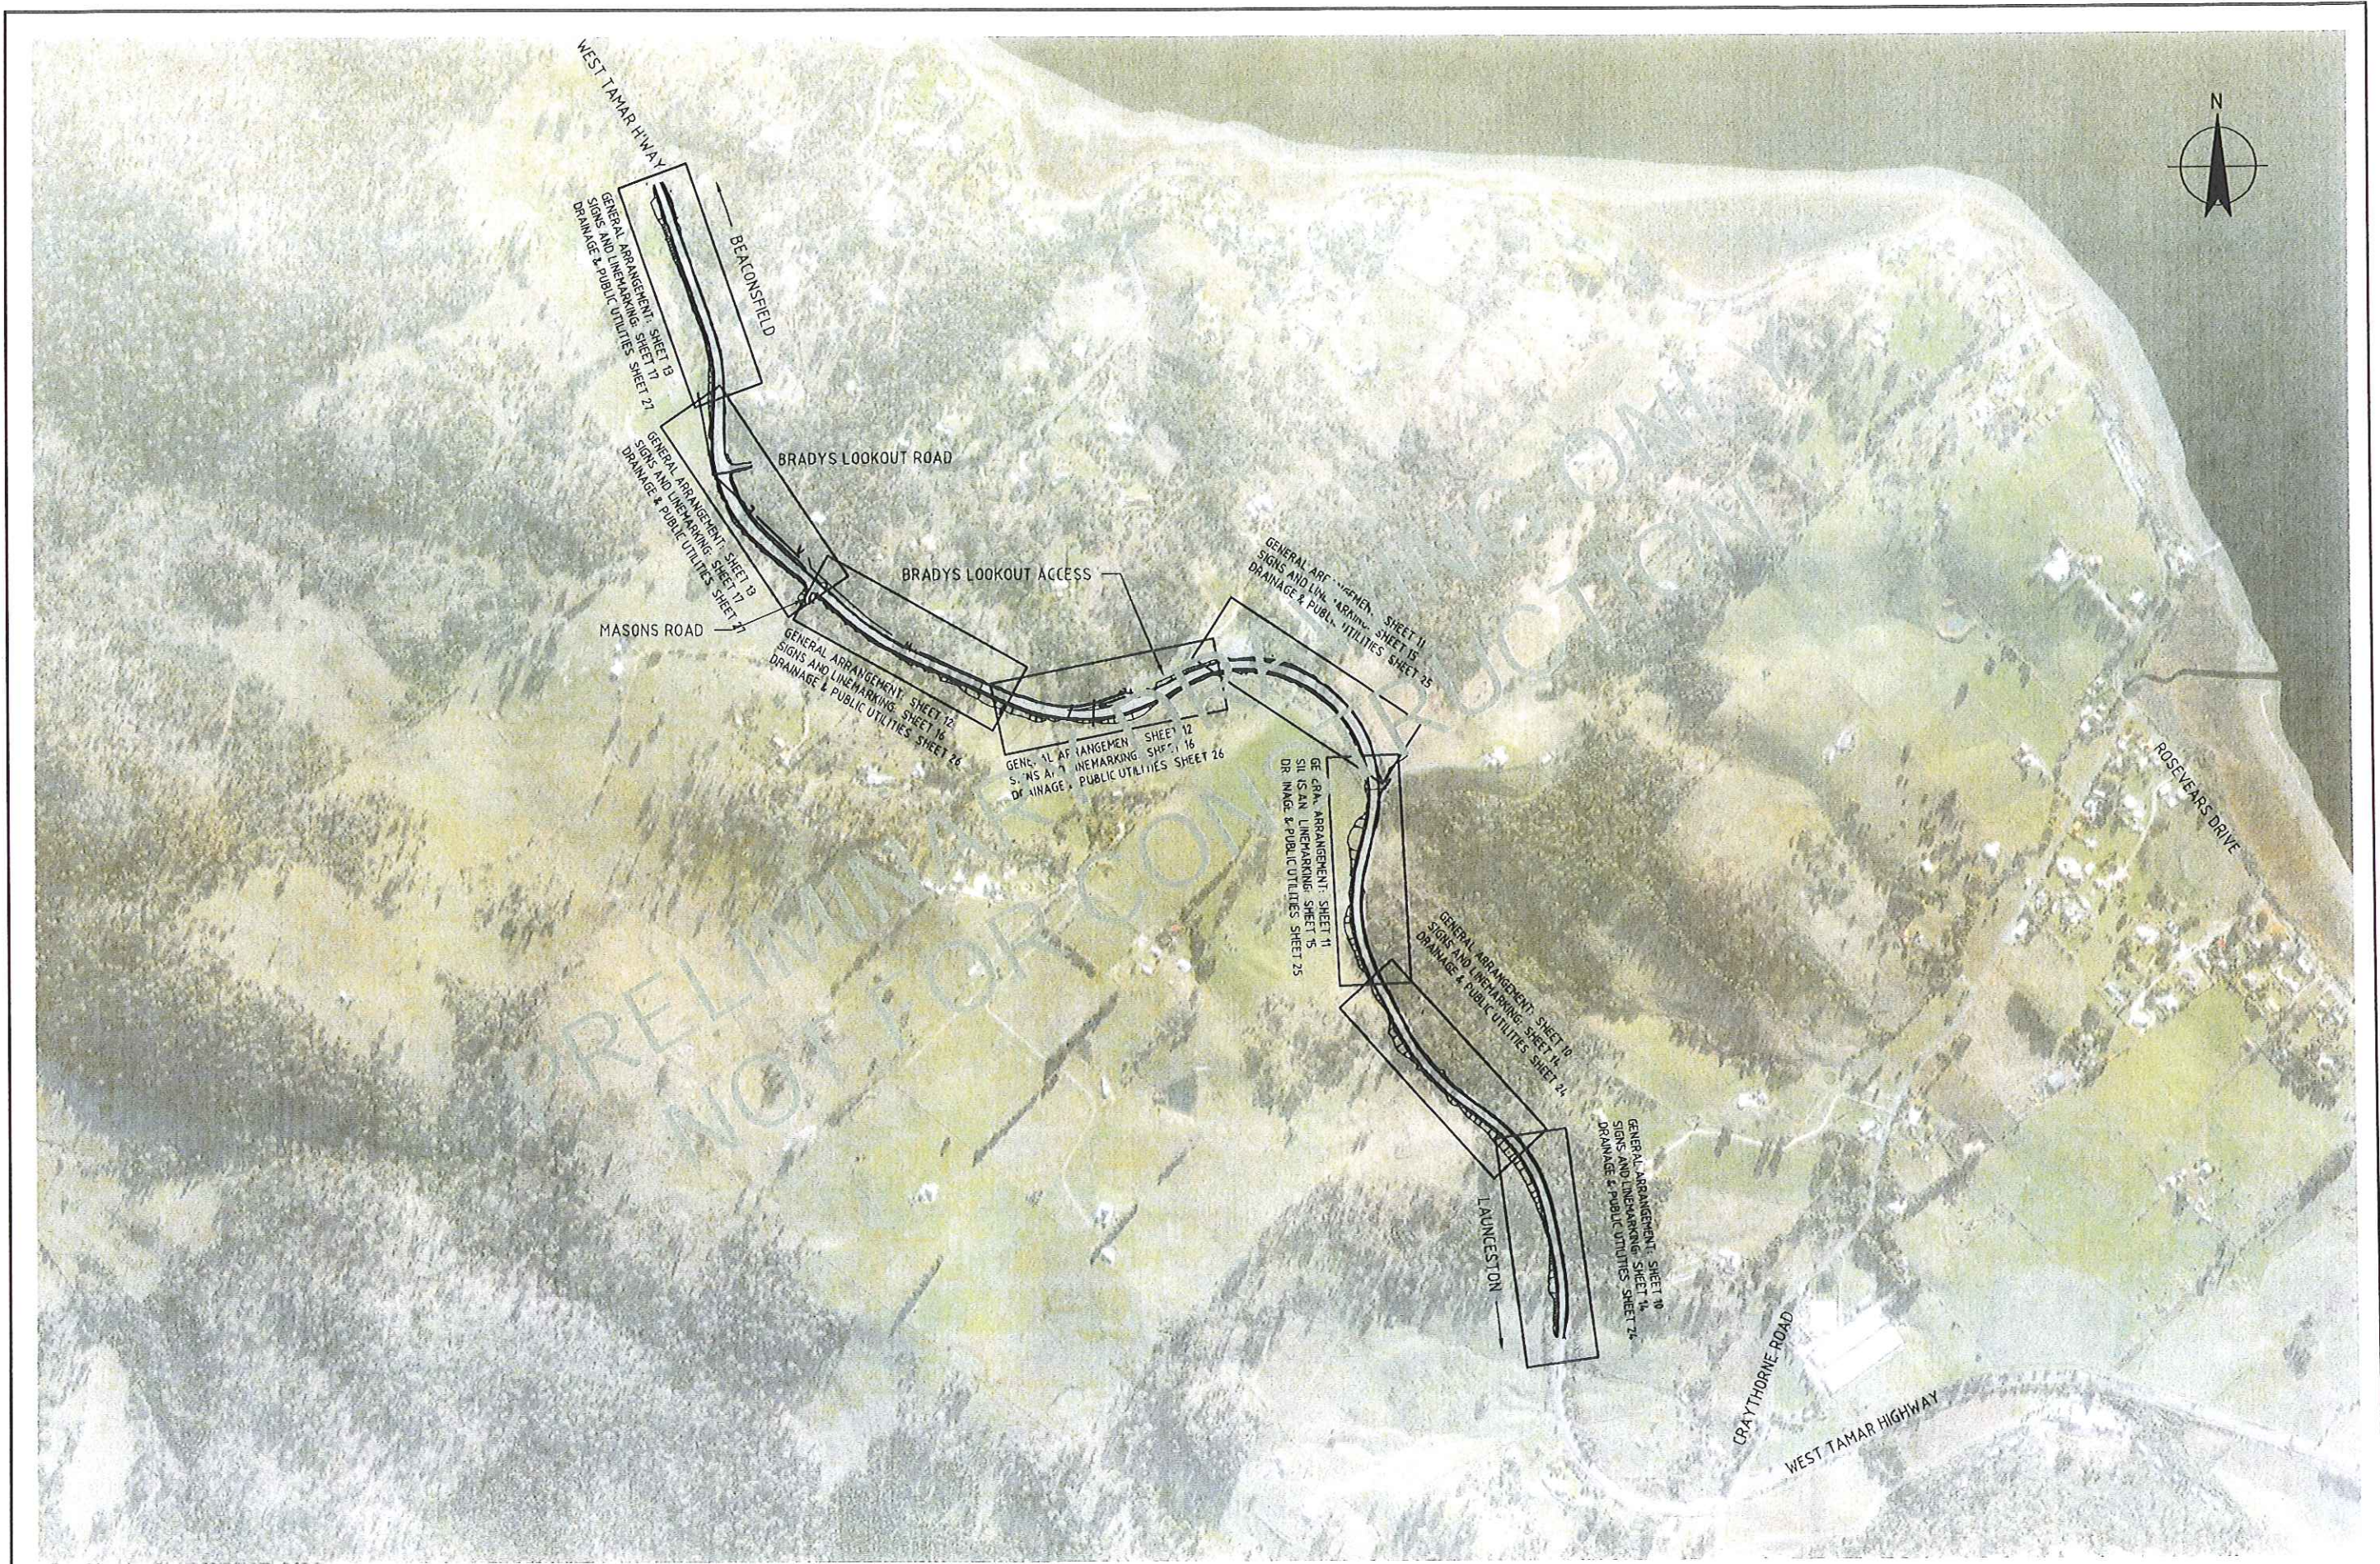
<p>SCALES</p> <p>0 100 200 300m</p> <p>SCALE 1:10,000 AT ORIGINAL SIZE</p>		<p>DESIGNED G.R.S.</p> <p>REVIEWED D.A.R.</p>		<p>Infrastructure Energy and Resources</p> <p>WEST TAMAR HIGHWAY (A0252)</p> <p>NEAR BRADYS LOOKOUT</p> <p>WIRE ROPE SAFETY FENCE AND</p> <p>PAINTED MEDIAN UPGRADE</p> <p>KEY PLAN</p>		<p>FILE No.</p>	<p>DRAWING</p> <p>32-15361-C009.dwg</p>	<p>PRINTED DATE</p> <p>06-Jun-11, 3:05 PM</p>	<p>SHEET No.</p> <p>5</p> <p>OF</p> <p>91</p> <p>VOLUME 1</p>
A	PRELIMINARY DESIGN	M.A.K.	11/03/11							<p>REGISTRATION NUMBER</p> <p>A0252.001</p>			
No.	Amendment Description	Initials	Date										
A3 original				This sheet may be prepared using colour and may be incomplete if copied		Co-ordinate System: MGA Zone 55		Height Datum: A.H.D.
