From: Kevin Moore
Sent: Monday, 14 July 2014 1:00 PM
To: Graeme Wood
Cc: Stuart Loone; Craig Heron
Subject: TRIM: Wharf Purchase
Attachments: Spring Bay Wharf Remedial Works 2011 PKC.doc.doc; ASD Pile inspections wharf stem.pdf.pdf; ASD Pile inspections wharf head.pdf.pdf

RE Triabunna Mill Wharf Inspection 1.7.09

SPRING BAY WHARF

Spring Bay Wharf

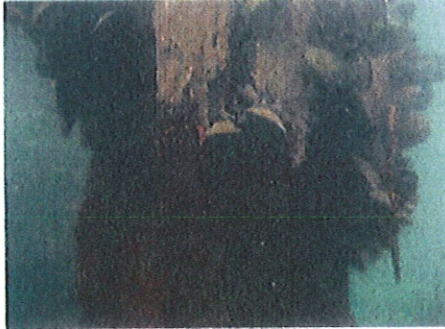
IMG_0932.jpg
01/07/2009

ROW No.	AISLE No.	ATTACK (Y/N)	PILE DAMAGE (%)	WRAPPING	CONC. SLEEVING	SCORE	REPAIRS NEEDED & COMMENTS
BD4	1	Y	15			4	
BD4	2	Y	20			3	
BD4	3	Y	50			2	Tidal area and top of pile # 0938 # 0932
BD4	4	Y	40			3	Tidal area
BD4	5	Y	35			3	
BD4	6	Y	75			2	Tidal Area # 0929 # 0930
BD5	1	Y	10			4	
BD5	2	Y	20			4	
BD5	3	Y	20			4	
BD5	4	Y	35			3	
BD5	5	Y	10			4	
BD5	6	Y	30			3	
BD6	1	Y	25			3	
BD6	2	Y	10			4	
BD6	3	Y	20			4	
BD6	4	Y	30			3	Tidal and mudline area
BD6	5	Y	20			4	
BD6	6	Y	10			4

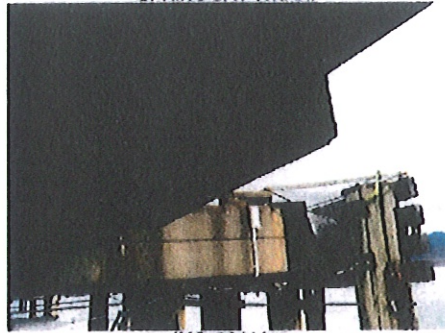
IMG_0944.jpg
01/07/2009

Cracking to 5mm over approx 3m side and underside of beam
[943](#)
[944](#)

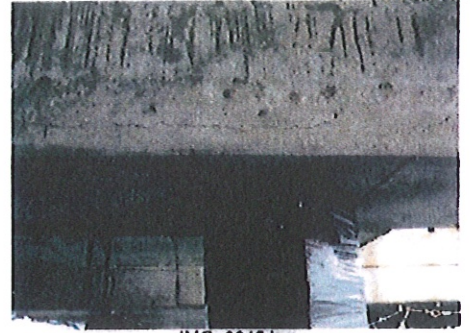
IMG_0946.jpg
01/07/2009

Cracking to 5mm to underside of beam over approx 3m
[946](#)
[947](#)

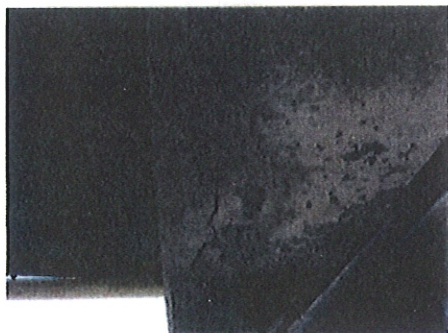
IMG_0949.jpg
01/07/2009

Cracking to 3mm on side and underside of beam
[949](#)
[950](#)

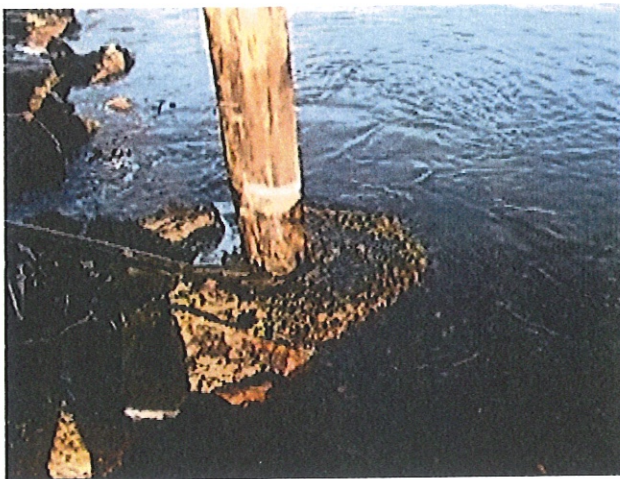
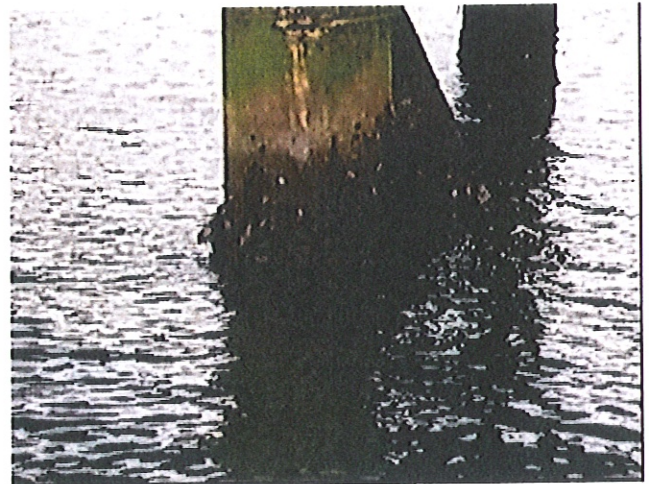
- The treated timber piles supporting the wharf stem have substantial loss of section mainly in the tidal zone caused by wave action due to damaged or no pile wrapping. The underwater sections of the piles have large amounts of marine growth and indicate that the pile could be subjected to Toredoworm attack. Toredoworm attack occurs from the inside out and the pile ends up with honeycomb sections and loss of

Photo shows the extent of the deterioration and pile condition

- The 2009 underwater pile inspection identified that a number of timber piles had substantial section loss in the range of 15%-75% and required concrete encasement. As there has not been a pile inspection undertaken since 2009 it would be expected that the extent of deterioration will have increased.
- Currently there is a program to encase 8 piles identified in the 2009 pile survey as having 50% or above deterioration in the 2010-11 financial year. A review of current pile deterioration is required to access future pile remediation work.
